IR 21-024
Department of Energy, Division of Enforcement
INVESTIGATION REPORT
OF
WATER PRESSURE REDUCTION MATTER
IN ROSEBROOK WATER SYSTEM
August 31, 2021
Abenaki Water Company, Inc – Carroll, New Hampshire

The investigation focused on a system pressure design issue within the Rosebrook water system. The Division of Enforcement Safety Staff reviewed the root causes of the pressure issue identified in Docket DW 17-165, the Company's efforts to resolve that issue, and alternative engineering options considered by the Company to address pressure concerns. Staff reviewed prior Company filings, conducted in-person investigations of the system and interviews of Company personnel, evaluated system operations, analyzed the source of the pressure issue, and proposed options put forth by AWC to address the existing water pressure issues. Safety Staff's review noted a number of deficiencies in the Company's operation and maintenance of the Rosebrook system.

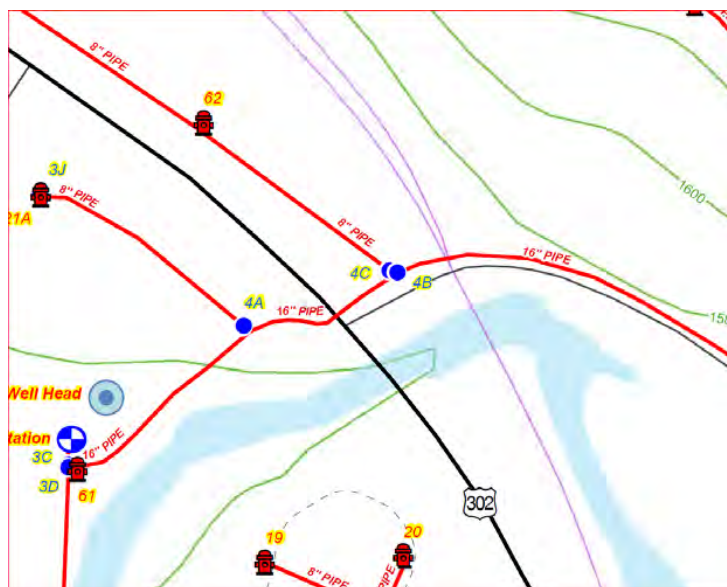
Figure 2-1 indicates an area in which excavation was performed near the 16-inch diameter water main between valves marked 4A and 4B but no markings by AWC were shown. Puc 800 rules require markings of any underground water mains within the tolerance zone or method of providing positive response that there are no such facilities within the tolerance zone. AWC did neither.

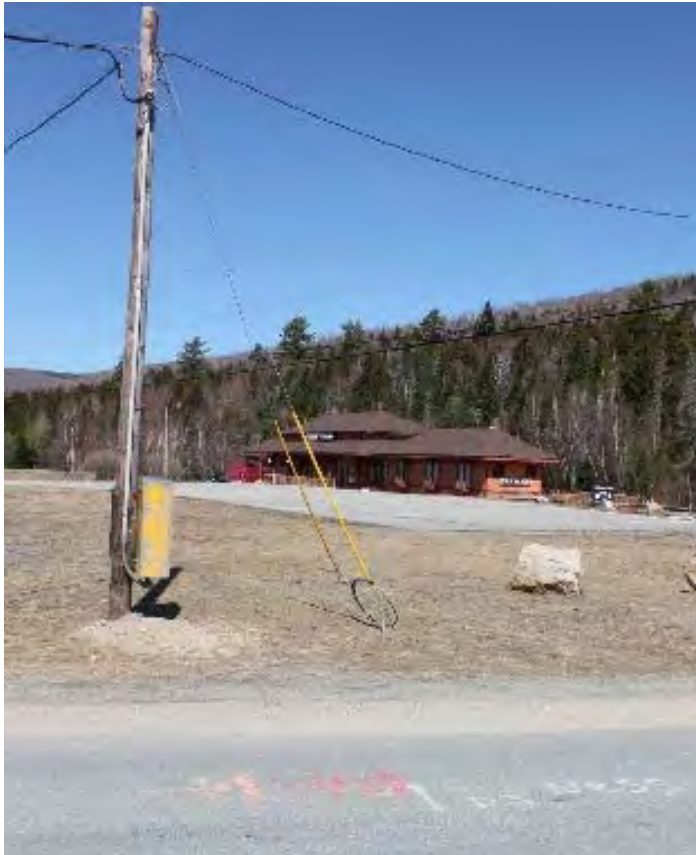
Photo 2-1 indicates an area in which excavation was performed to install a pole as indicated by the fresh dirt with Dig Safe pre-marks to show the tolerance zone in white with no blue markings by AWC. Puc 800 rules require markings of any underground water mains within the defined tolerance zone of an excavation area.

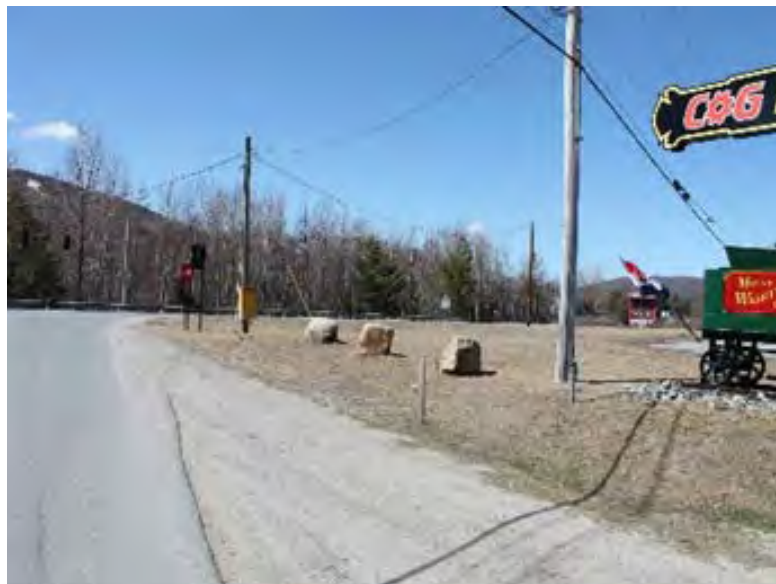
Photo 2-2 indicates an area in which excavation was performed but no markings by AWC are shown. Puc 800 rules require markings of any underground water mains within established tolerance zones or provide positive response that no water mains are present within the tolerance zone.

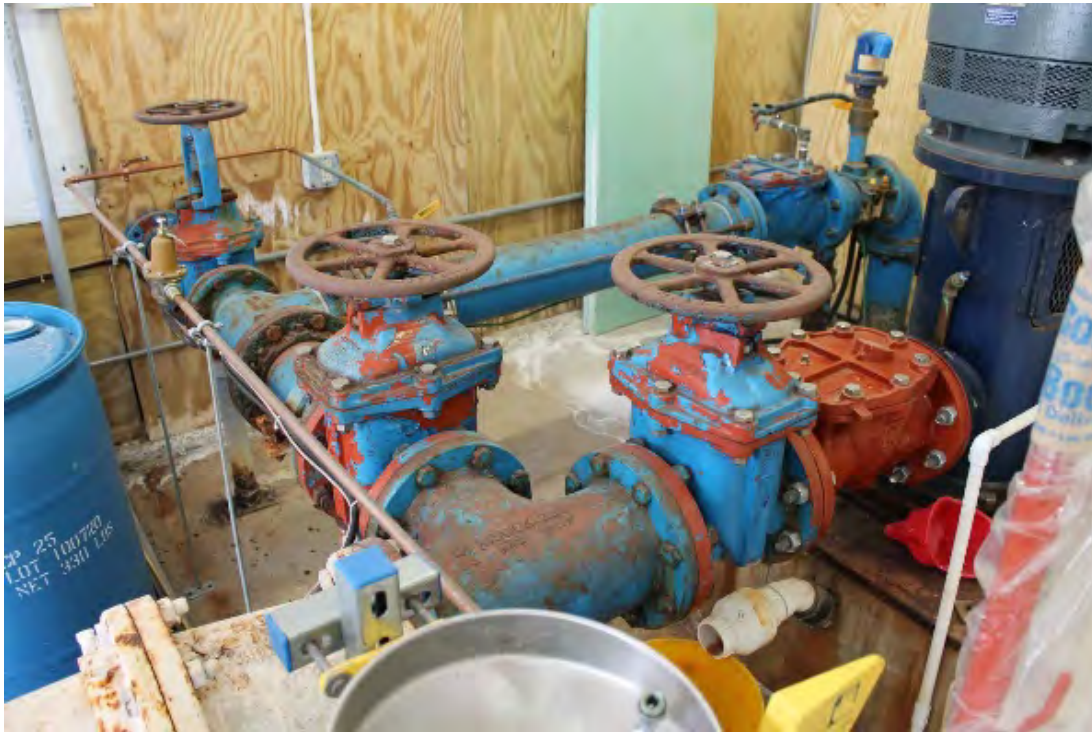
Photo #5-01 Depicts corrosion of pump station piping components.

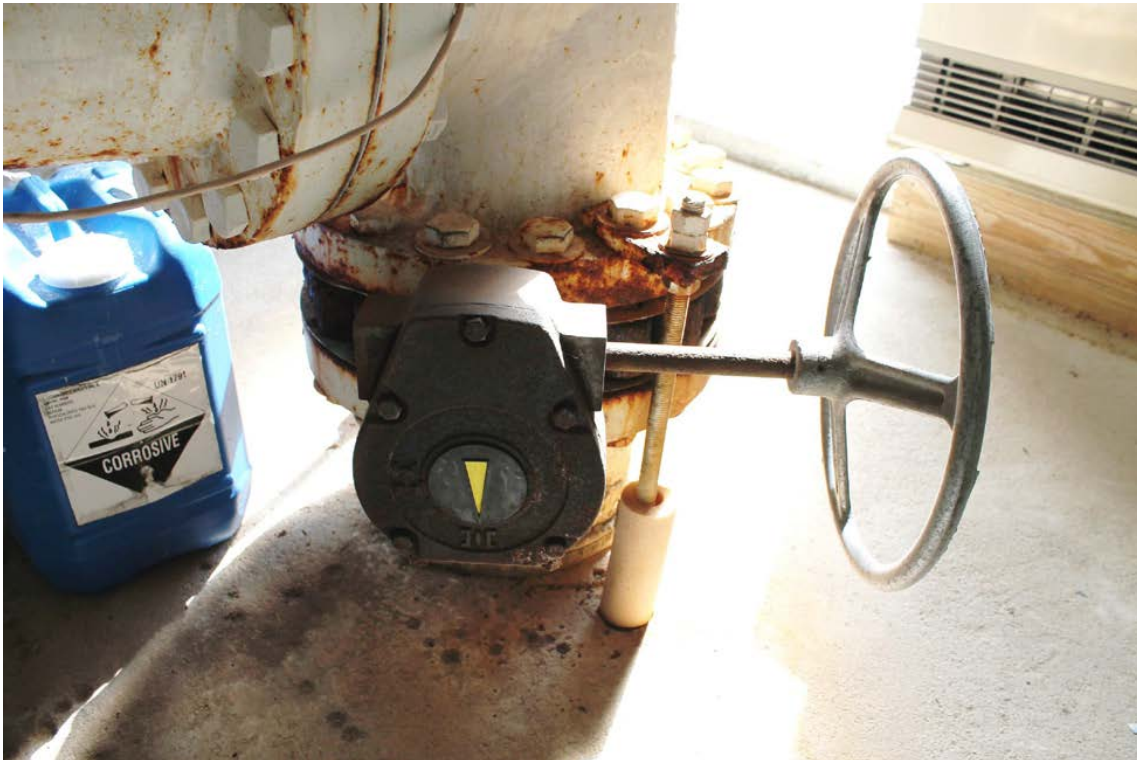
Photo #5-02 Depicts main system shut off valve noting storage of corrosive chemicals.

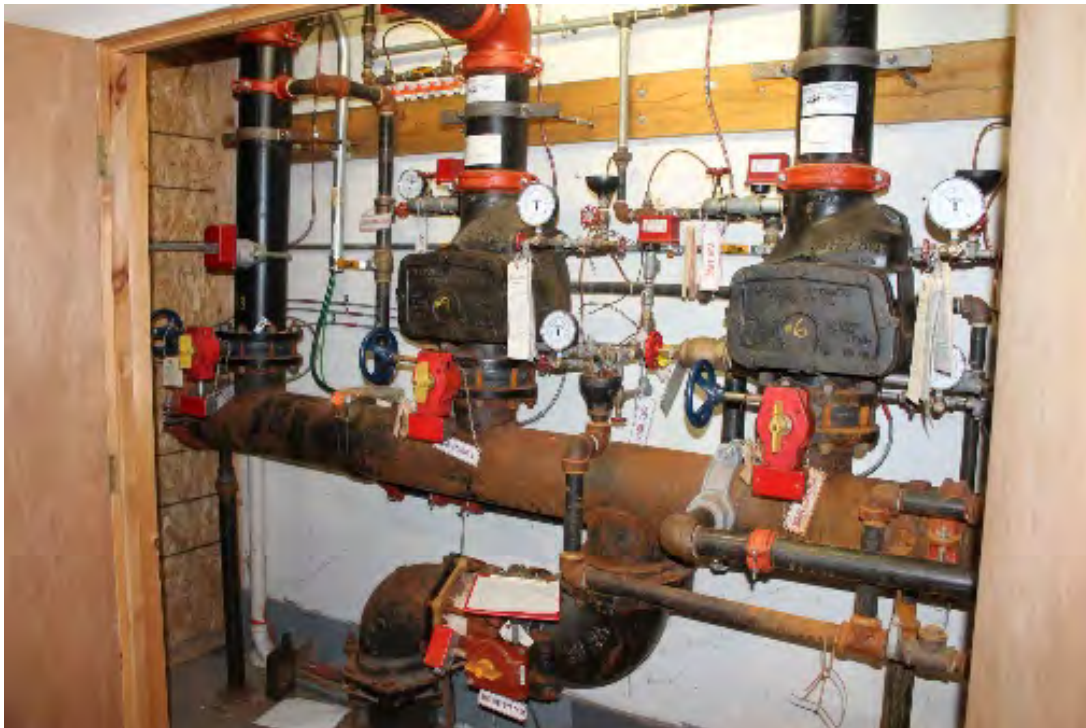
hundred to 880 gallons per minute for the design of the systems. Hotel personnel were questioned and advised to seek guidance from their fire protection companies and fire protection design teams in order to be able to properly determine the greatest water supply demand in pressure and flow in order for these code-required fire protection systems to properly operate as designed.

Photo #5-03 View of several fire sprinkler system risers at Mt. Washington Hotel.

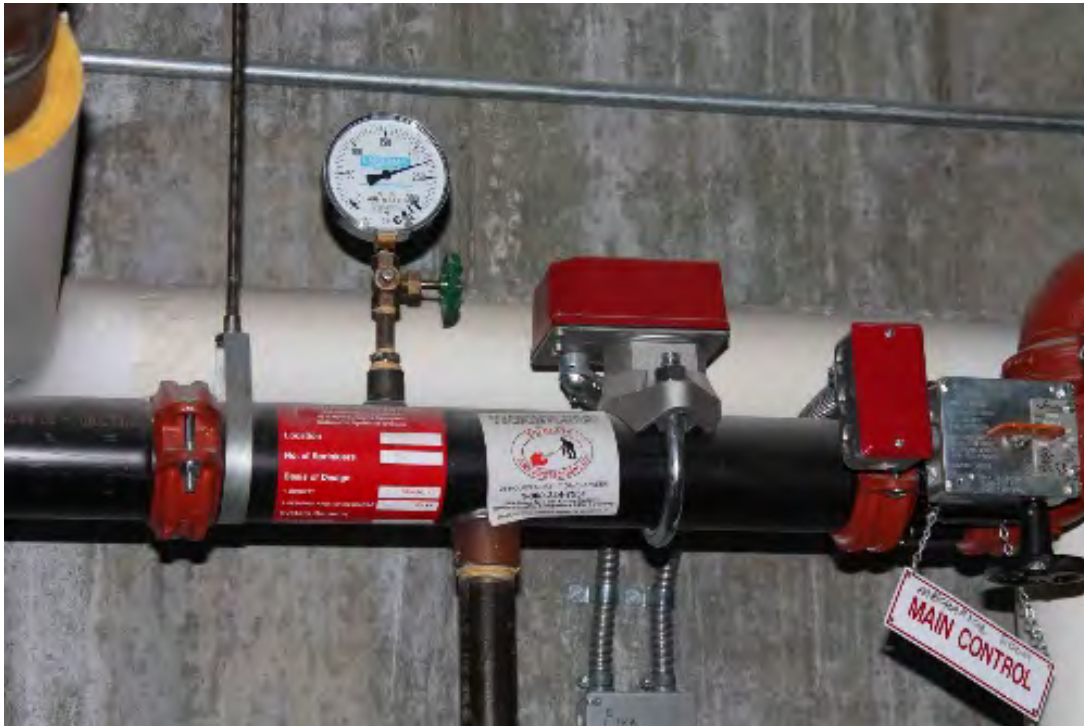
³ Although AWS and its engineering consultant indicated that pressures ranged 150 -200 psi, Staff later observed pressures as high as 225 psi in the Mt Washington Hotel as shown in Element #5 Item 3 and photo #5-4.

Photo #5-04 View of a Mt. Washington hotel fire sprinkler system pressure gauge noting 225 psi.

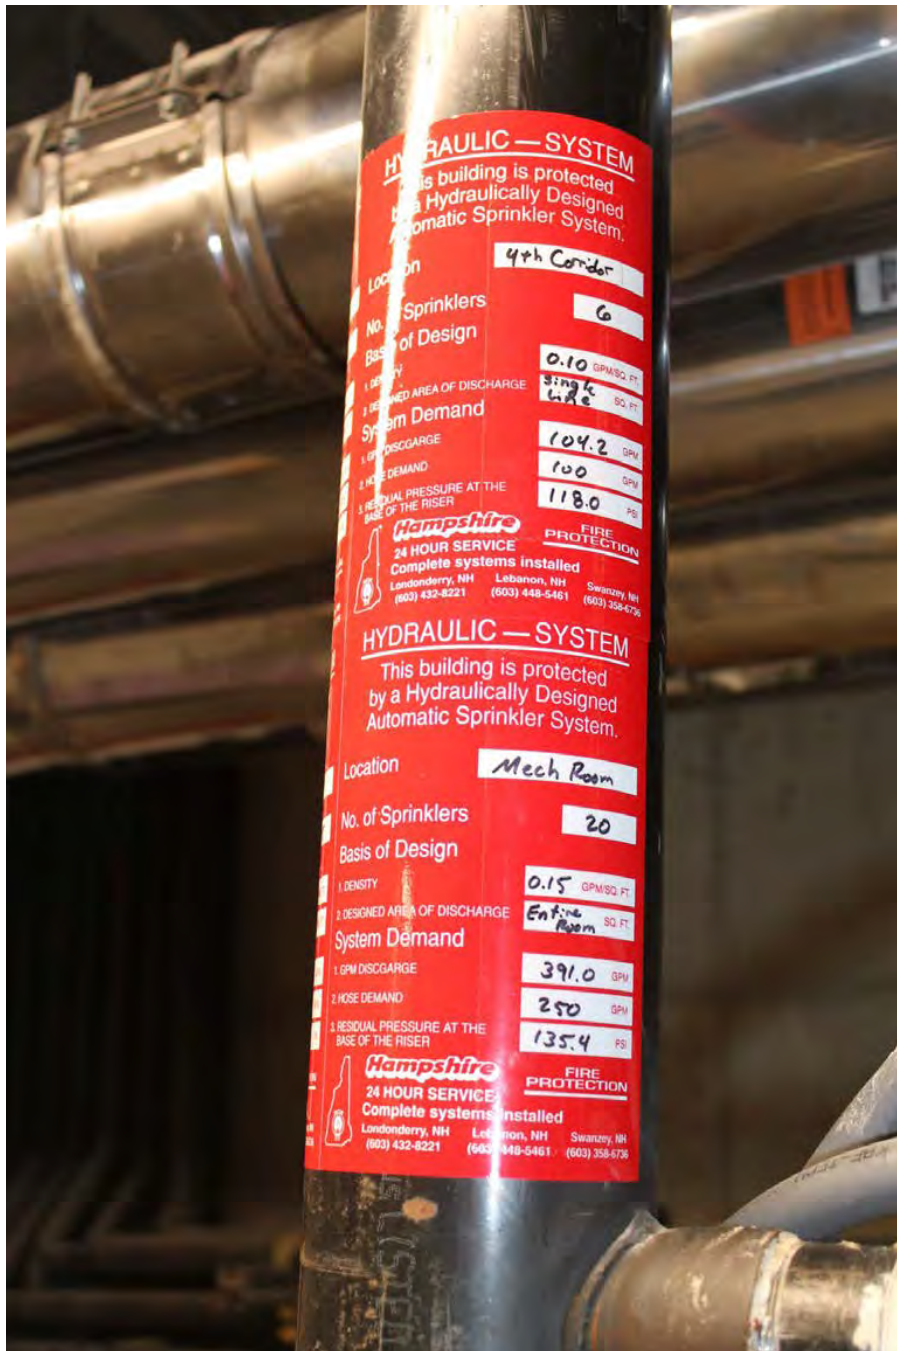
Photo #5-05 View of hydraulic data plates on Mt. Washington hotel fire protection, noting a system demand of 135 psi.

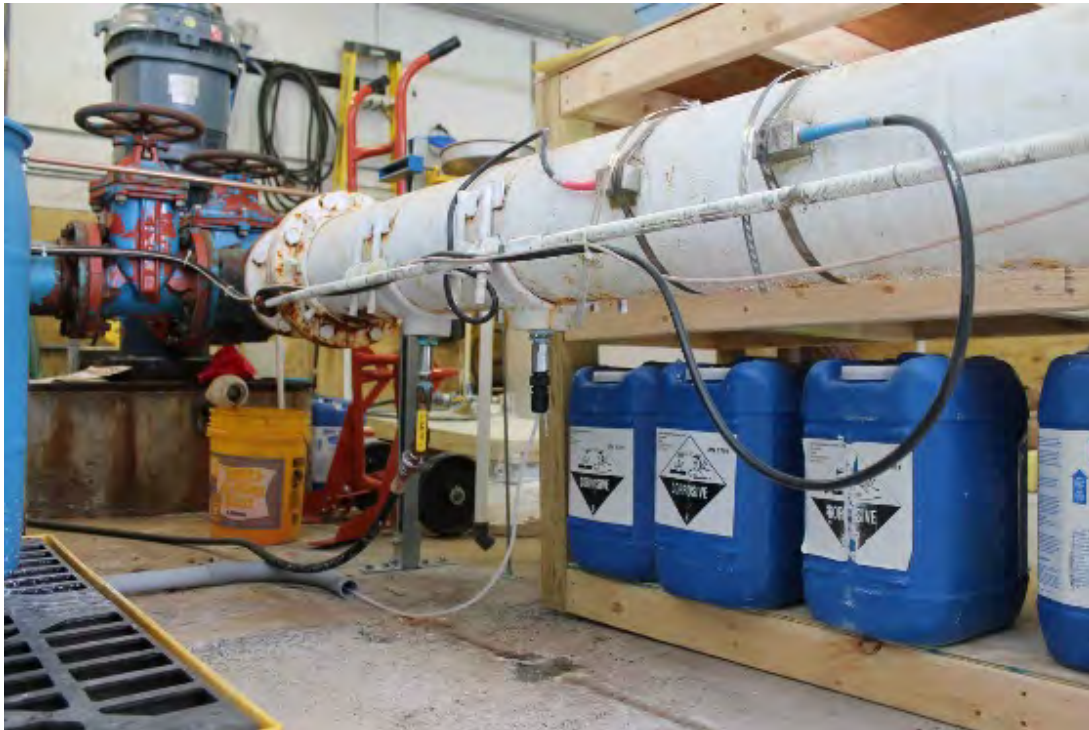
Examination of the pump station building revealed the area of greatest employee safety to be related to chemical injection equipment and water main control valves that displayed corrosion most likely resulting from equipment age, wear-and-tear, and the corrosive atmosphere from stored chemicals.

Photo #5-06 View of pump station components with stored corrosive chemicals, creating corrosive atmospheric environment.

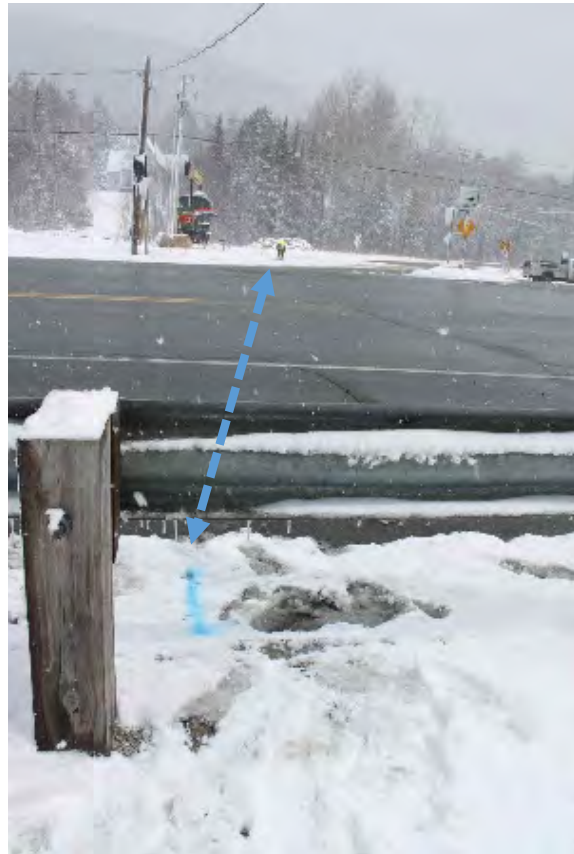
Photo #5-07 Blue dotted line represents approximate location of 16" transmission main crossing US Route 302 toward Base Station Road. Recently erected utility poles were installed within immediate area of transmission main, as shown.

Results of this water utility mark-out process, which was not completed by AWC personnel as required prior to the bridge construction work in this area, resulted in the confirmation the installation of utility poles and anchoring systems clearly entered the water utility facility space. The significance of this issue cannot be understated as identified during this investigation.

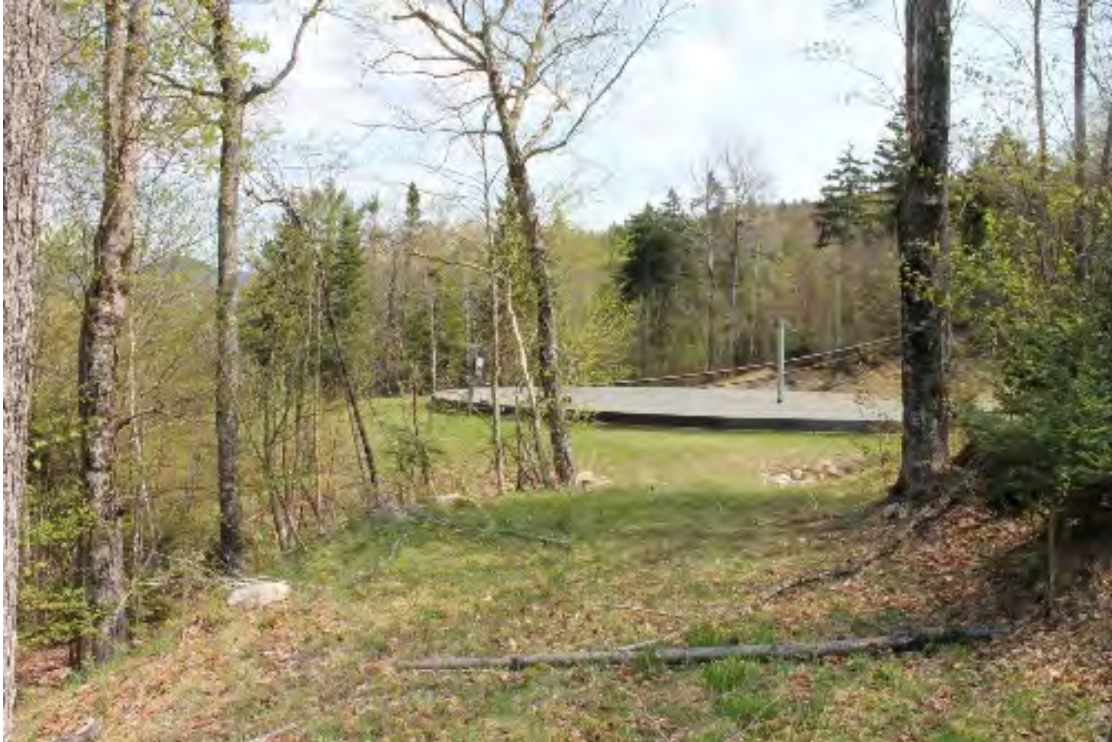
Photo 5-10 View of underground storage tank located in area of Bretton Woods ski slope depicting lack of security fencing.
