CHAPTER IV

System Planning, Design, Construction, and Protection

DECEMBER 2008 ICE STORM
Chapter IV - System Planning, Design, Construction, and Protection

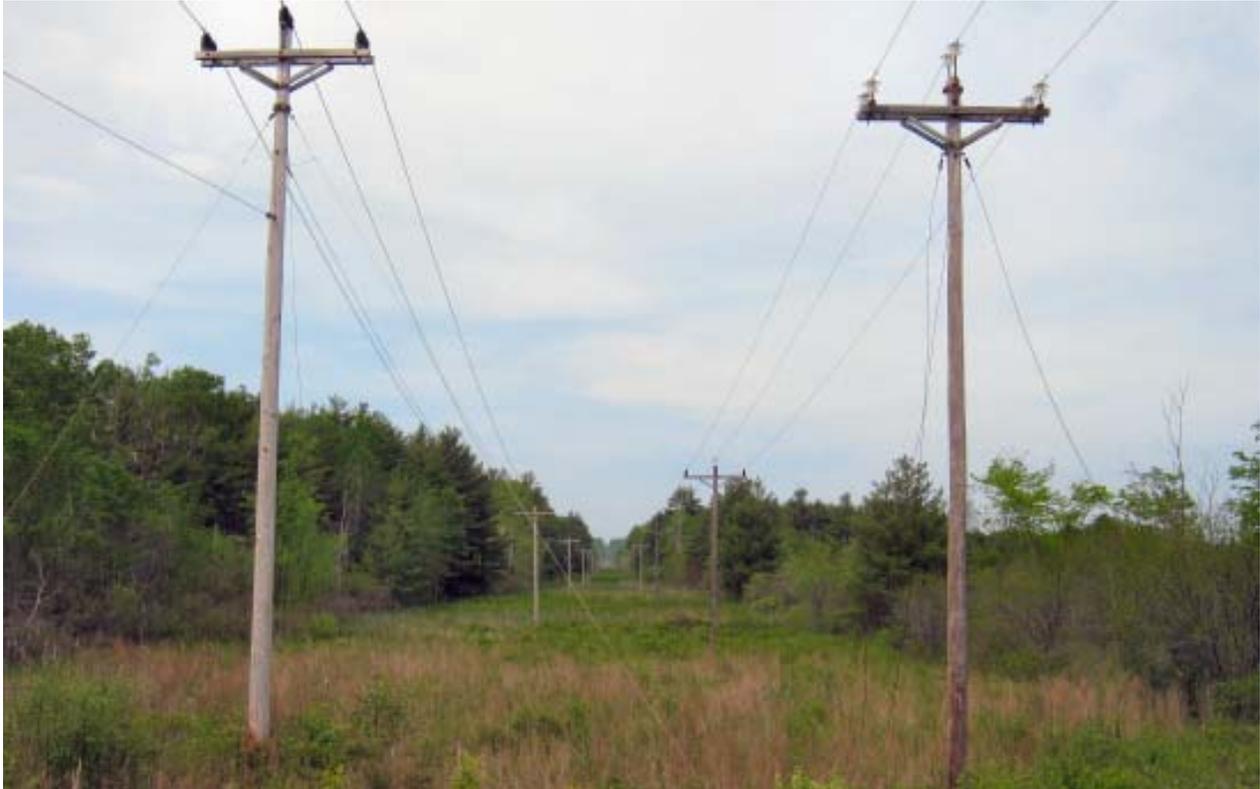
Figure IV-3 shows a pair of 34.5 kV sub-transmission lines on the Unitil system. The 34.5 kV circuit on the left consists of single wood poles, three current-carrying conductors attached to cross arms, and a grounded neutral wire attached to the pole below the cross arm. The 34.5 kV circuit on the right has three current carrying conductors, but has no grounded neutral wire and thus relies on the neutral of the other line in the ROW for single-phase, 19.9 kV distribution loads. In both circuits, the current carrying conductors are bare and rely on air for electrical insulation. Note that the construction of the sub-transmission lines is not as robust as the previously described transmission lines and, in this case, consists of wood poles and cross-arms that take on a similar appearance to the distribution system described below. Also note in this case that the electric sub-transmission lines are located in a dedicated ROW that is reasonably free of tall vegetation. There are no trees under or between the lines and the tall vegetation at the edges of the ROW is kept clear of the lines. The ROW in Figure IV-3 represents a very good practice and is more typical of a transmission ROW than a distribution ROW. The practice of clearing vegetation from the ROW results in greater reliability for the line. It limits incidental contact between the energized lines and vegetation and reduces the possibility that wild fires could occur under the line causing damage.

Figure IV-3 – Two 34.5kV sub-transmission lines located on the Unitil system. (Photo by NEI - Unitil System)

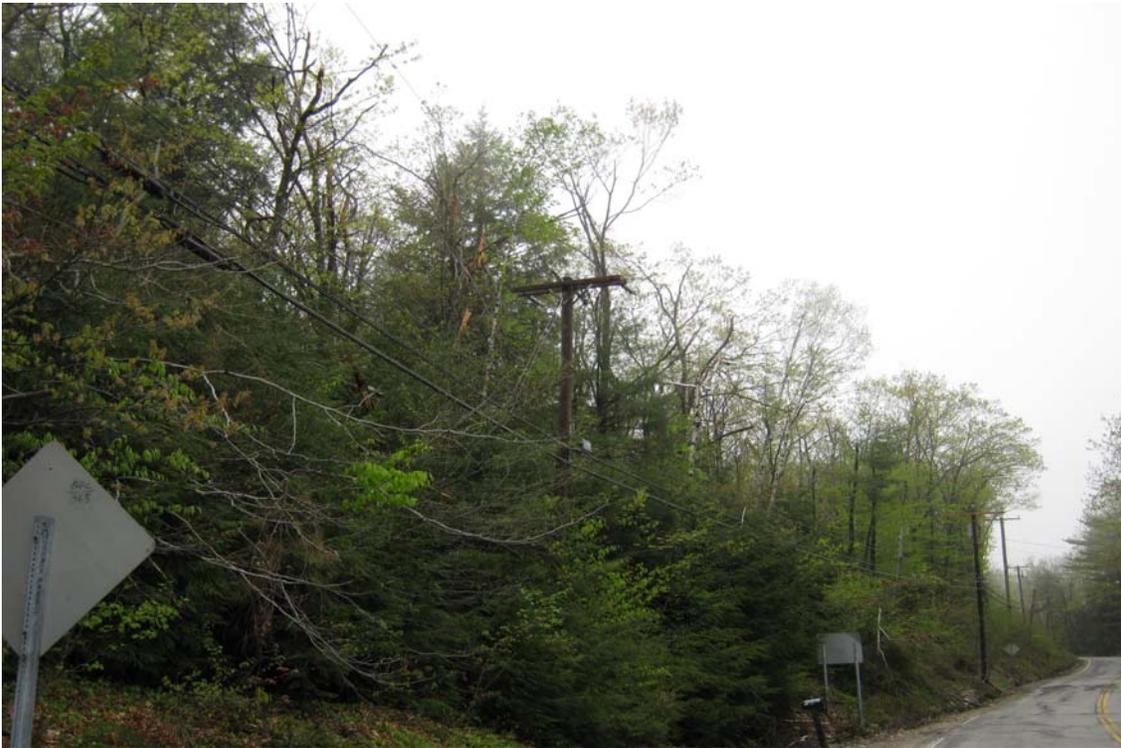
Figure IV-5 shows a typical rural overhead distribution line located in southwestern New Hampshire. Distribution lines in New Hampshire are usually constructed adjacent to roads and highways where they share a combination of public and private land and compete for space with trees. This distribution line follows the road and each pole must be capable of handling the cables and equipment shown in Figure IV-4. Unlike the transmission and sub-transmission lines shown in Figure IV-1, Figure IV-2, and Figure IV-3, the ROW under this line has not been well cleared.

Figure IV-5 - Typical PSNH distribution circuit near Greenville, New Hampshire.
(Photo by NEI - PSNH System)

Distribution systems are planned, designed, constructed, and protected in accordance with the National Electrical Safety Code and good utility distribution practices. During the December 2008 ice storm, the electric distribution system in New Hampshire was extensively damaged by ice laden tree limbs and whole trees falling onto power lines. Absence of a clear ROW, as is shown in Figure IV-5, can contribute to such damage.

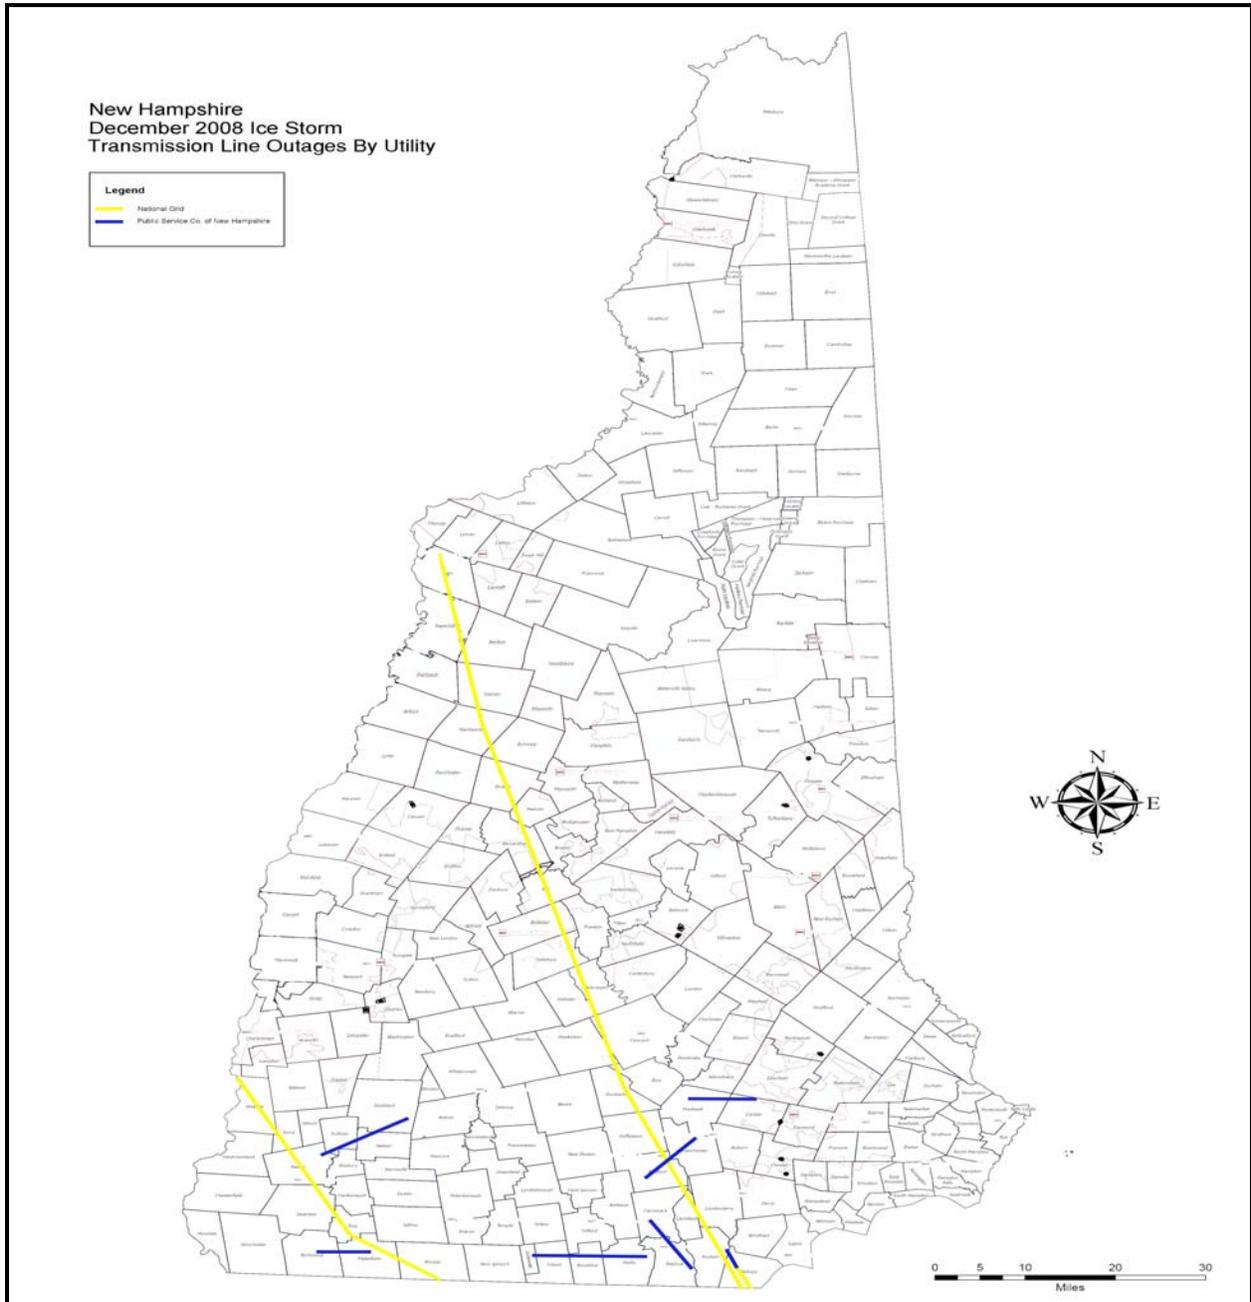
The following is a summary of each utility's transmission line outages including a map in Figure IV-8 that shows the locations of the transmission lines which tripped off during the storm.

Figure IV-8 – Transmission line outages due to the December 2008 ice storm.

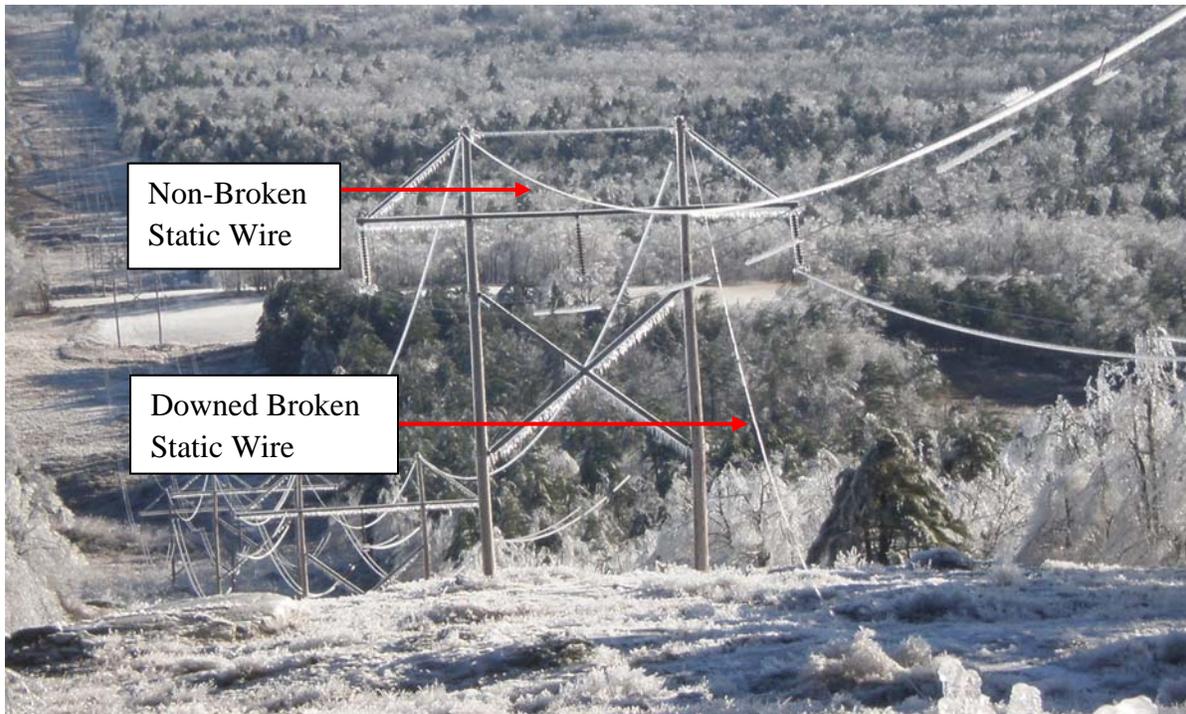
The PSNH broken static line was probably one of the more severe problems on the transmission system since it affected a 345 kV line that was out of service for over 61 hours. A review of that incident revealed that an ice laden static wire²⁷ came into contact with energized phase conductors.

Figure IV-9 shows the conditions after the static line failure. As can be seen in the bottom right side of the picture, the static wire which is normally on the top of the right leg of the two-pole wood H-Frame 345 kV structure is now lying on the ground. The static wire attached to the top of the left leg is still in place but sagging extremely low and appears to be near one of the 345 kV phase conductors. While this could be somewhat of an optical illusion, a small wind could blow the static wire into the phase conductor. Evidence that wind accompanied the formation of the ice on the line is shown in Figure IV-10 where it may be seen that the icicles attached to the conductor are not vertical.

Figure IV-9 - PSNH 345kV line 367 - Static Wire Failure. (Photo courtesy of PSNH)

Recommendation No. 1: PSNH should inspect the condition of the static wire on Line 367, compare it with the original design, and present a report to the NHPUC.

- PSNH should determine if the 7 No. 10 Alumoweld static wire was damaged during the December 2008 ice storm.
- PSNH should determine if a similar failure during a similar icing condition is likely in the future.
- PSNH should determine if any upgrades or static wire replacements are needed as a result of the December 2008 ice storm.
- PSNH should determine and document the life expectancy of the remaining static wires on its system.
- PSNH should plan for upgrading static wires which may be reaching the end of their life and consider replacing existing wires with fiber optic overhead ground.

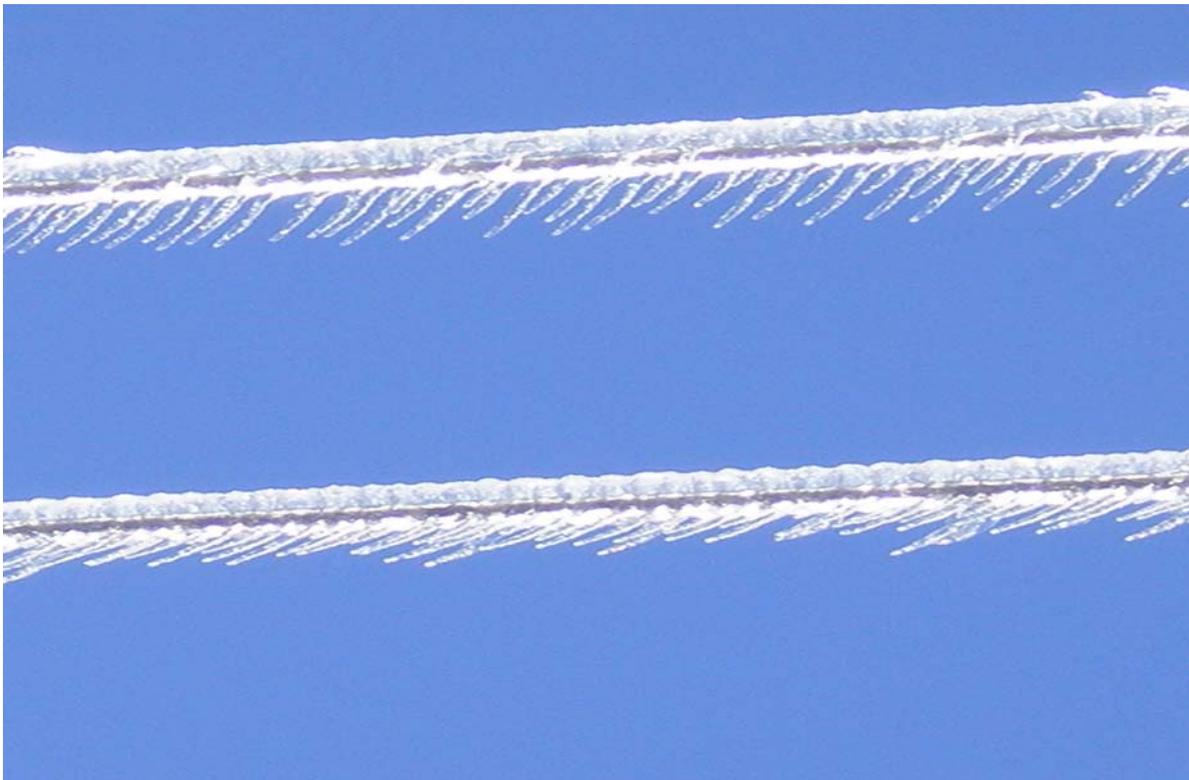
Figure IV-10 - Close-up of ice shown in Figure IV-9. (Photo courtesy of PSNH)

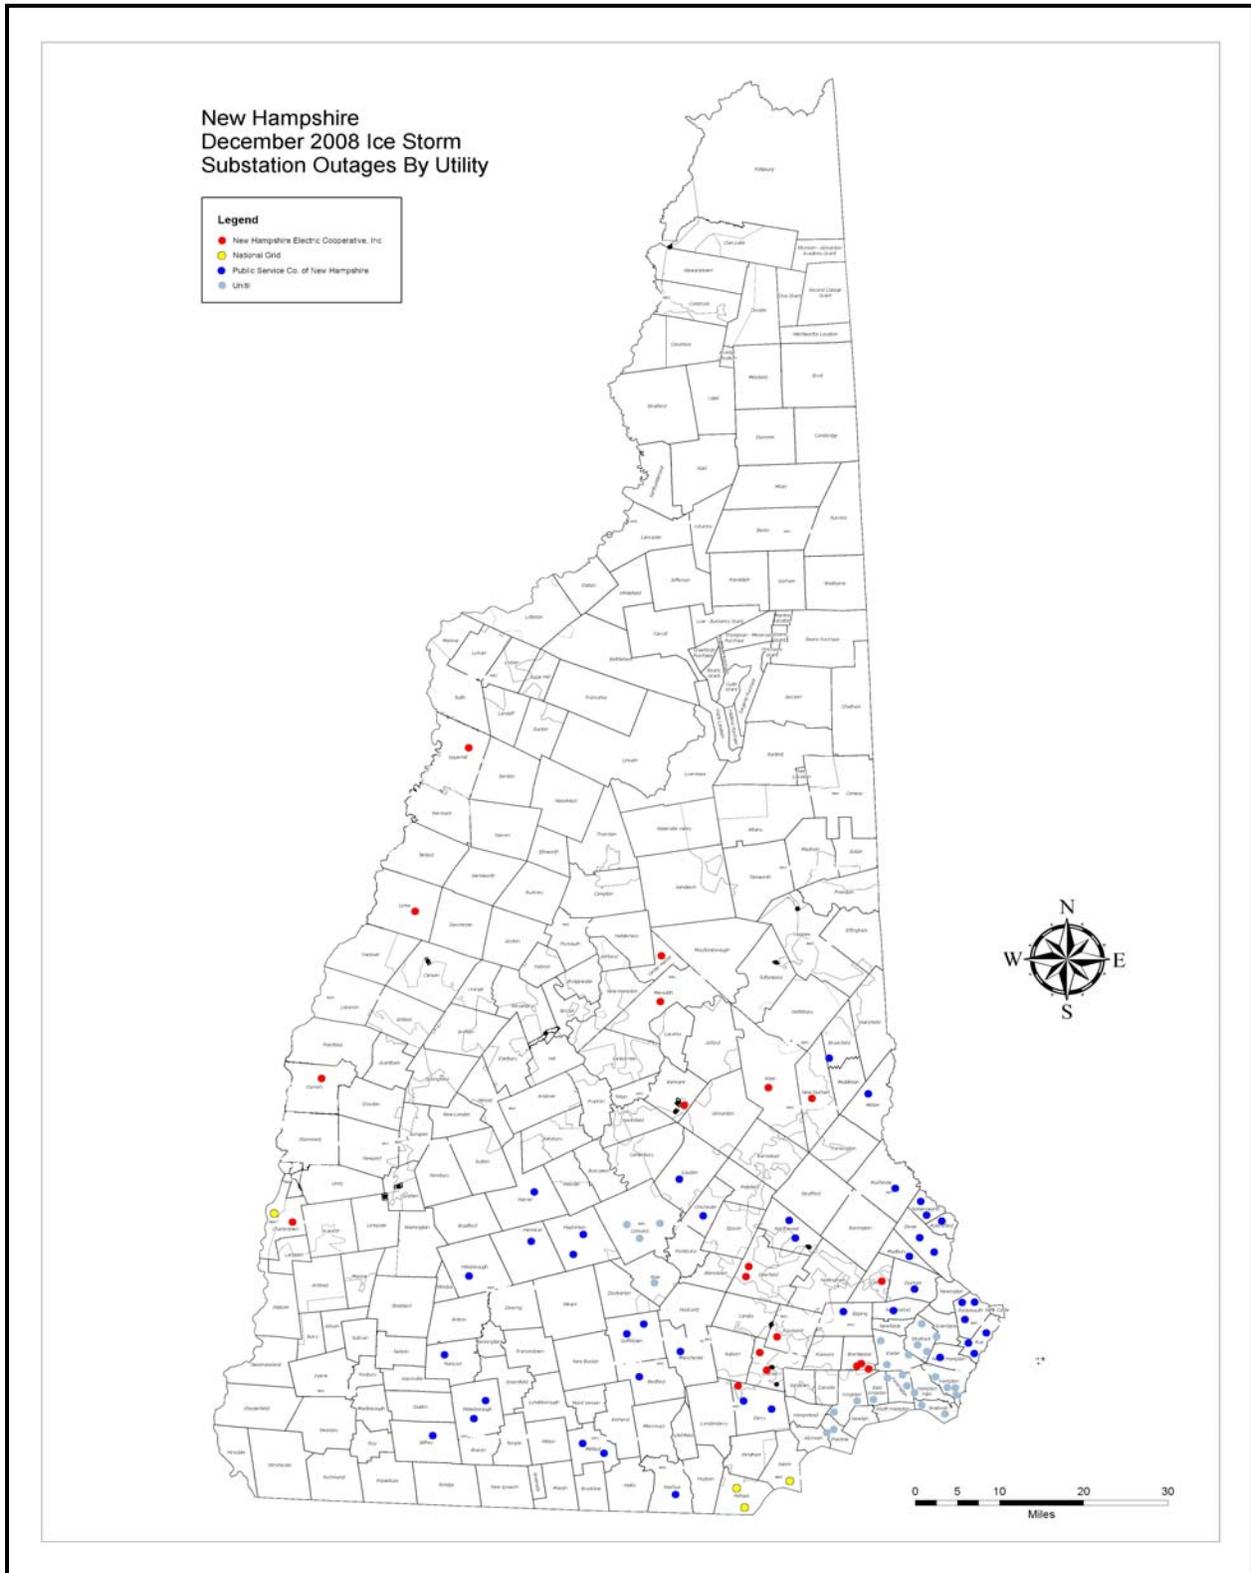
Conclusion: Approximately 100 distribution substations lost power during the December 2008 ice storm, affecting 159,549 customers. These substations are shown in Figure IV-11. Except for two minor exceptions, none of the outages appear to have been the result of inadequate planning, design, construction, or protection of the distribution substations.

Figure IV-11 – Substation outages due to the December 2008 ice storm.
