**State of New Hampshire  
Public Utilities Commission**

**Energy North Natural Gas, Inc. d/b/a National Grid NH  
Cast Iron/Bare Steel Replacement Program  
DG 10-139**

## 2009 New Hampshire Condition Bare Steel Main Replacement Program – Sample Analysis

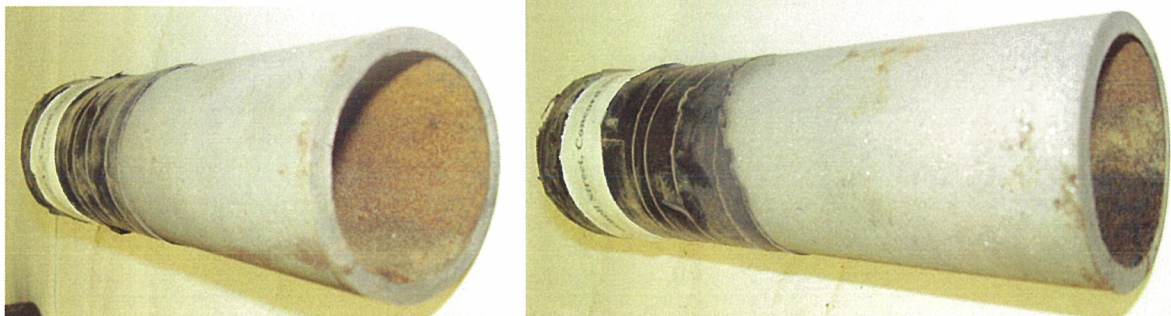
(1) **2-7Cornell Street, Concord – wo#641873** – 2 inch, 60 psig - installed in 1955

- A soil sample was taken and analyzed. The pH was measured to be between 7 and 8, slightly alkaline to neutral. Testing for chlorides was negative. Testing for microbiological acid producing (APB) and sulfate reducing bacteria (SRB) were performed. The APB testing produced a reading of 1,000 bacteria colonies per ML. The testing for SRB produced a reading of 10 bacteria colonies per ML. The soil was observed to be a normal color and odorless. Based on the testing, the bacteria levels of the soil do not appear to have accelerated the rate of corrosion.

- The pipe sample was coated steel, not bare as the records system had indicated. The sample was observed to be in good condition. Slight pitting was observed along the lines of the end of the tape seams. This segment was selected for replacement based on the attributed material of bare steel and the operating pressure of 60 psig. The selection was not based on leak history or an indication of poor condition. Exposure of this main should not result in a recommendation for replacement based on condition alone. Pit depths were not measured as the samples are available for continued visible review. Any pit depth readings taken are from the reference point of the remaining wall and do not represent the total amount of wall loss.

- (8) Segments for replacement should not be approved based on attributes alone. Segments of coated steel main that were previously thought to be bare have been included in the replacement program. Examples include Cornell St in Concord and Depot St in Franklin.

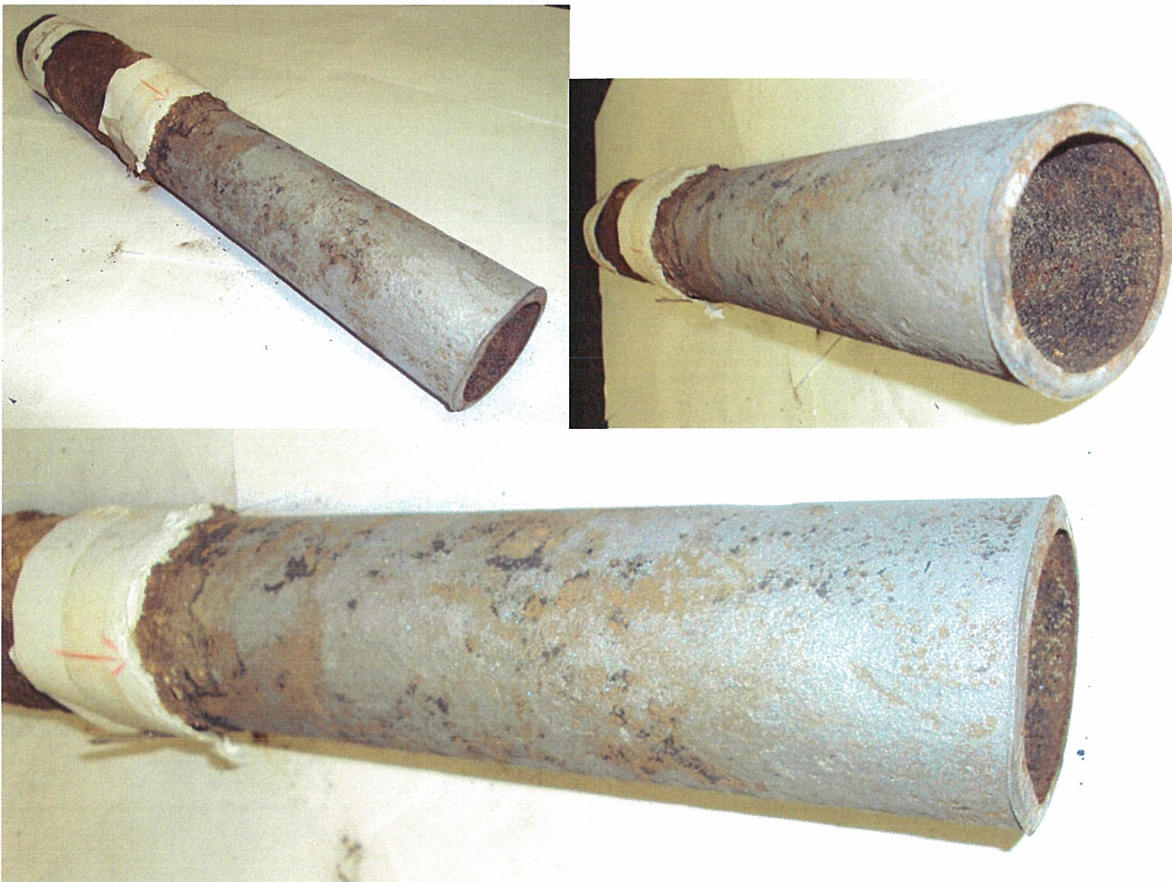
(2) **83 Pleasant Street, Concord – wo#588562** – 2 inch, low pressure, installed in 1900

- A soil sample was taken and analyzed. The pH was measured to be approximately 6, slightly acidic to neutral. Testing for chlorides was negative. Testing for microbiological acid producing (APB) and sulfate reducing bacteria (SRB) were performed. The APB testing produced a reading of 100,000 bacteria colonies per ML. The testing for SRB produced a reading of 100 bacteria colonies per ML. The soil was observed to be a normal color and odorless.
- The pipe sample was observed to be in fair to poor condition with some areas of pitting and wall loss observed. Exposure of this main should result in a recommendation for replacement. Pit depths were not measured as the samples are available for continued visible review.
- The following pictures were taken:

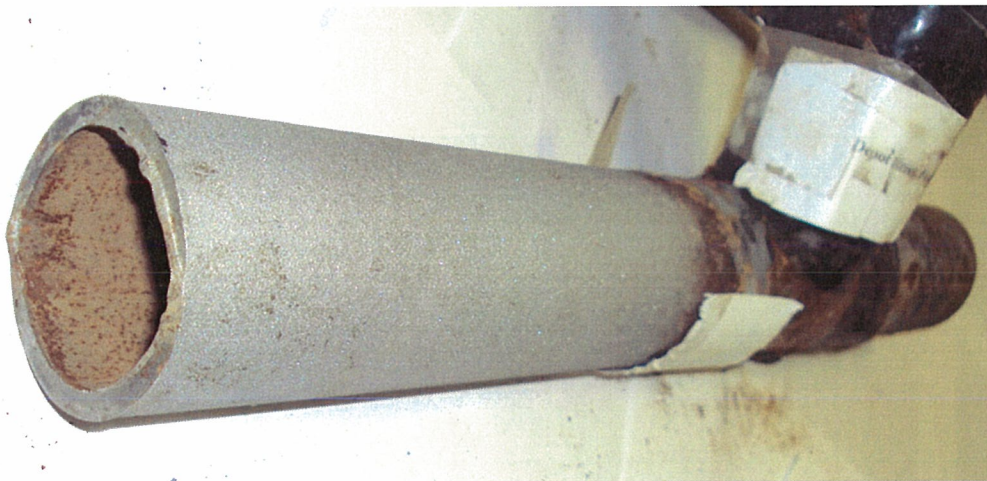
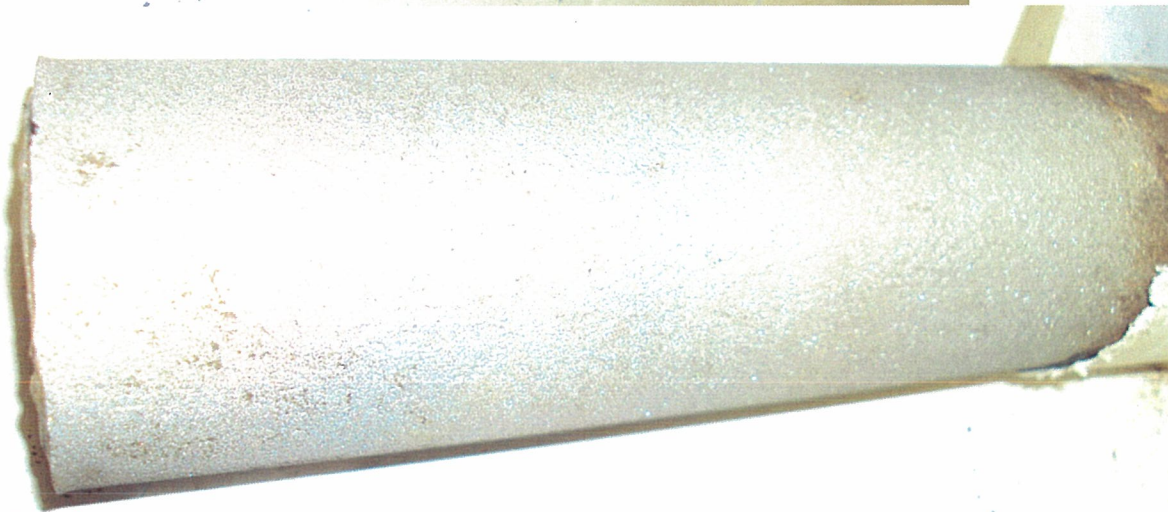
(3) **25-28 Depot Street, Franklin – wo#641892** – 2 inch, 60 psig, installed in 1931

- A soil sample was taken and analyzed. The pH was measured to be approximately 6, slightly acidic to neutral. Testing for chlorides was negative. Testing for microbiological acid producing (APB) and sulfate reducing bacteria (SRB) were performed. The APB testing produced a reading of 100,000 bacteria colonies per ML. The testing for SRB produced a reading of 100,000 bacteria colonies per ML. The soil was observed to be a normal color and odorless.

- The pipe sample was coated steel, not bare as the records system had indicated. This segment was selected for replacement based on the attributed material of bare steel and the operating pressure of 60 psig. The selection was not based on leak history or an indication of poor condition. The pipe was observed to be in good condition with some minor pitting. Exposure of this main segment should not result in a recommendation for replacement based on condition alone. Pit depths were not measured as the samples are available for continued visible review.

- (4) A combination of high levels of microbiological acid producing (APB) and sulfate reducing bacteria (SRB) appeared to contribute to a higher rate of corrosion of the steel gas main based on 2008 testing. The sample from Depot Street in Franklin tested with high levels of both bacteria without the expected pipe corrosion. Further testing should be conducted test this scenario.

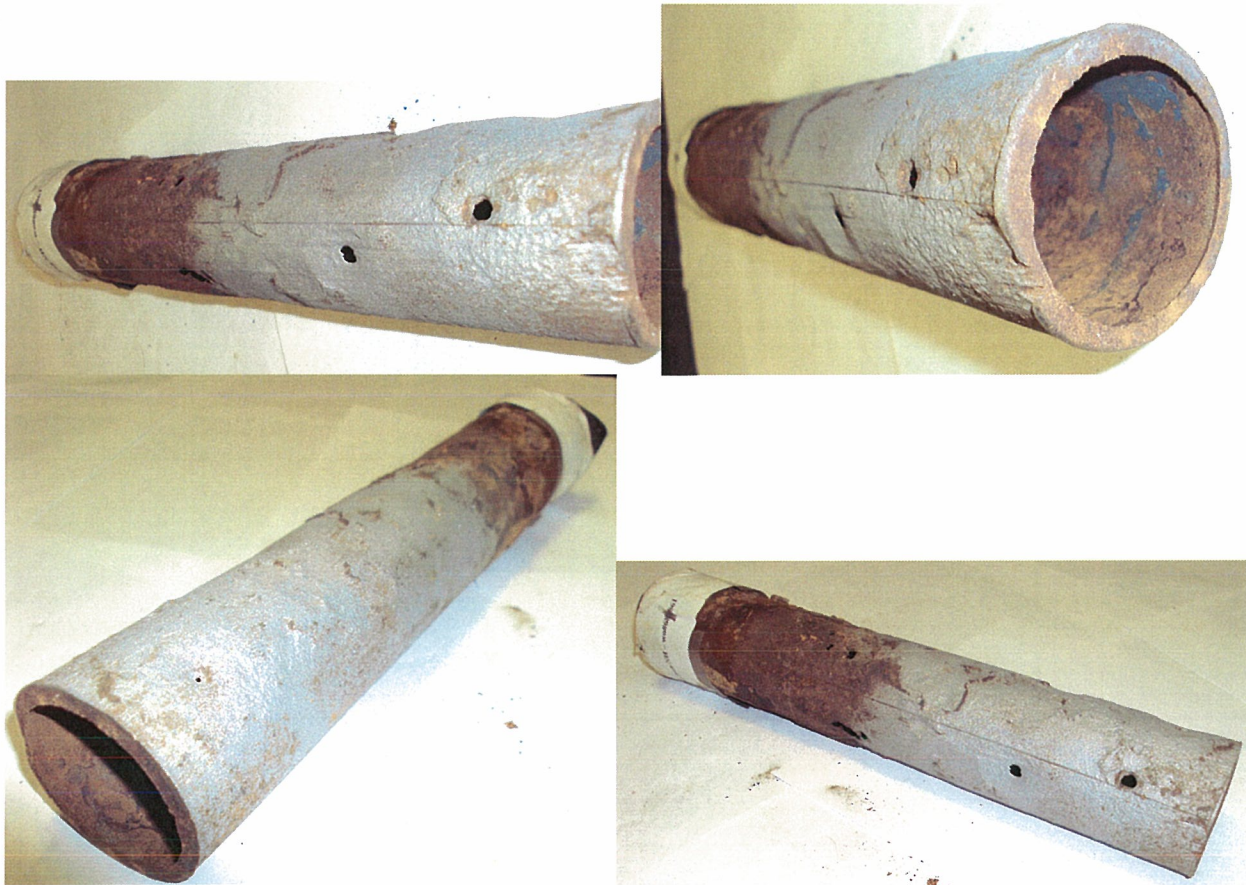
(4) **80-113 Blossom Street, Nashua – wo#681861** – 2 inch, low pressure, installed in 1908 & 1913

- A soil sample was taken and analyzed. The pH was measured to be approximately 5, acidic to neutral. Testing for chlorides resulted in a reading of 500 mg/l. Testing for microbiological acid producing (APB) and sulfate reducing bacteria (SRB) were performed. The APB testing produced a reading of 1,000 bacteria colonies per ML. The testing for SRB produced a reading of less than 10 bacteria colonies per ML. The soil was observed to be a normal color and odorless. Based on the testing, the bacteria levels of the soil do not appear to have accelerated the rate of corrosion. Acidic soil and/or the presence of chlorides are possible contributors to the high amount of corrosion.

- The pipe sample was observed to be in extremely poor condition. This segment was specifically noted by field personnel for priority replacement. Pit depths were not measured as the samples are available for continued visible review. Exposure of this main should result in a recommendation for immediate replacement based on condition.

- (7) Special attention should be paid to locations where the presence of chlorides is observed. The soil sample taken from Blossom St in Nashua indicated the presence of chlorides around a highly corroded pipe sample.

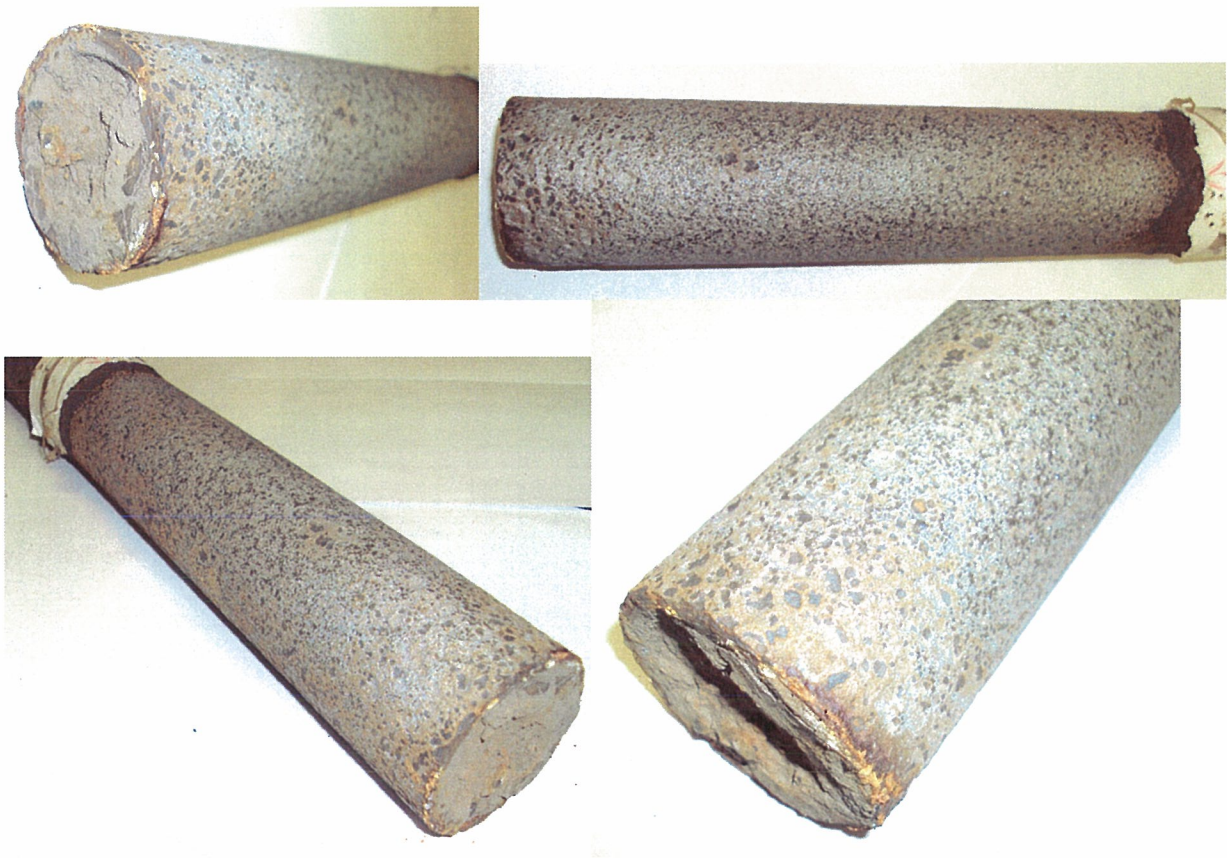
(5) **5-11Bristol Street, Nashua – wo#642292** – 4 inch, low pressure, installed in 1947, 1951, 1954, & 1957???

- A soil sample was taken and analyzed. The pH was measured to be approximately 7, or neutral. Testing for chlorides was negative. Testing for microbiological acid producing (APB) and sulfate reducing bacteria (SRB) were performed. The APB testing produced a reading of 10,000 bacteria colonies per ML. The testing for SRB produced a reading of 1,000 bacteria colonies per ML. The soil was observed to be a normal color and odorless.
- The pipe sample was observed to be in fair condition. Some moderate, uniform pitting was observed. Pit depths were not measured as the samples are available for continued visible review. Exposure of this segment should result in a recommendation for replacement based on condition.
- The following pictures were taken:

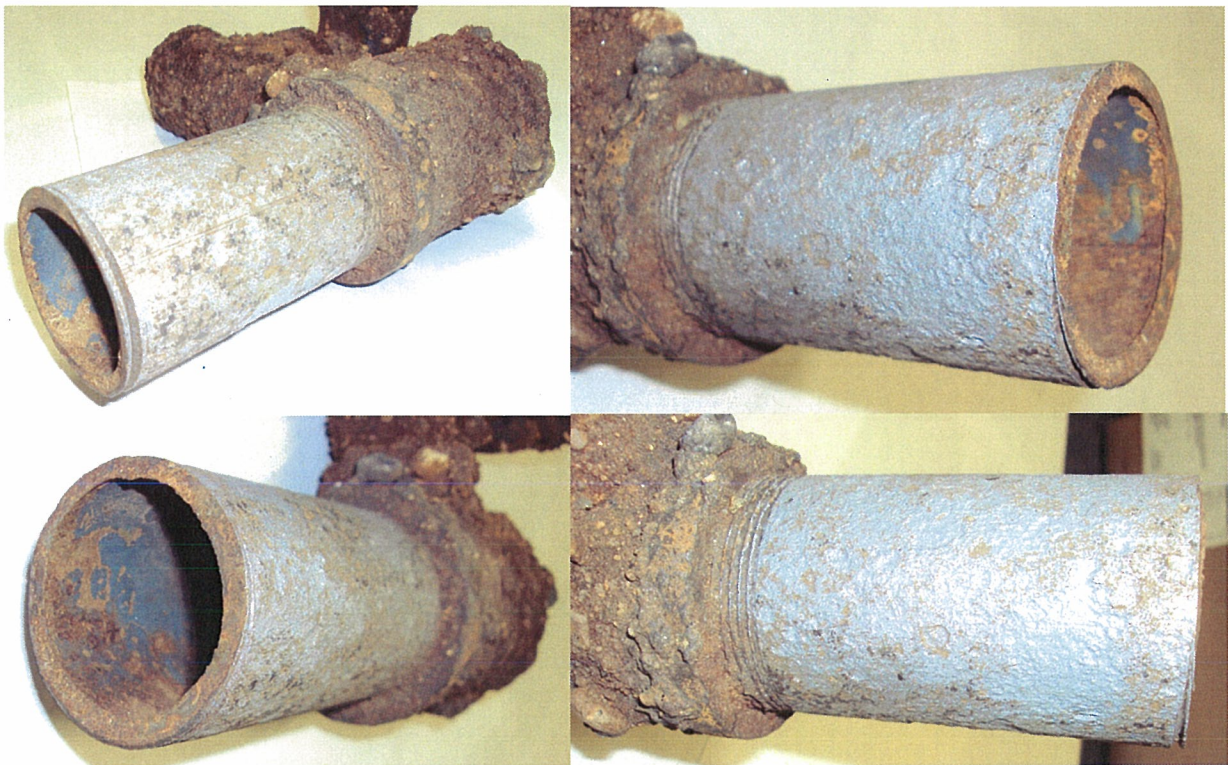
(6) **12-25 Buck Street, Nashua – wo#655576** – 2 inch, low pressure, installed in 1901, 1903, & 1911

- A soil sample was taken and analyzed. The pH was measured to be between 6 and 7, slightly alkaline to neutral. Testing for chlorides was negative. Testing for microbiological acid producing (APB) and sulfate reducing bacteria (SRB) were performed. The APB testing produced a reading of 100,000 bacteria colonies per ML. The testing for SRB produced a reading of 100 bacteria colonies per ML. The soil was observed to be a normal color and odorless.
- The pipe sample was observed to be in poor condition with some heavy pitting observed. A threaded coupling was also included as part of the pipe sample. Pit depths were not measured as the samples are available for continued visible review. Exposure of this segment should result in a recommendation for replacement.
- The following pictures were taken:

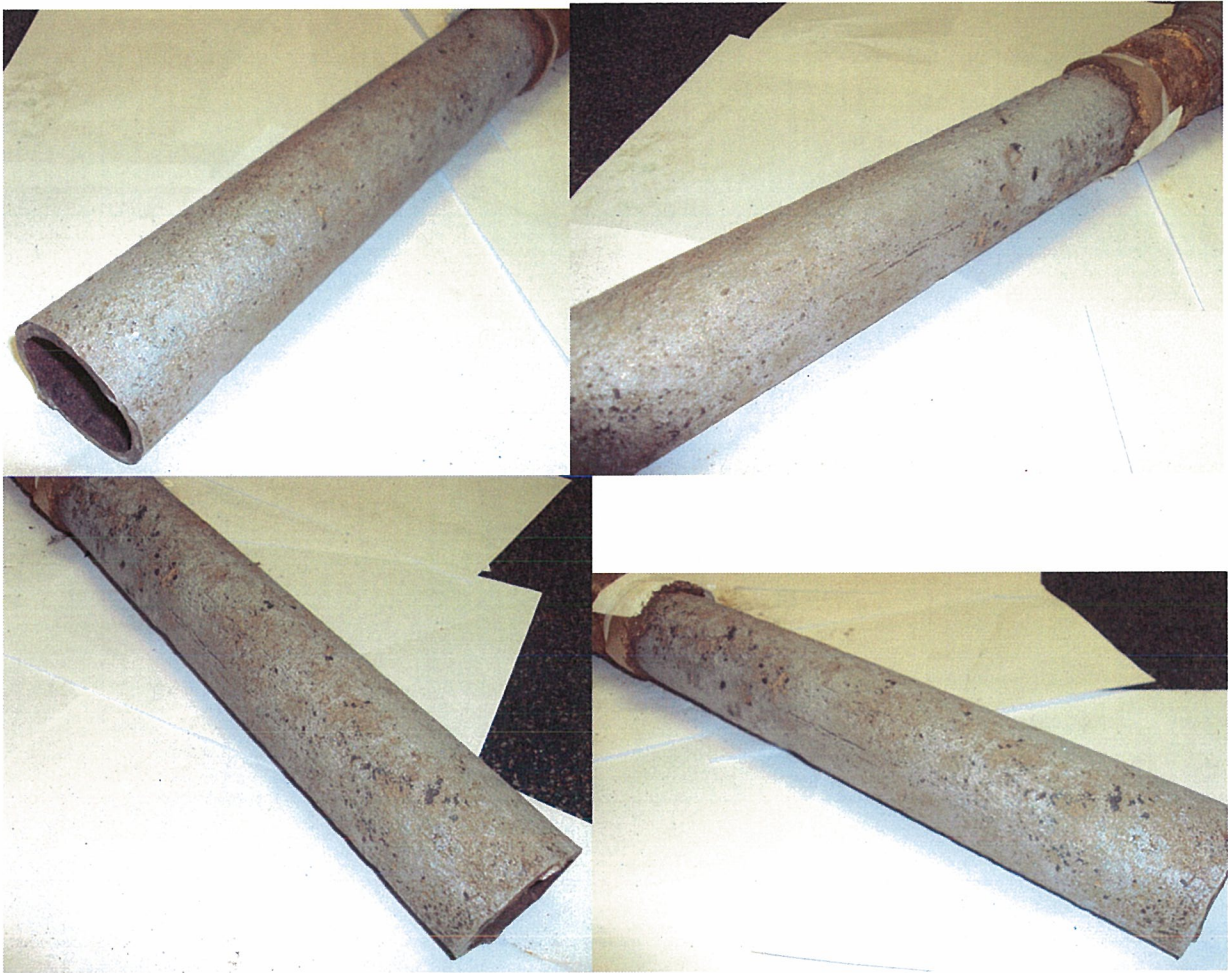
(7) **2-4 Fourth Street, Nashua – wo#642294** – 2 inch, low pressure, installed in 1926

- A soil sample was taken and analyzed. The pH was measured to be approximately 6, slightly acidic to neutral. Testing for chlorides was negative. Testing for microbiological acid producing (APB) and sulfate reducing bacteria (SRB) were performed. The APB testing produced a reading of 100,000 bacteria colonies per ML. The testing for SRB produced a reading of 100 bacteria colonies per ML. The soil was observed to be a normal color and odorless.
- The pipe sample was observed in poor condition with one area of significant deep pitting. Pit depths were not measured as the samples are available for continued visible review. Exposure of this main should result in a recommendation for replacement based on condition.
- The following pictures were taken:

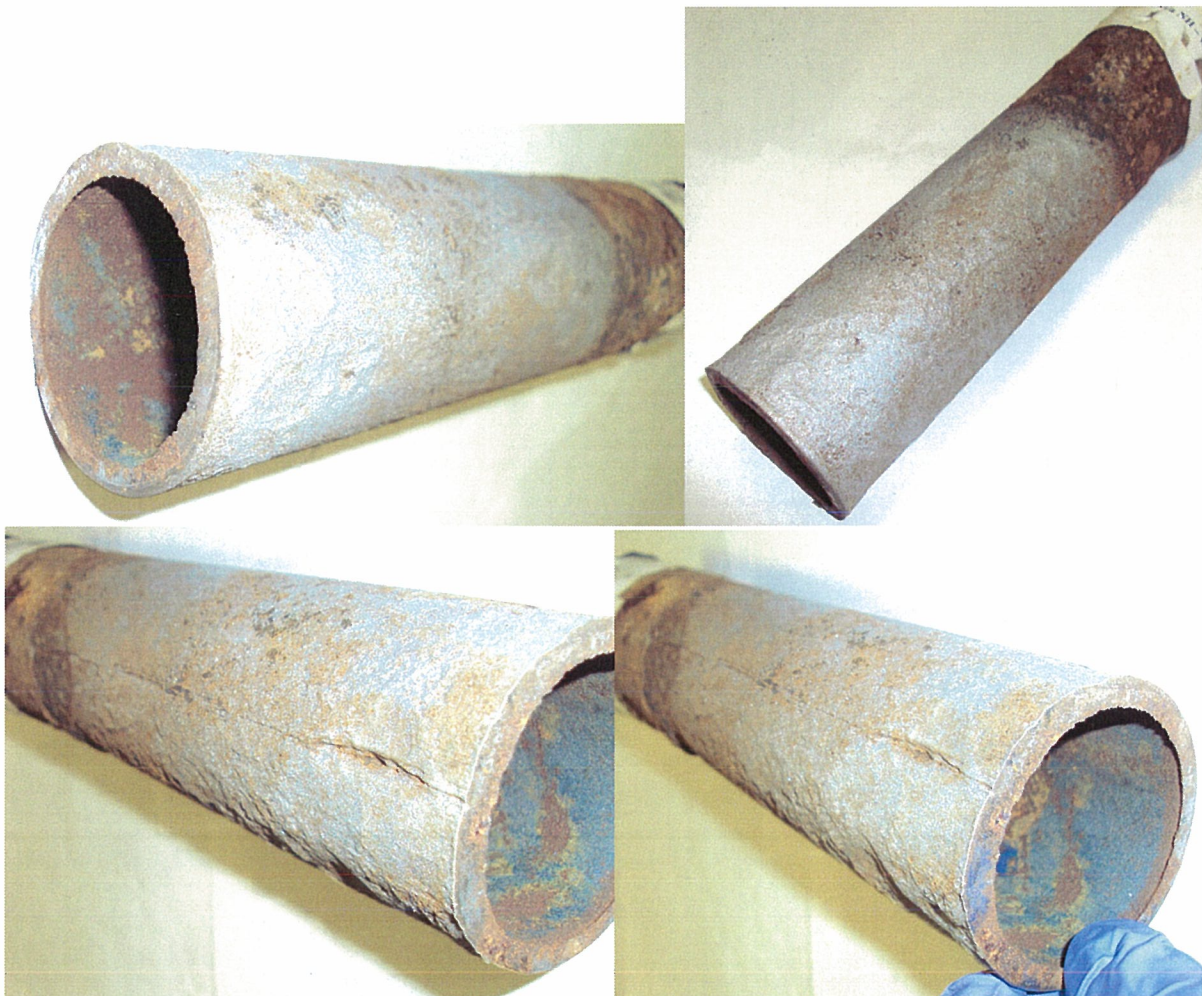
(8) **31-39 Newbury Street, Nashua – wo#642295** – 2 inch, low pressure, installed in 1898/1910/1928

- A soil sample was taken and analyzed. The pH was measured to be between 3 and 4, highly acidic. Testing for chlorides was negative. Testing for microbiological acid producing (APB) and sulfate reducing bacteria (SRB) were performed. The APB testing produced a reading of 10 bacteria colonies per ML. The testing for SRB produced a reading of 100 bacteria colonies per ML. The soil was observed to be a normal color and odorless. Based on the testing, the bacteria levels of the soil do not appear to have accelerated the rate of corrosion.
- The pipe sample was observed to be in poor condition with some significant wall loss observed. Pit depths were not measured as the samples are available for continued visible review. Exposure of this main should result in a recommendation for replacement based on condition.
- The following pictures were taken:

- (6) Special attention should be paid to locations where the pH is highly acidic or highly alkaline. The Newbury St, Nashua sample testing showed highly acidic soil with a highly corroded pipe sample.

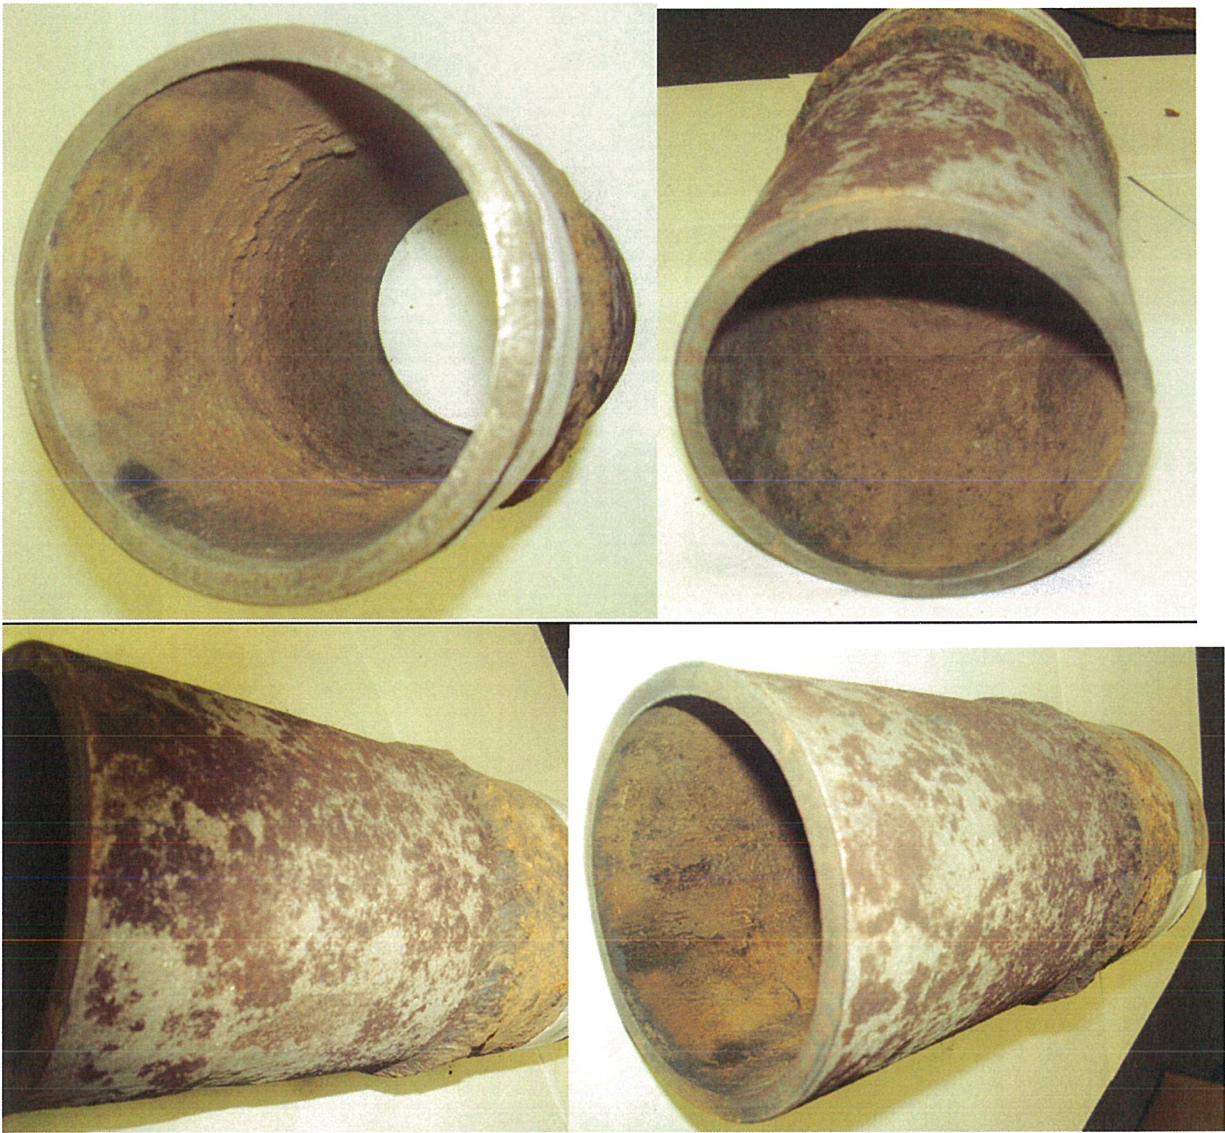
(9) **5-21 Winter Street, Tilton – wo#586554** – 4 inch, 60 psig, installed in 1931

- A soil sample was taken and analyzed. The pH was measured to be approximately 7, or neutral. Testing for chlorides was negative. Testing for microbiological acid producing (APB) and sulfate reducing bacteria (SRB) were performed. The APB testing produced a reading of 100,000 bacteria colonies per ML. The testing for SRB produced a reading of 1,000 bacteria colonies per ML. The soil was observed to be a normal color and odorless.
- The pipe sample was observed to be in fair condition. This segment was selected for replacement based the pipe attributes, bare steel with an operating pressure of 60 psig. Pit depths were not measured as the samples are available for continued visible review. Exposure of this main should not result in a recommendation for replacement based on condition alone.
- The following pictures were taken:
