**Re: DG 14 - 233 Report on status of Repowering Concord Steam**

RE: Fire Marshal's Inspection Report, December 30, 2016  
Concord Steam Plant  
Concord, NH

Subject: Correction of Alleged Deficiencies Found During a State Fire Marshall Inspection

PROJECT: CONCORD STEAM AND POWER

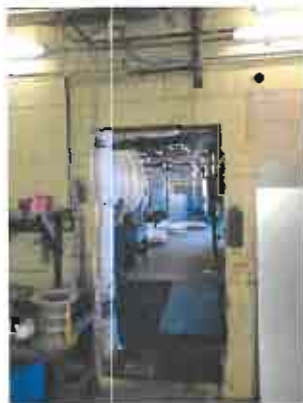
1. No header above man door leading from FD Fan Room to maintenance garage resulting in a crack in CMU wall above the door.

1. The man door opening cut through the hollow CMU wall has resulted in a crack above the header. We recommend installing a steel channel header above the door and steel channel door jambs on each side of the opening to support the header. This will provide support to the wall above the opening with no further danger of wall cracking. (see drawing S-100 for details.)

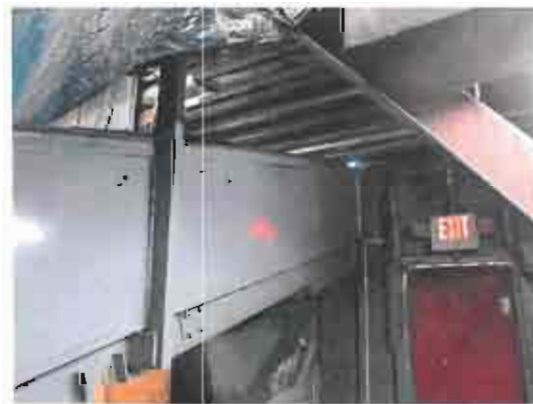
2. Large opening cut through 17" thick concrete bunker wall for chip conveyor to pass without means of support of wall above the opening.

2. The large opening cut into the 17" thick concrete coal bunker wall was done in 1979, with no damage above the opening occurring since then. However for added assurance that the wall above the opening will not suffer any damage we recommend installing two steel pipe columns from the floor slab to the underside of the openings. This will provide additional wall support and be sufficient to insure that the wall above will not move. (See drawing S-101 for details)
