*New England Pipeline Safety Representatives
Annual Seminar – Hyannis, Massachusetts
San Bruno, CA – Lessons Learned*

Randy Knepper
Director of Safety
New Hampshire Public Utilities Commission
1 Oct 27, 2011

San Bruno, CA Overview

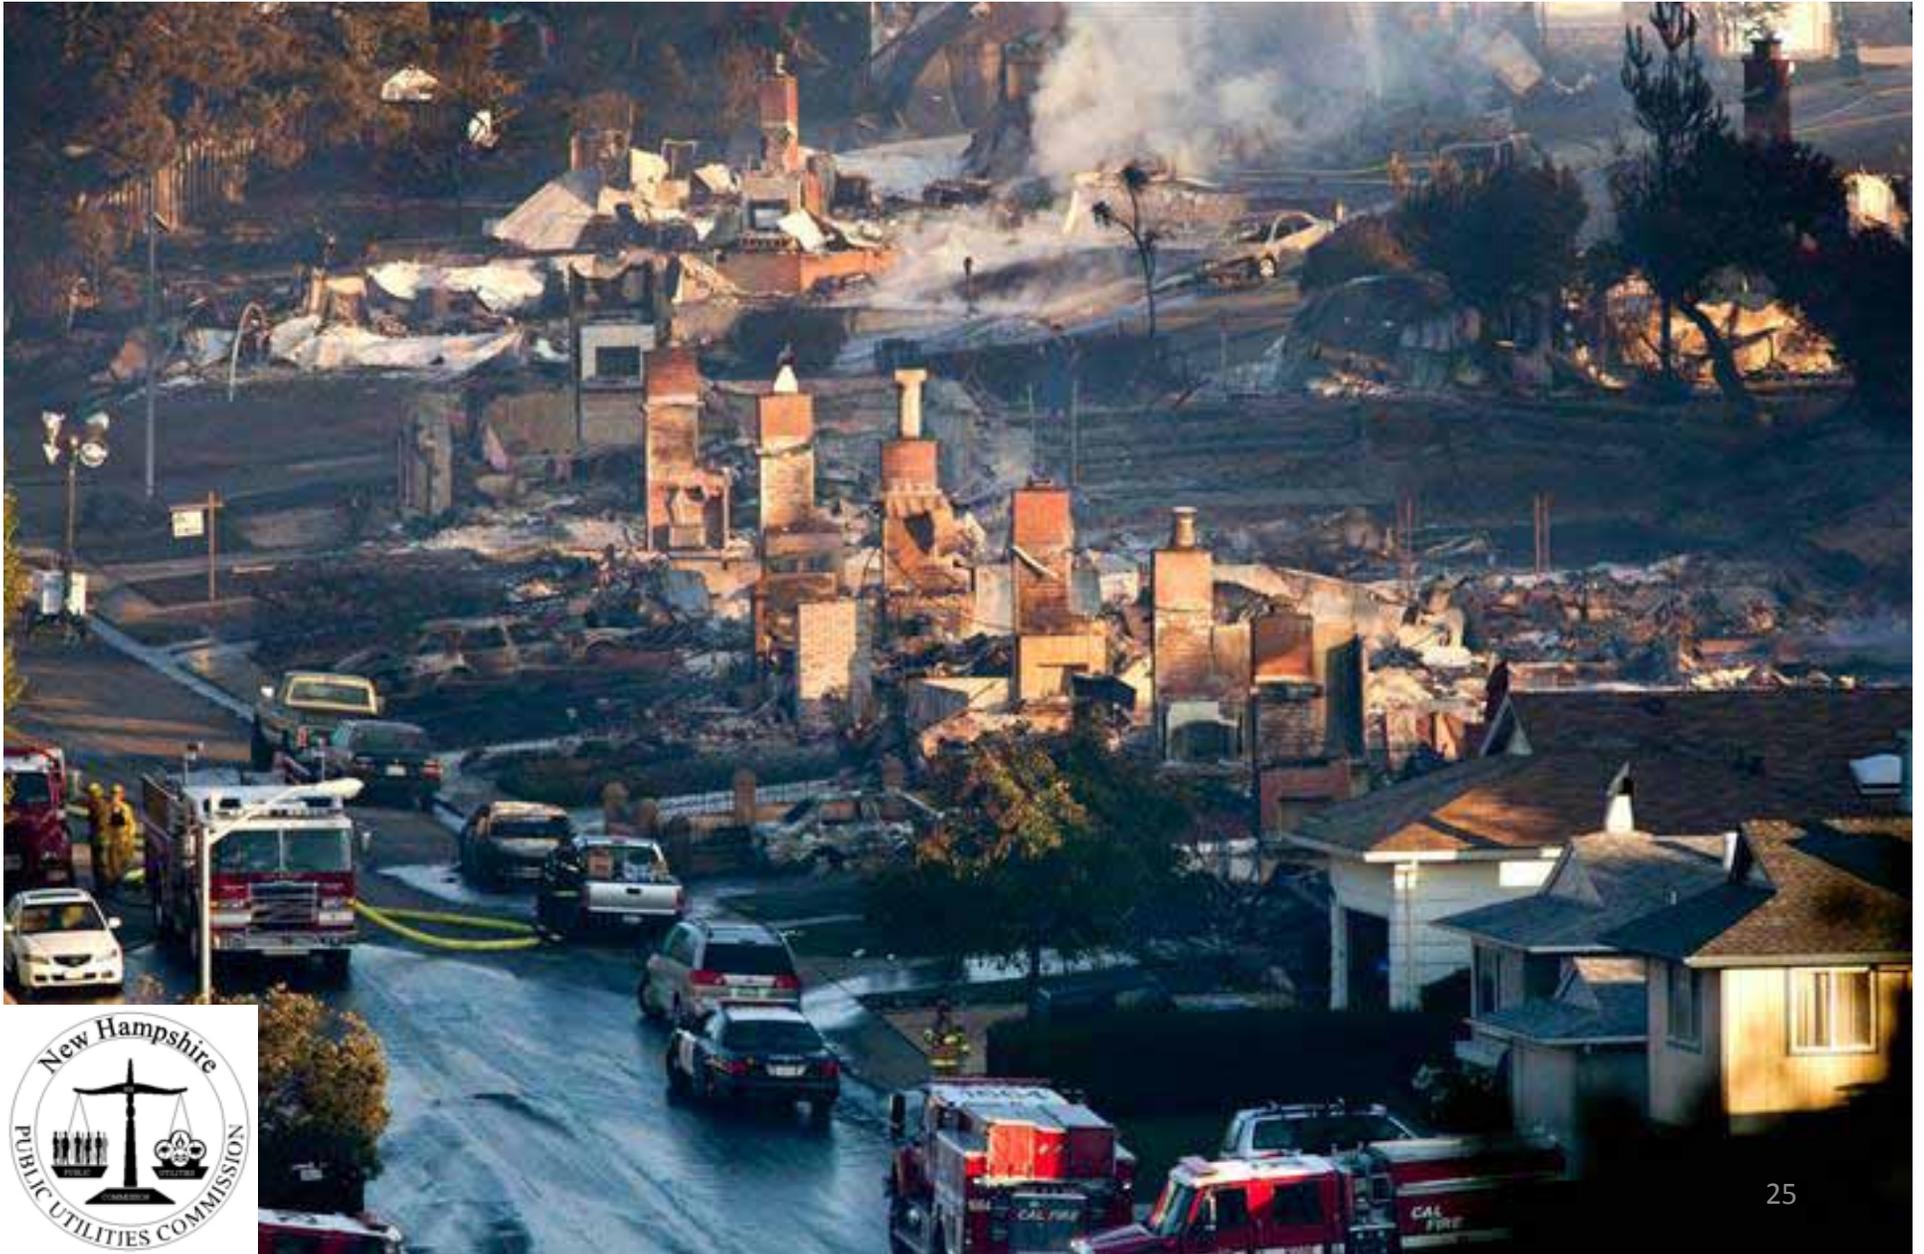
San Bruno, CA –Aerial View Post Explosion

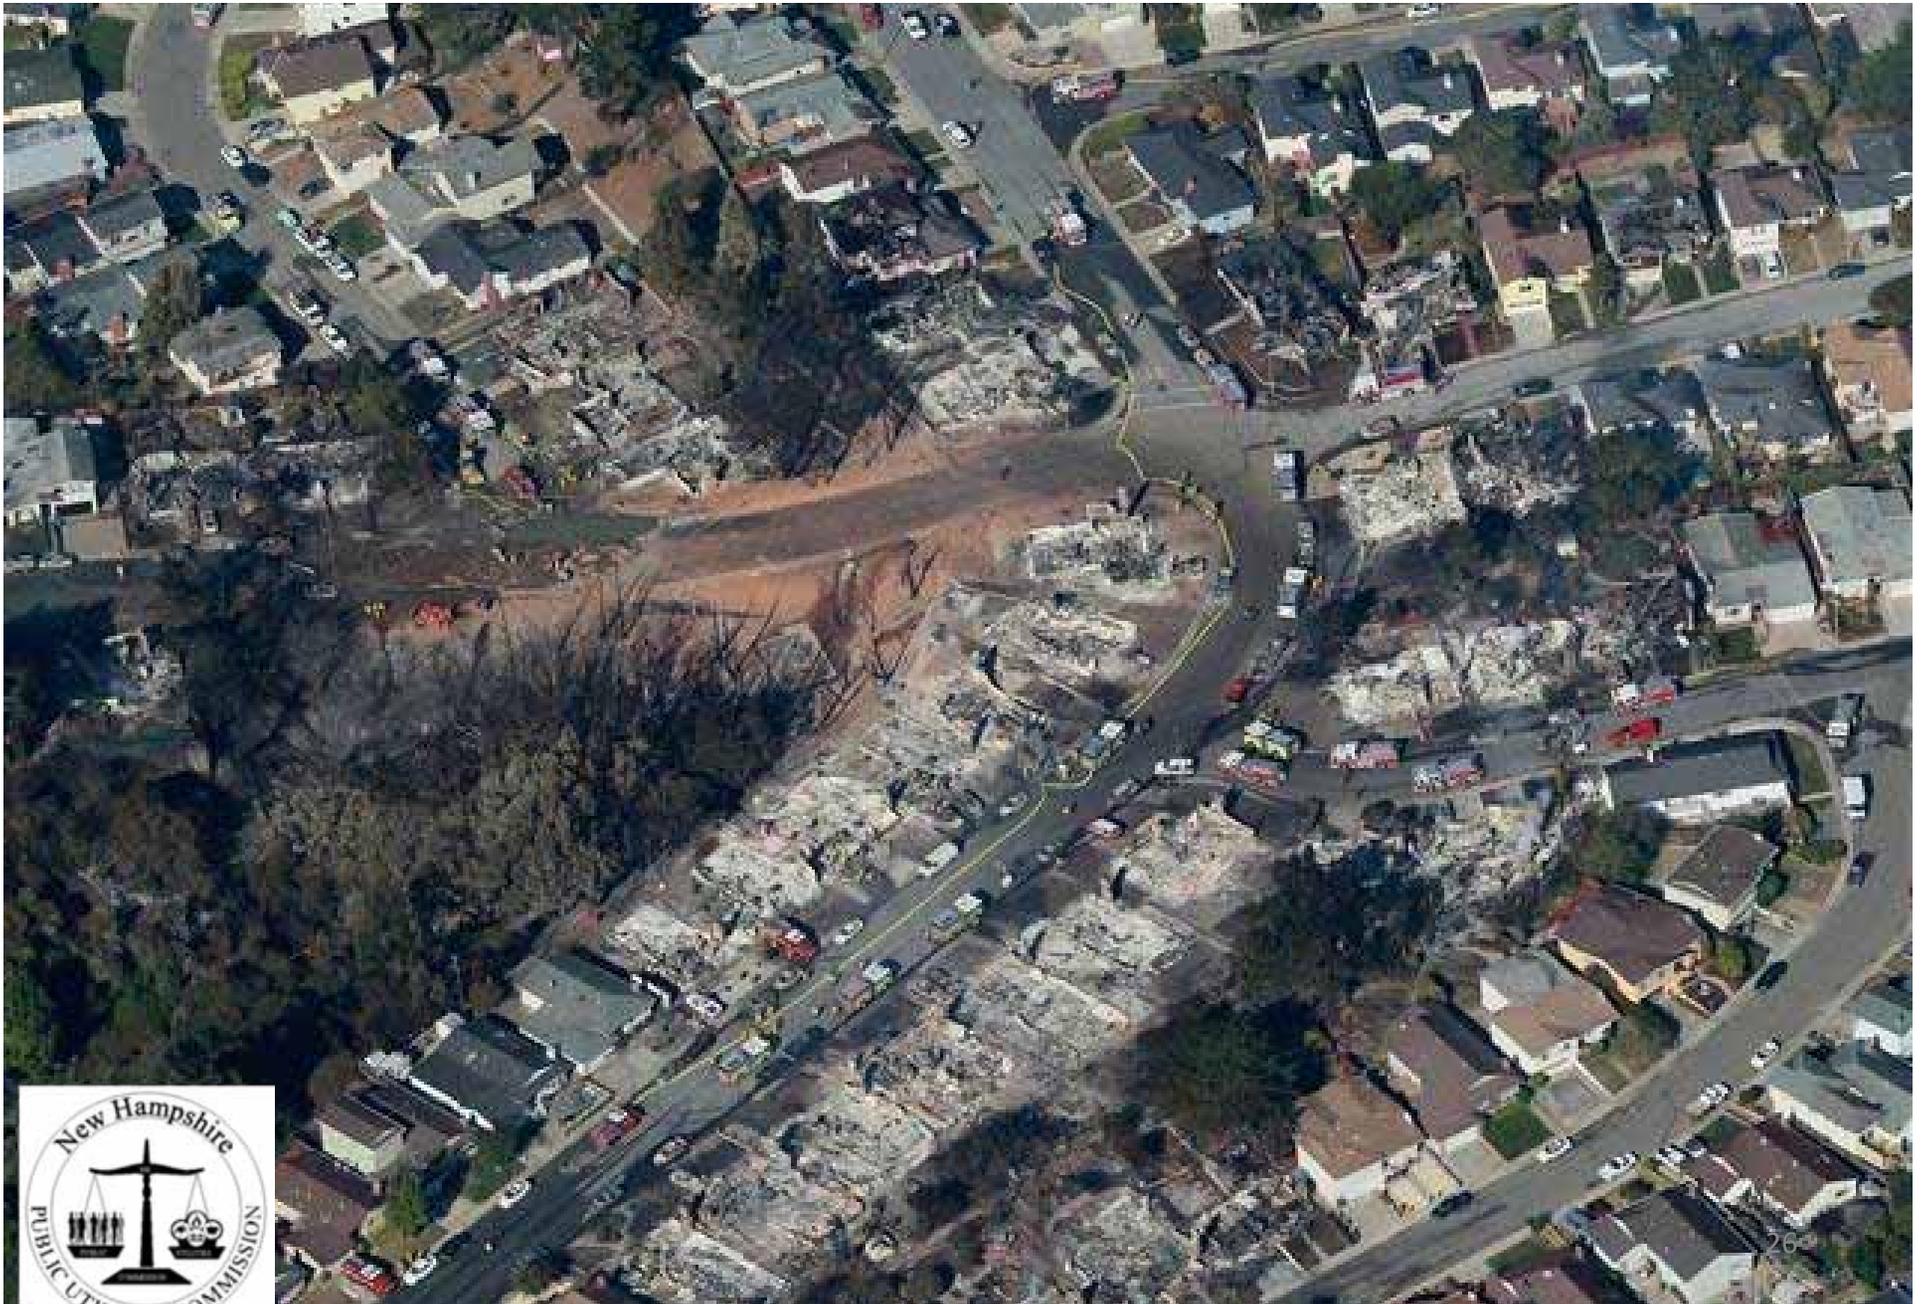
San Bruno, CA – Incinerated Remains of Vehicles

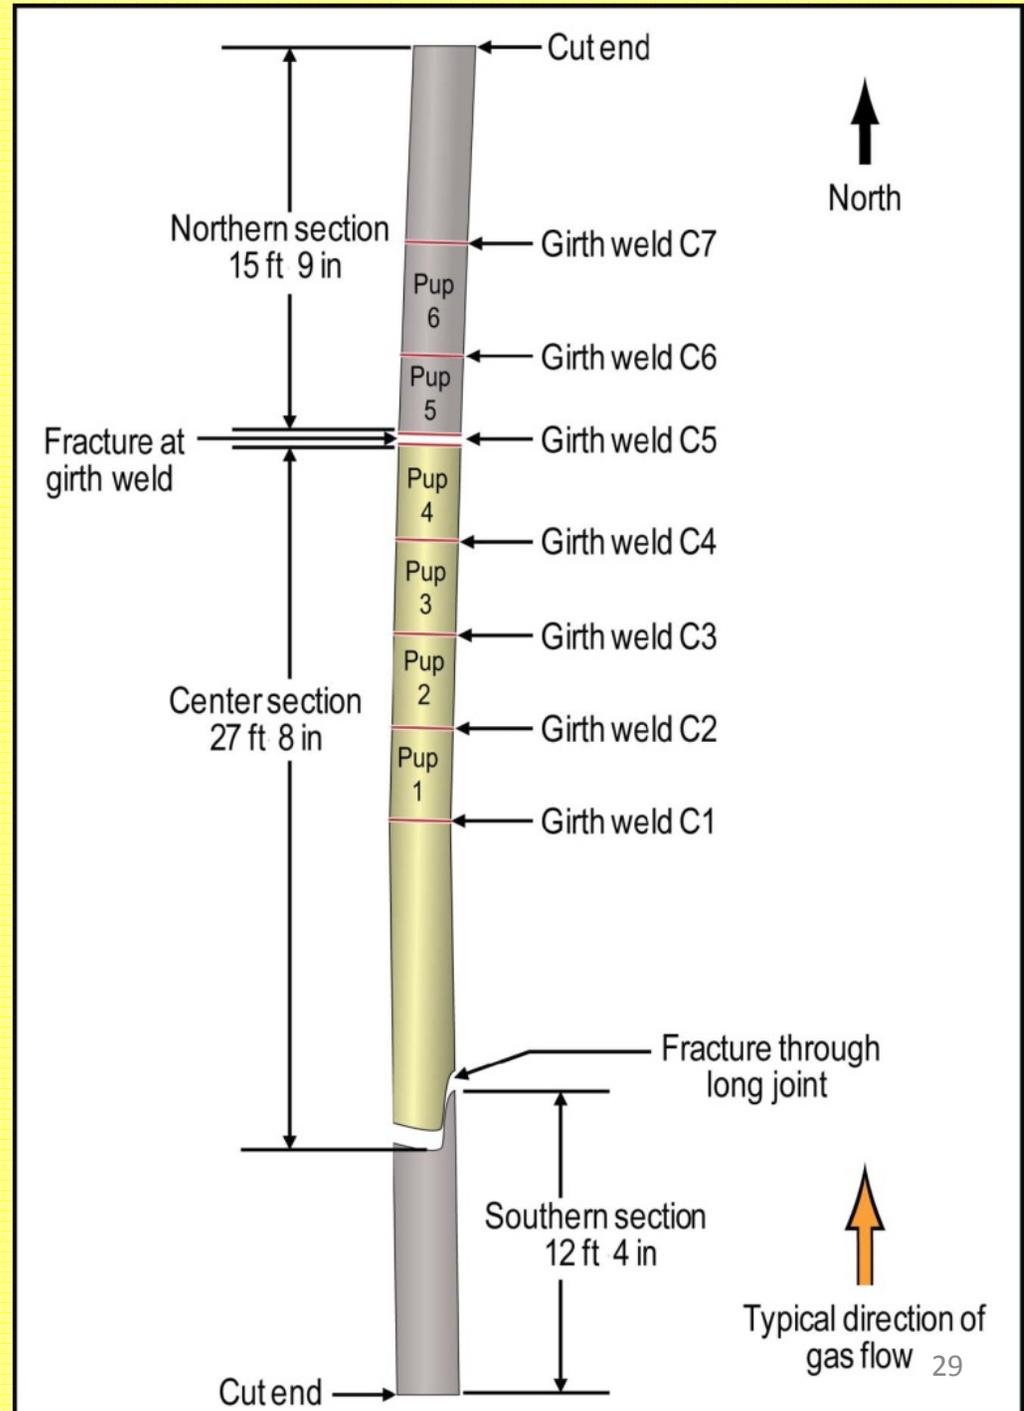
Pipeline Segment that Failed

- Pup pieces were approximately 3.5 feet to 4 feet long (.375 in wall)
- .312 in wall at the north end

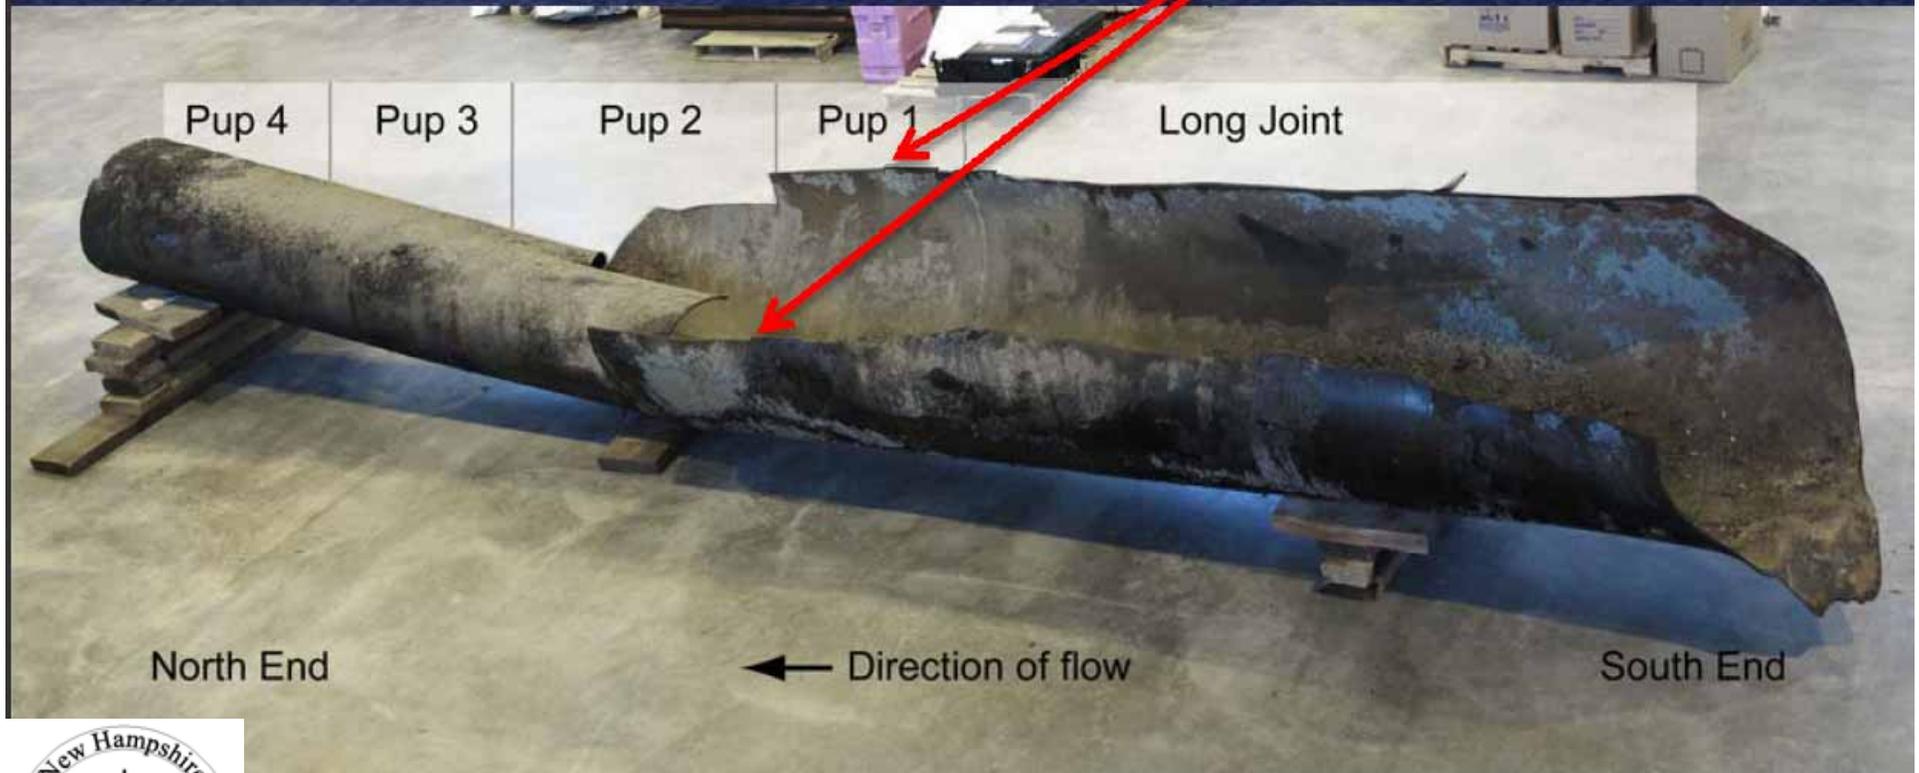
Fracture Initiation

- 5.** The fracture of Line 132 Segment 180 originated in the partially welded longitudinal seam of pup 1, which was progressively weakened due to ductile crack growth and fatigue crack growth.

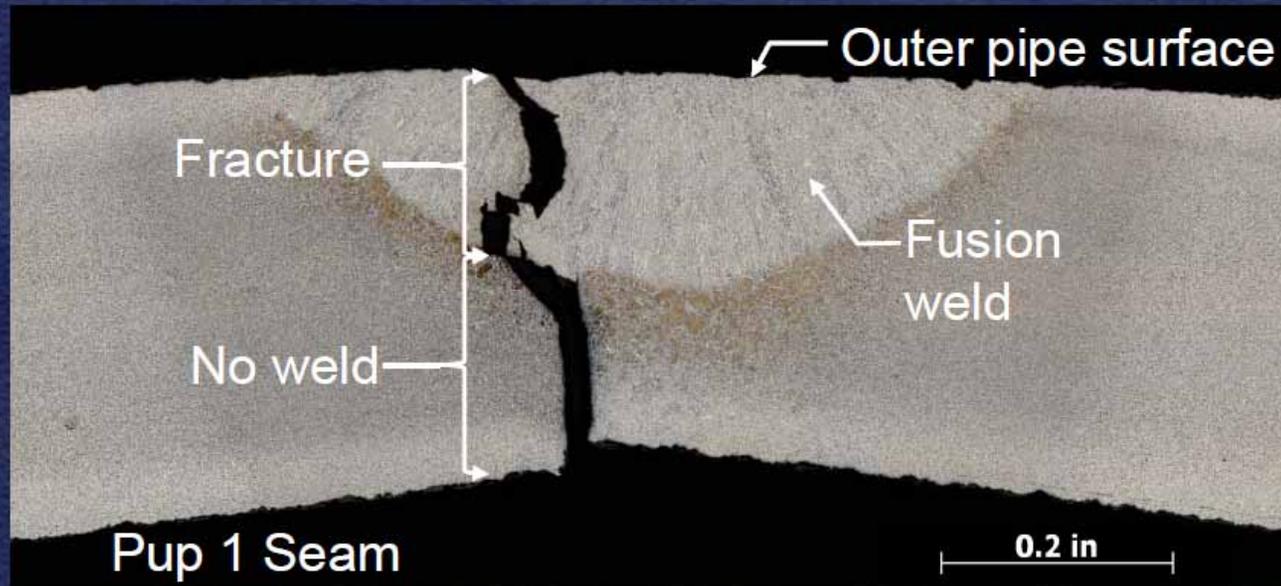
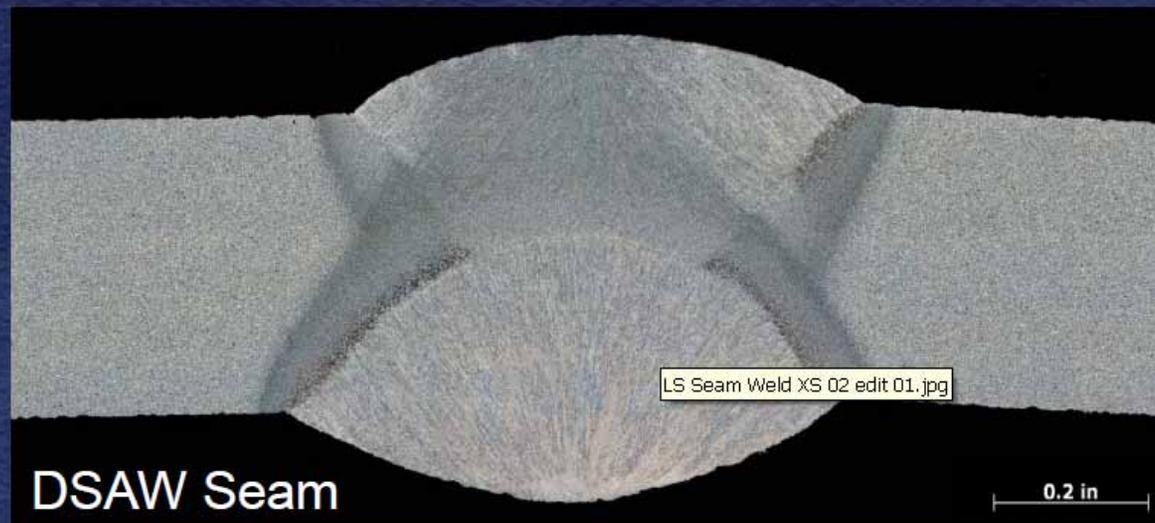
Cross Section of Pipe Seams

- Welds showed indications of different Welding Methods such as Fusion Welding Process, Manual Arc Welding, Shielded Metal Arc Welding on Girth Welds (Field)
- Double Submerged Arc Welding (Factory)
- Evidence of Porosity, incomplete fusion, undercutting, Lack of Penetration, slag inclusion
- Squared Ends versus Beveled Ends

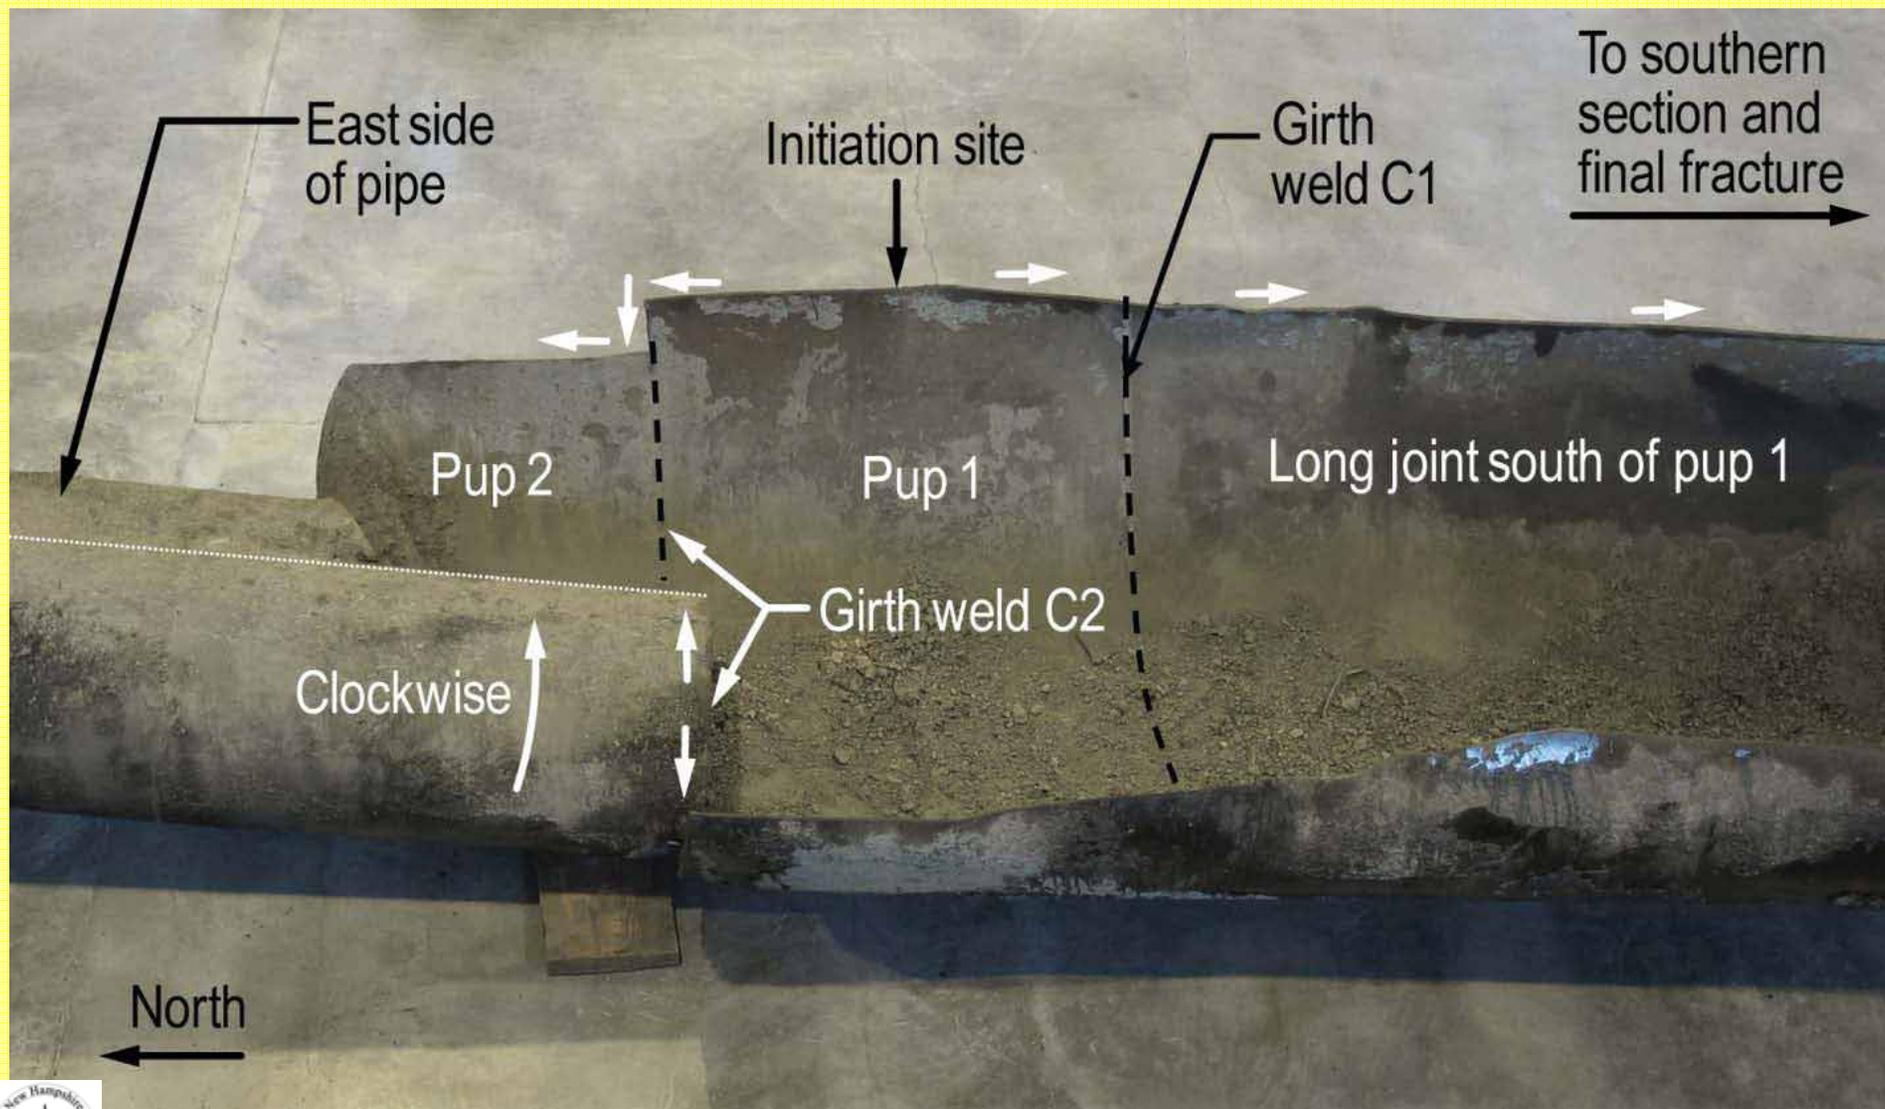
Location of Initiation of Cracks

- 6.** The combination of the size and shape of the weld defect significantly reduced the strength of the pup 1 longitudinal seam, making it susceptible to unstable crack growth under internal gas pressure.

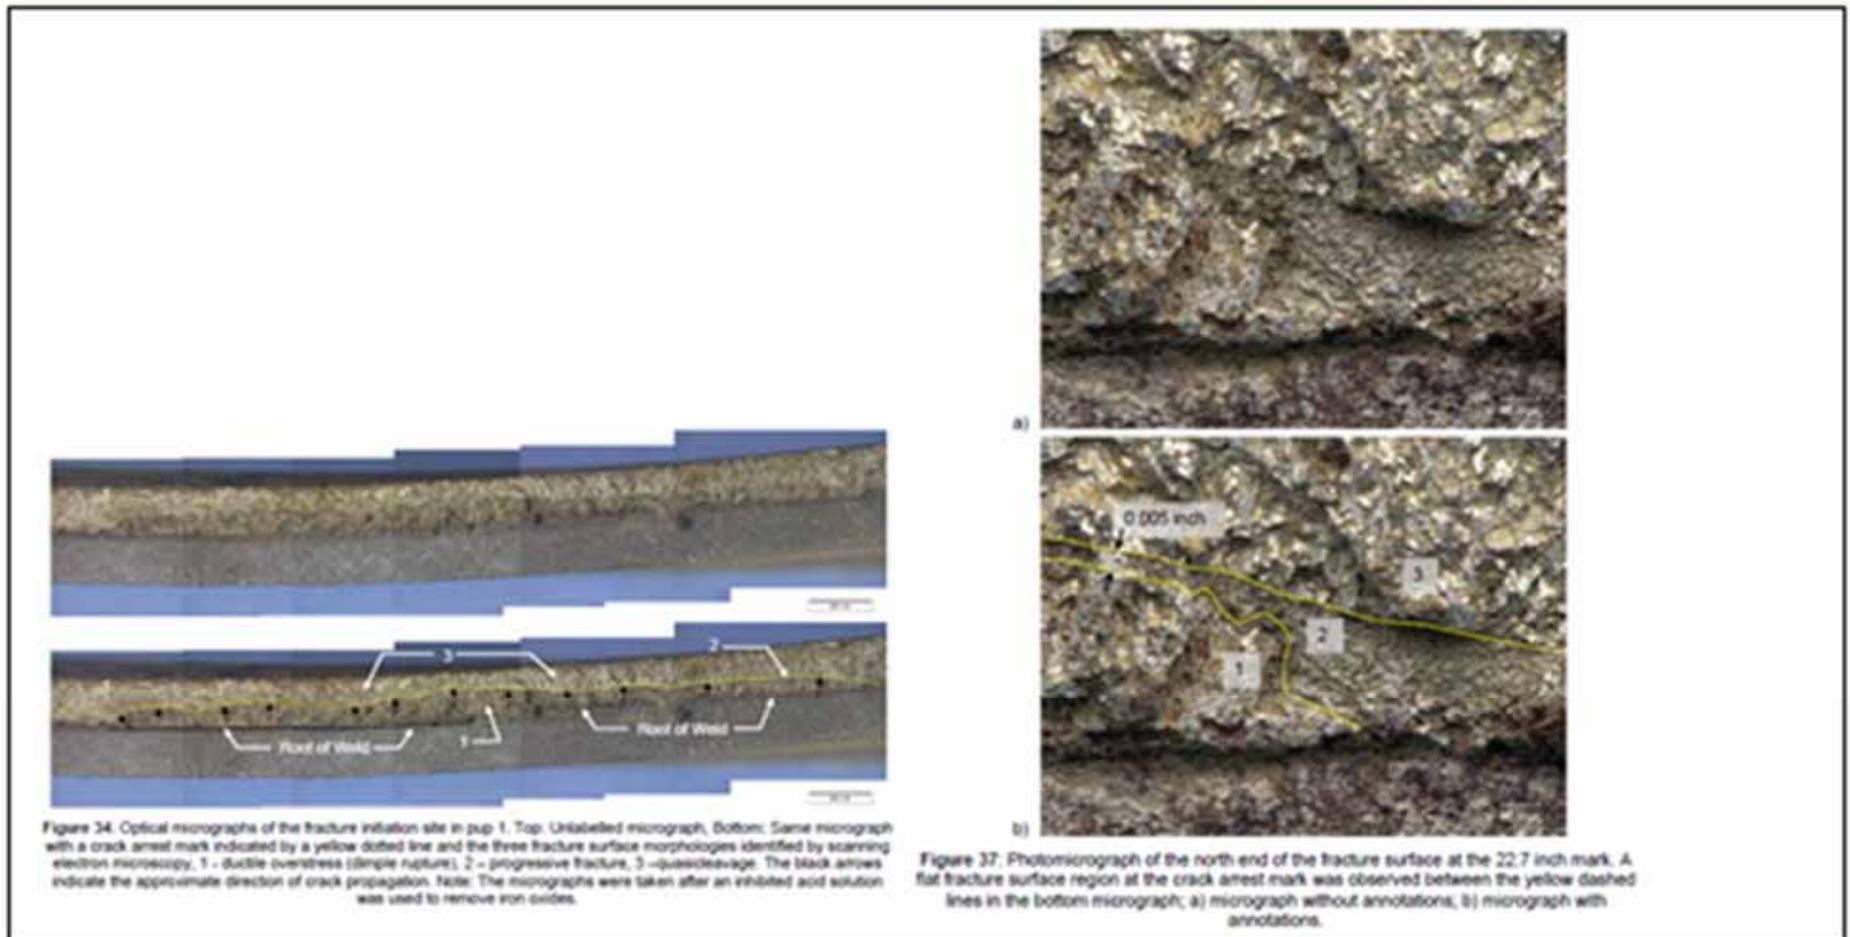
How did the Fracture Occur?

Figure 1. Source: NTSB Metallurgical Report 3A, exhibit 459184. The NTSB photos show the lack of penetration, the ductile Zone 1 and striated Zone 2. 53

- NTSB discounted the effect of the Sewer installation as a root cause of the failure
- Considered video of jacking operation
- Considered Studies on pipe bursting by Army Corp of Engineers 2001 and 2004 Paper at North American Trenchless Technology regarding Vibrations
- Found equivalent stress on pipe was raising internal hoop stress to approximately
 - 6 psi due to bursting head
 - 2.5 psi due to external soil pressure
 - .01 psi due to vibrations
- Considered **minimal** compared to the pressure variations within the pipe of 110 psi
