STATE OF NEW HAMPSHIRE
PUBLIC UTILITIES COMMISSION

Docket Nos. DW 10-141, DW 07-105, DW 10-043, and DW 11-021

Lakes Region Water Company, Inc.

Record Request No. 5

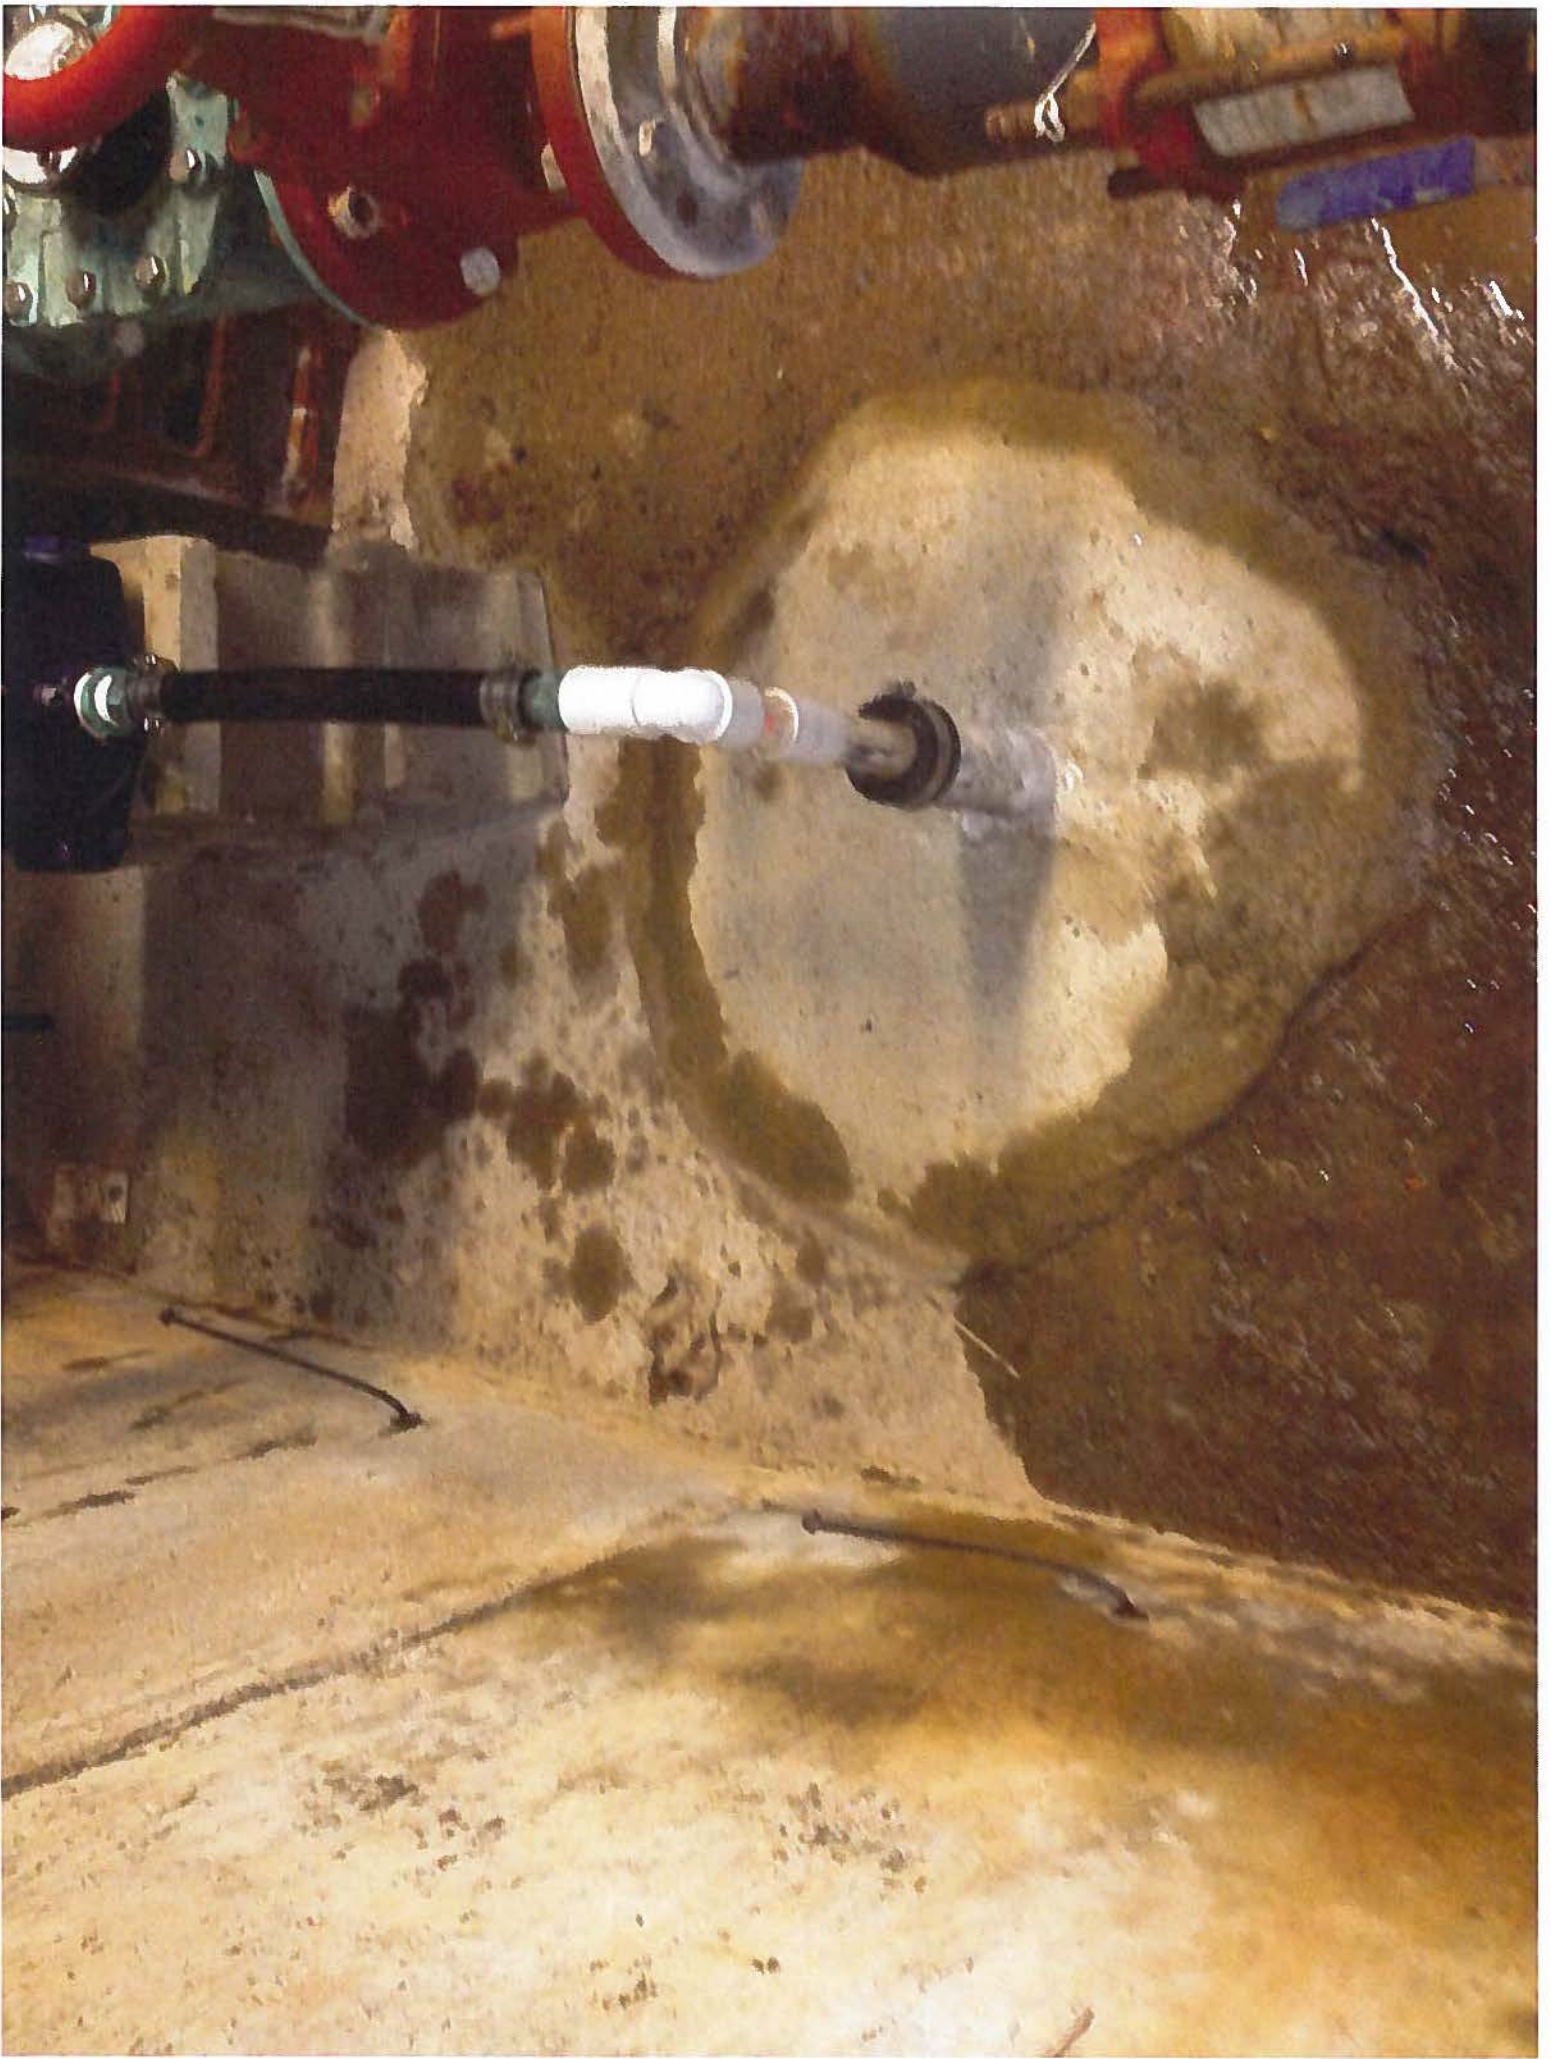
CLOSED... after review of photos sig1-4. All said photos verify that the PH floor is no longer flooding. Photo sig2 shows that the formerly leaking male adapter, located prior to the blue pre-charged pressure tank, is no longer leaking.

CLOSED... after review of photo sig1, showing the chemical treatment tank and feed line have been set back up for operation.

- November 23, 2011. The leaking fitting was repaired and the flooding was corrected. The treatment system reported to be inoperable due to the flooding conditions was corrected and fully operational.

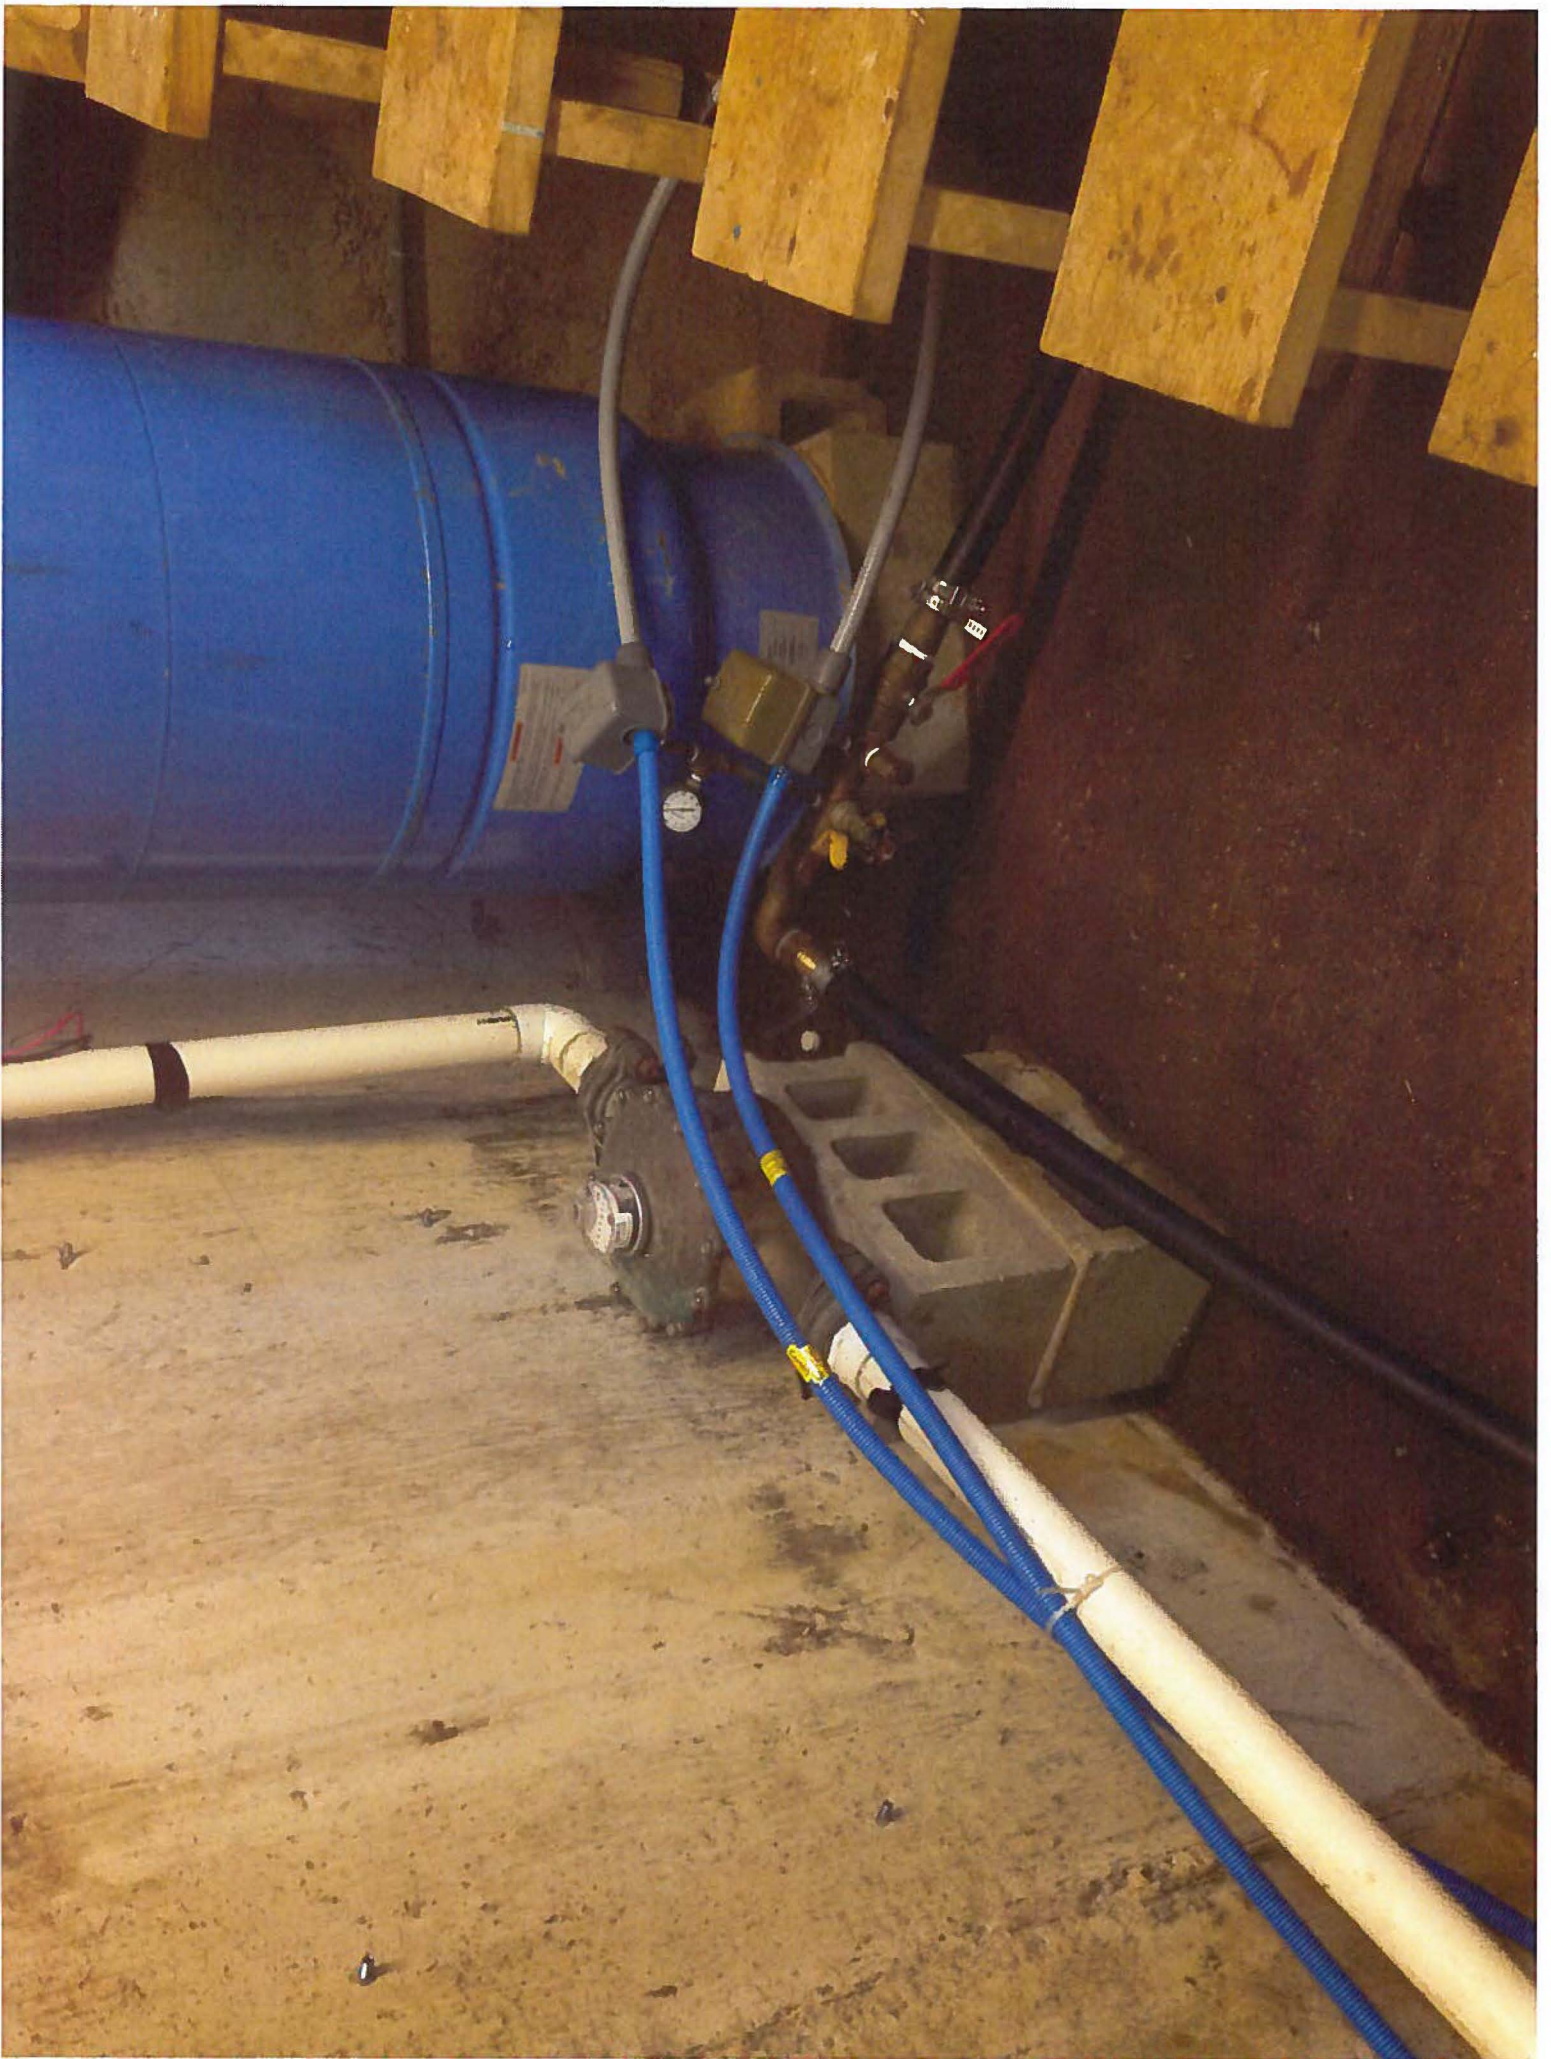
CLOSED... after review of photos sig2-3, which shows the electric wiring now housed inside blue conduit tubing and secured with zip ties well above the PH floor.

- January 25, 2011. The electrical hazard was corrected by the installation of conduit.
- On-going. The Company's leak detection efforts are on-going. The Company intends to evaluate upgrades to its distribution system and has agreed to submit a Water Conservation Plan for the system to the NHDES on a voluntary basis by May 1, 2012.
- By email dated March 23, 2012, the NHDES administratively closed the January 24, 2012 NOV.

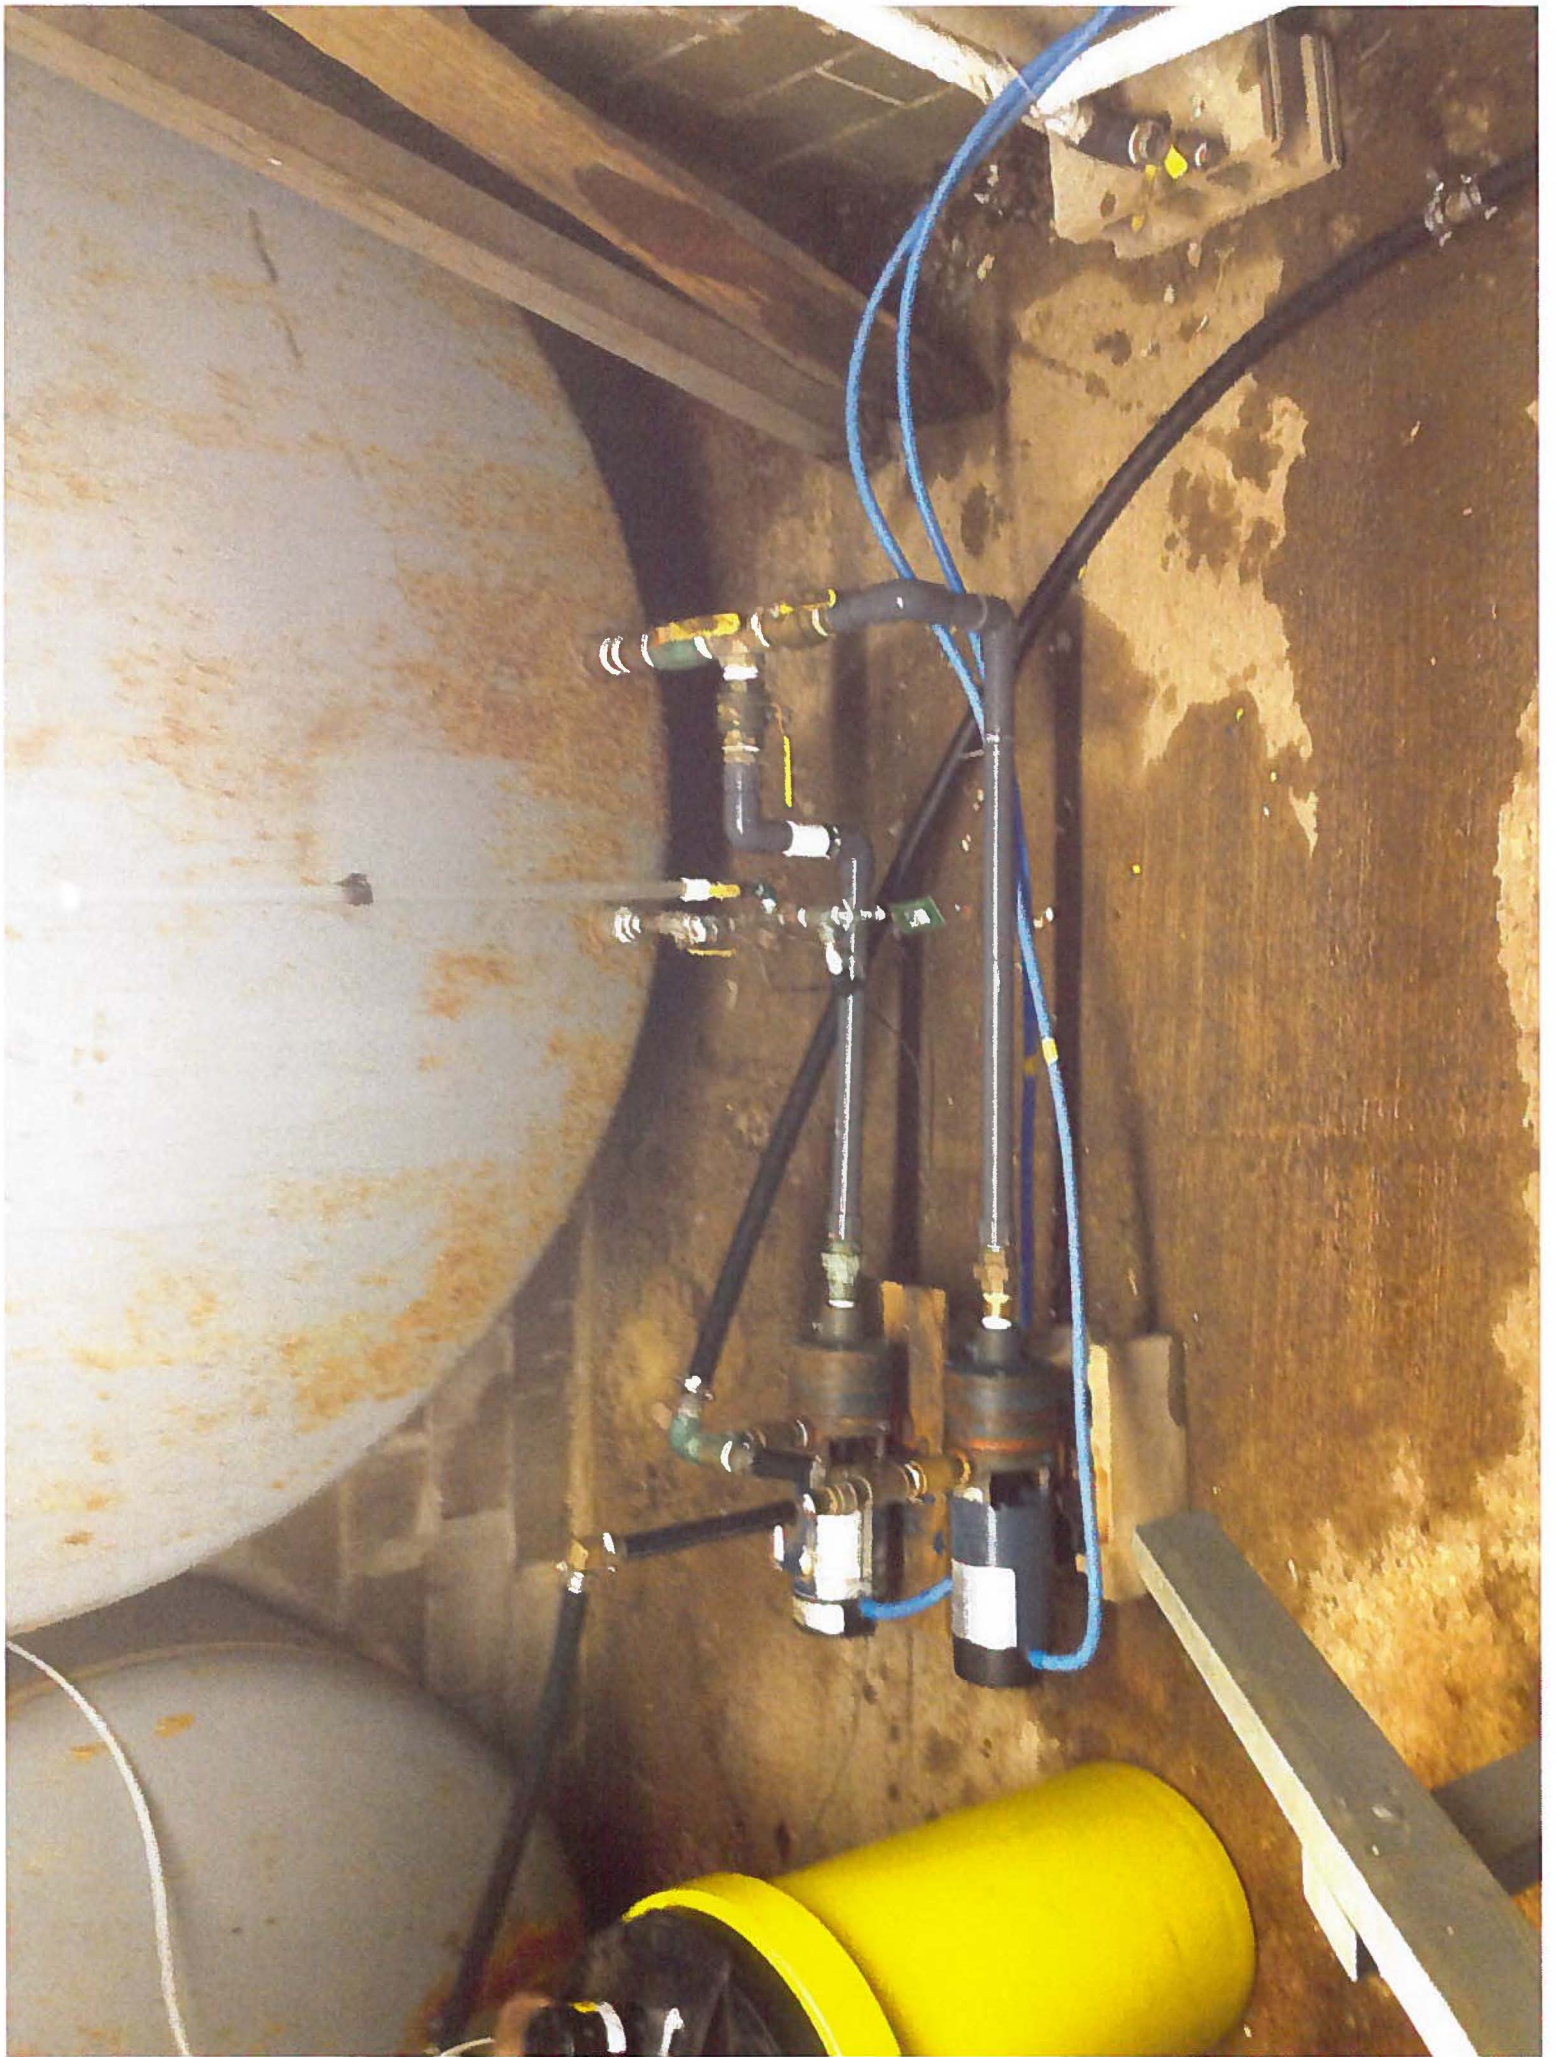
CLOSED... after review of photo sig4. Said photo verifies there is no longer flooded water around the casing of the active point well, PTW 1.
