Mass Tank Inspection Services, LLC  
29 Abbey Lane  
Middleboro, MA 02346  
Office 508-947-8826  
email: [Matt@masstankinspection.com](mailto:Matt@masstankinspection.com)

March 2, 2020

Abenaki Water Company Inspection Report  
2 @ 15,000 Gallon Underground Storage Tanks  
Service: Potable Water  
Inspection Date: February 11 & 19, 2020

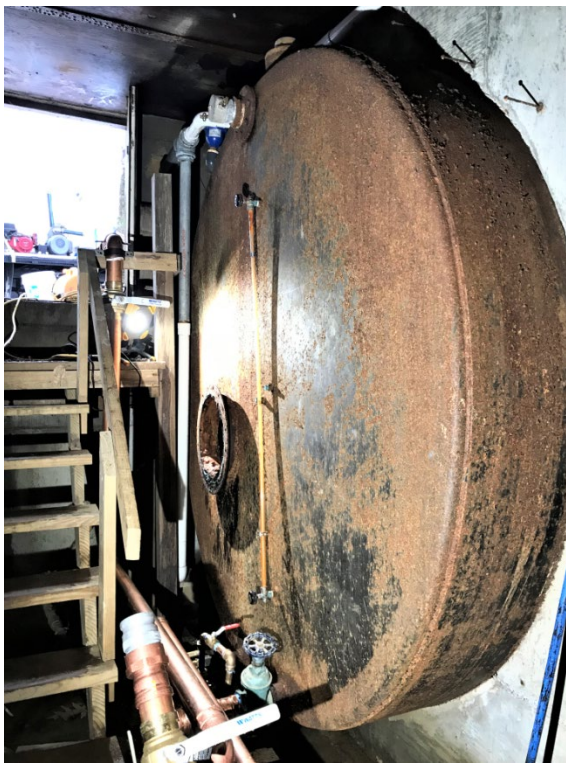
Picture left shows the front head and a 1-foot portion of the tank shell of Tank #1, that extends through the concrete service room wall. Moderate generalized corrosion is seen on the shell and head plate surface. Concrete wall remains in good condition with some minor cracking underneath the tank.

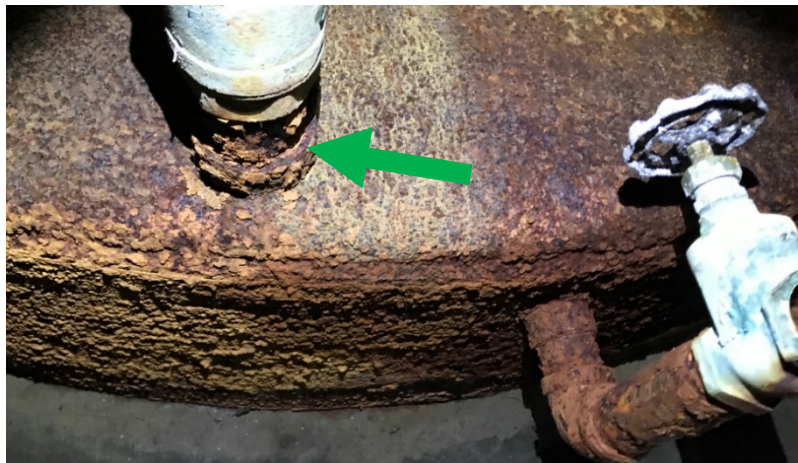
The picture on the right shows a more significant degree of corrosion to the exposed bottom and shell of the tank. Green arrow points to corroded piping that is in need of replacement.

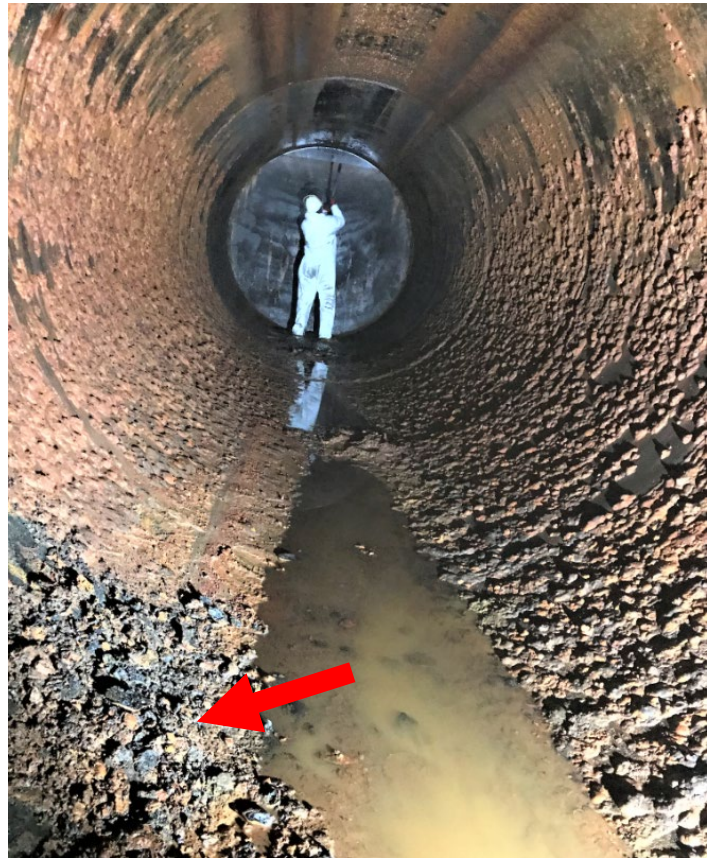
The red arrow points to loosened tubercle formations as the tank cleaning process is started by scraping all interior shell surfaces prior to power washing and vacuum cleaning.

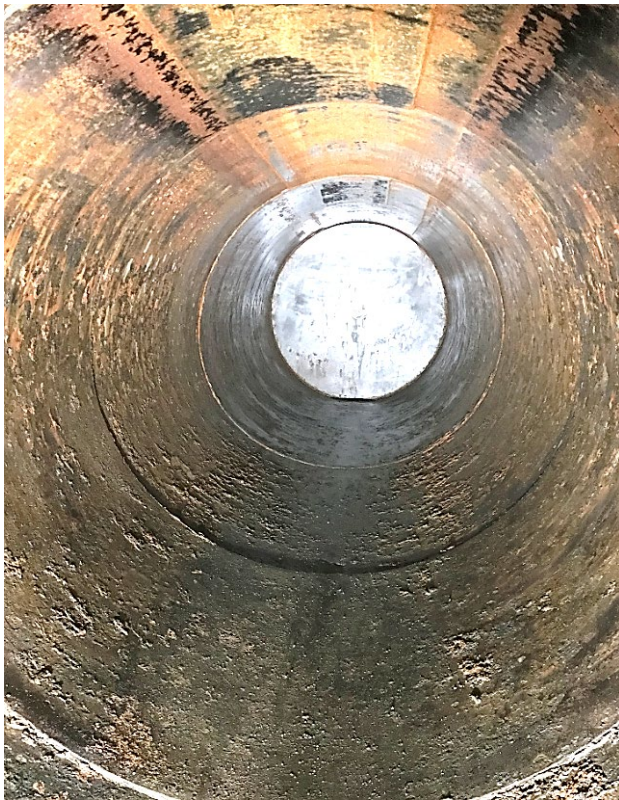
Picture on the left shows the tank after cleaning which provides a clean surface for ultrasonic thickness measurements, weld examination and access to the exposed areas of pitting corrosion for further evaluation. Widespread corrosion of varying degrees is evident.

**Action Item #1** – Abrasive blast and apply NSF approved liner to interior of Tank 1 and 2 to maintain tank integrity and effect improved sanitary storage condition.

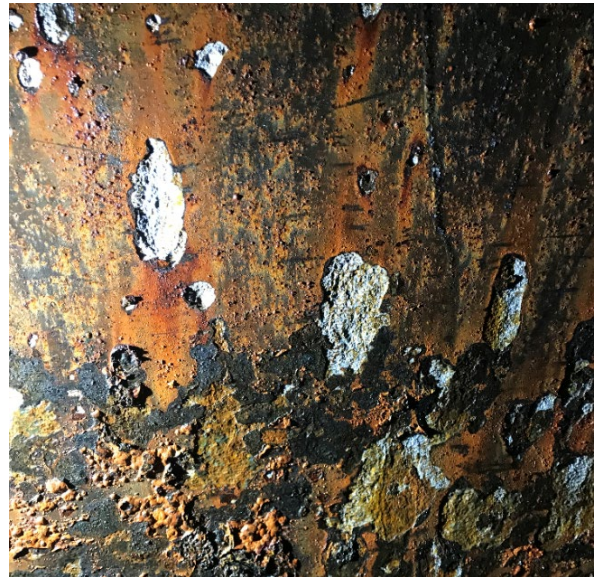
Picture right shows coating failures where tank cleaning revealed active corrosion occurring underneath the tubercle formations.

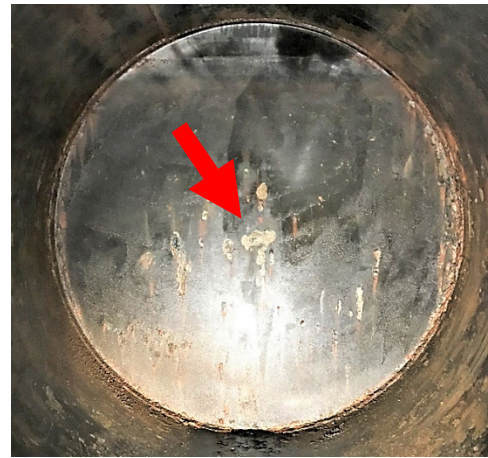
Picture left (*enlarged area from picture above*) shows a crack in the weldment located on the internal side in the center of the back head. This crack measures an inch and a half in length. A pitometer was used to measure the depth of the crack but was impinged at a depth of .245 inches. This crack requires a welded repair. It is unknown whether a full penetration has occurred without vacuum box testing however there were no indications of groundwater infiltration during the examination.

| Welds | Back head center plug weld has 1.5" long crack requiring repair. | | | X | | |

**Action Item #2** – Make weldment repair to the cracked weld of Tank #1.

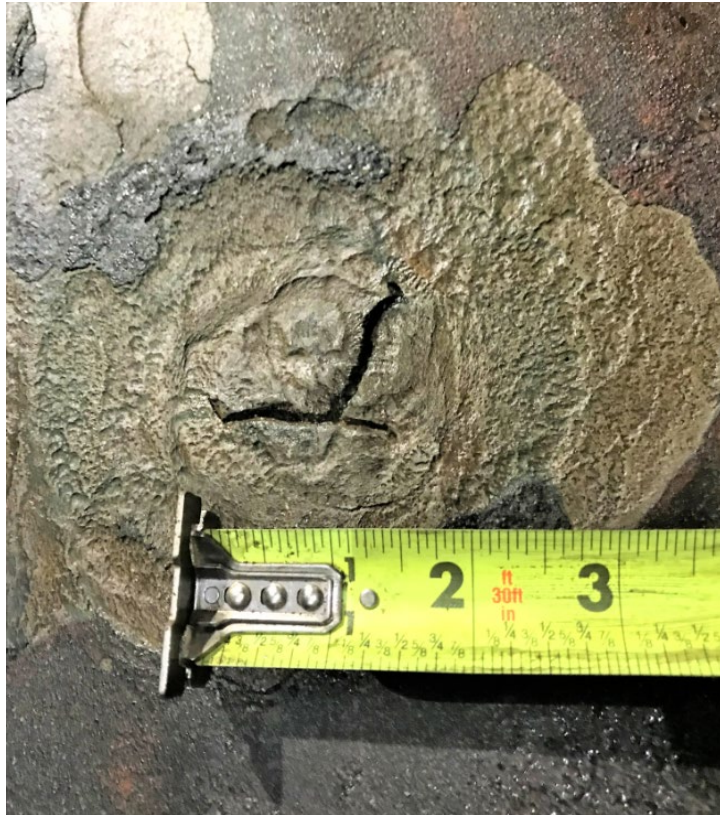
The red arrow in picture to the right points to the location on the plate surface of the back head that has a cracked weld that requires a welded repair. During the tank fabrication process a hole is commonly drilled in the center of the tank head which allows the large piece of steel to be manipulated for fitting after which, the hole is repaired in various ways. In tank 1 the crack is indicative of a method where an external patch plate was used to cover the drill hole and additionally a plug weld was made internally. In this case fabrication temperatures and stresses likely caused the plug weld to crack at some point.

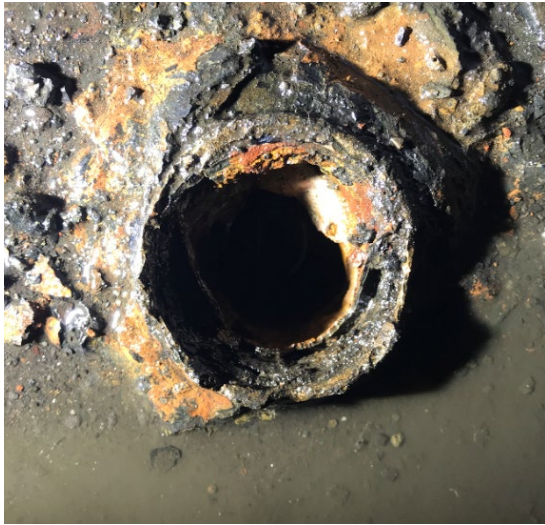
Picture of bottom drain nozzle clear of obstruction but in poor condition.

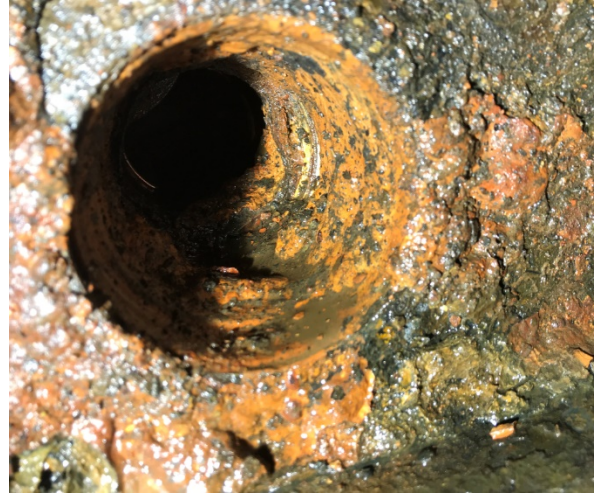
Pictured right is the 3-inch nozzle at the bottom of the front head showing no obstructions.

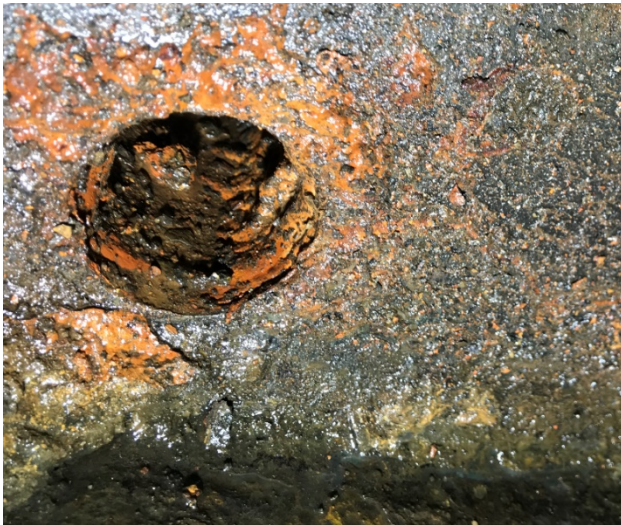
Picture left shows the 2-inch nozzle at the bottom of the front head. Corrosion byproduct is building up inside the piping.

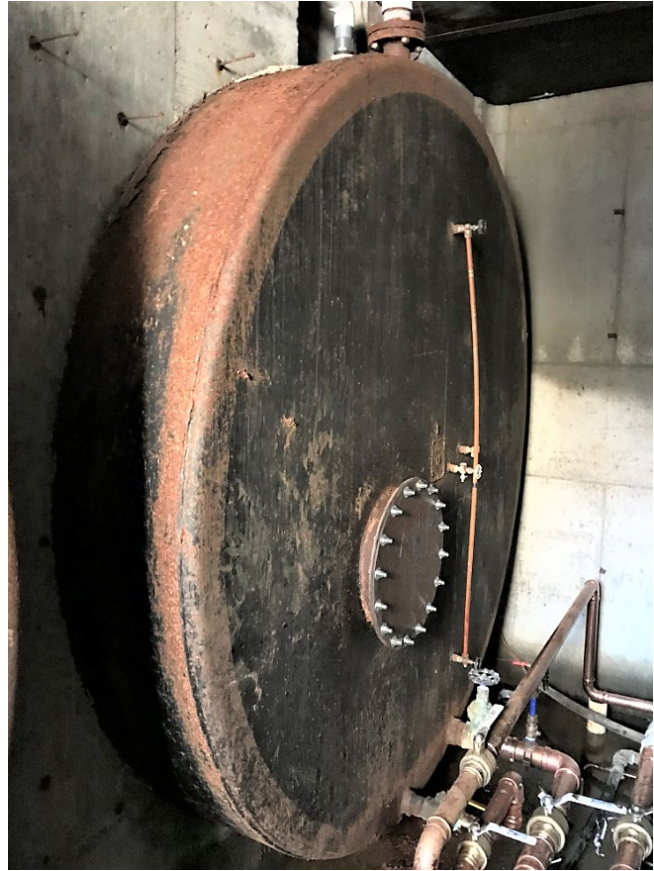
Picture to the right shows the front head and tank shell, of Tank #2, that extends through the concrete pump house wall. Moderate generalized corrosion is seen on the shell and head plate surface. Concrete wall remains in good condition.

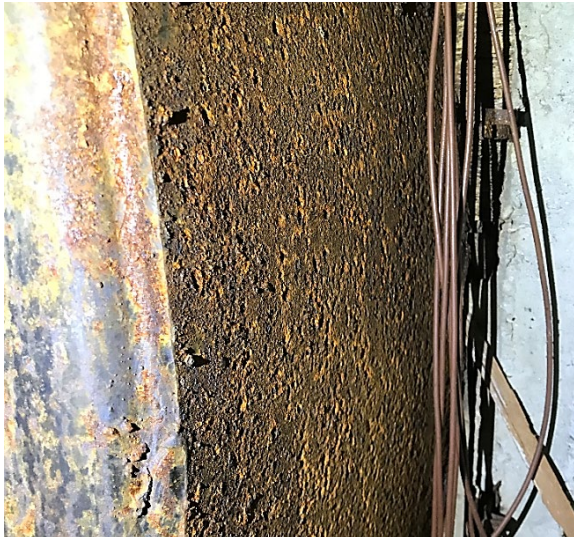
The tank shell shown left currently displays moderate pitting corrosion that is measured at .008 inch in average depth. The failed exterior coating has left the carbon steel susceptible to corrosion. When condensation collects in the irregular surfaces of the exposed shell it becomes conducive to attack by pitting corrosion.

**Action Item #3** – Abrasive blast and apply coating to exterior of both Tank 1 and 2 to maintain tank integrity.

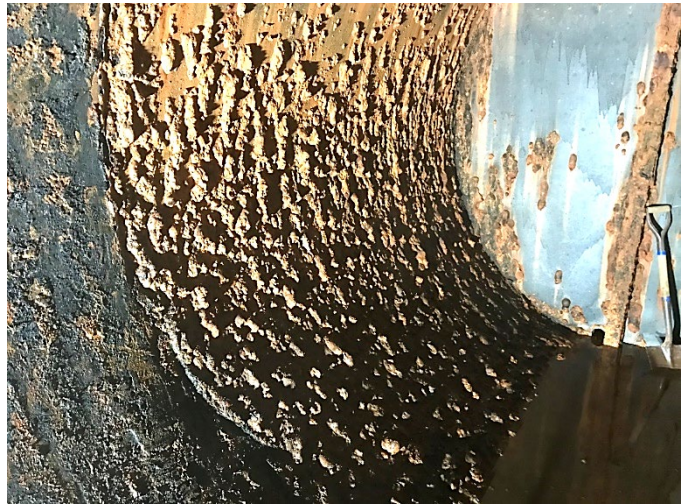
Picture right shows the heavy tubercle growth on the internal side of tank #2 prior to cleaning.

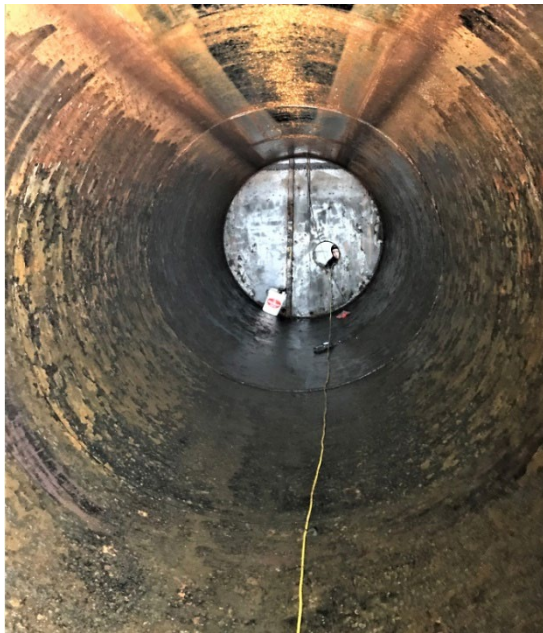
Picture left shows the interior tank shell after cleaning. Areas of bare steel are exposed after cleaning failed coating.

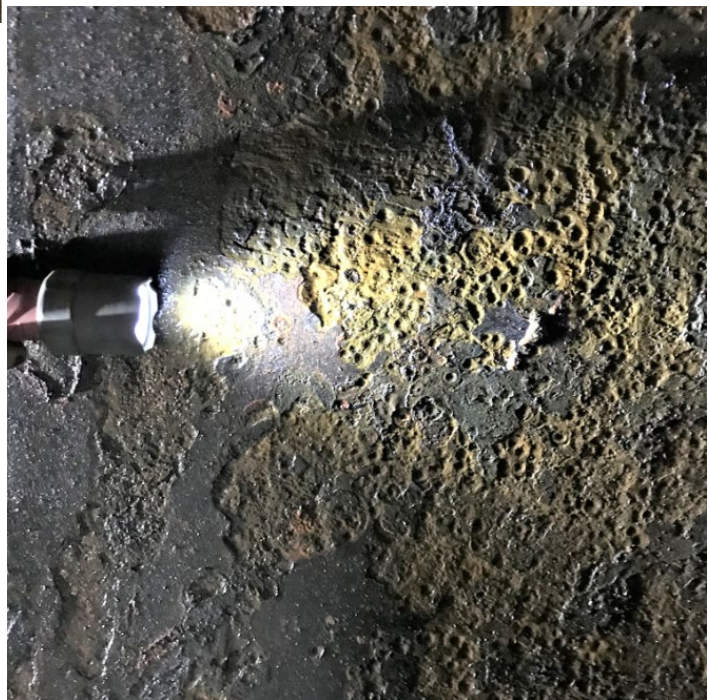
Picture right shows an area of the tank bottom that has been affected by scattered localized pitting of moderate depth. This is an example of a typical condition that exists throughout 40% of the entire shell field.

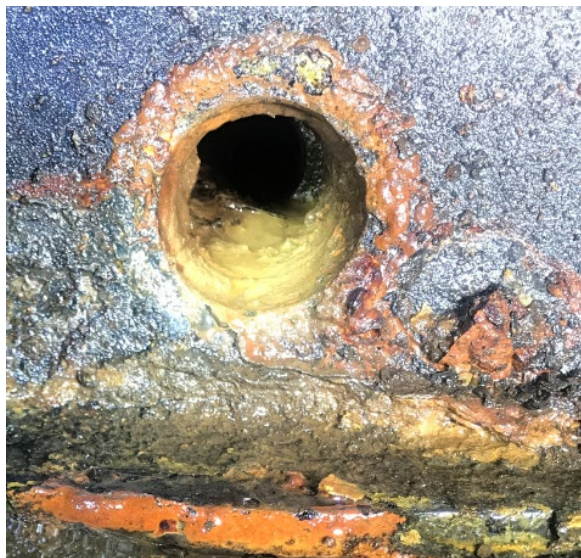
Fillet welds of the shell to shell and shell to head lap joints (*example shown right, red arrow*) show minimal pitting in scattered locations but otherwise remain sound. No indications of undercutting or incomplete penetration were identified.

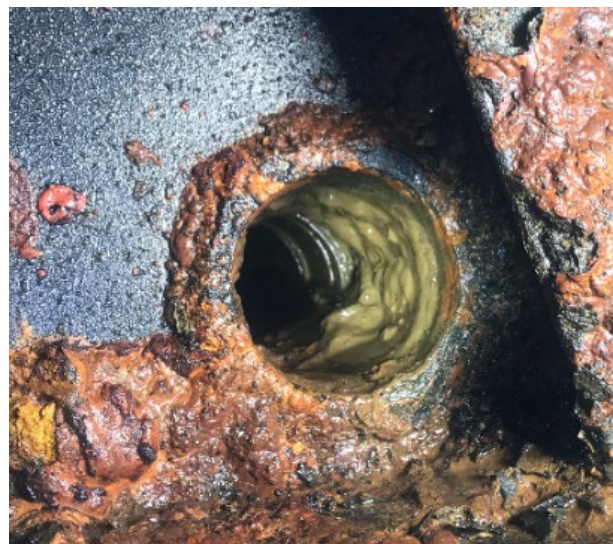
Fill and discharge nozzles are free of obstruction as shown in the picture above and to the right.

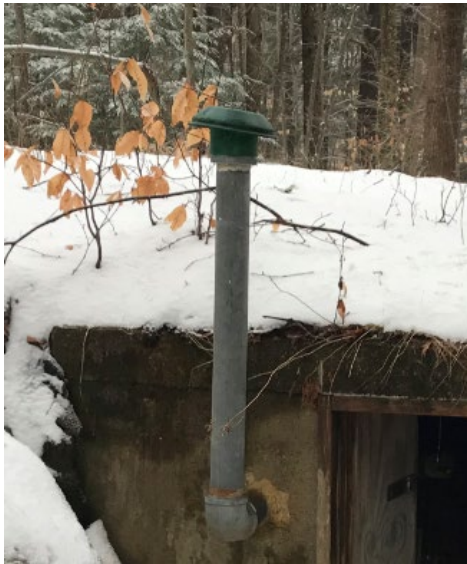
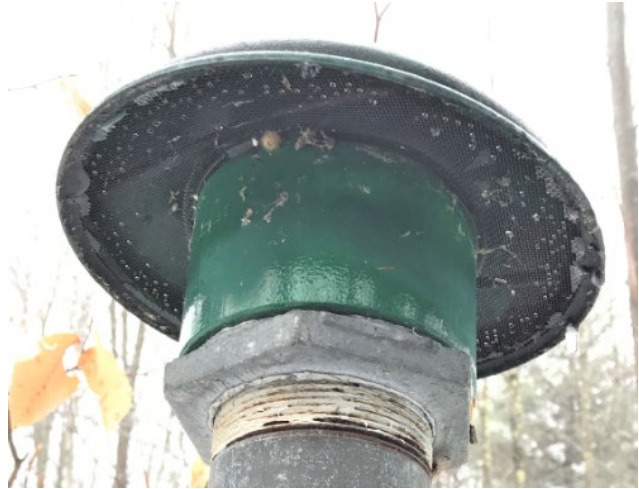
Venting for both tanks is achieved via a shared inline 2" schedule 40 PVC pipe. The pvc pipe is then fitted to a 3-inch metal pipe which penetrates the underground service room and terminates vertically with a rain shield/bug screen attached. The normal designed venting of storage tanks is typically at least as

large as the filling or withdrawal connection, whichever is larger. In certain water demand conditions, the current shared 2-inch vent may not adequately service both at once and vacuum/pressure forces could be exerted on subject tanks.

**Recommended Action Items** – Make modifications to the subject tanks vent and overflow so that they are independent of each other and are adequately sized.

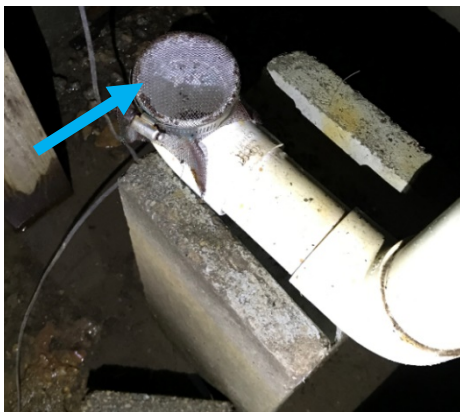
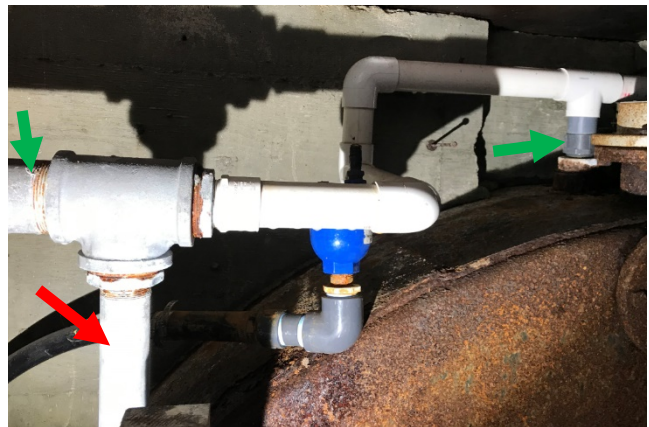
Both tanks share a common pvc overflow pipe that is also part of the vent piping. Systems for overflow and venting are typically separate. Per AWWA D100-11, a vent pipe shall not be considered an overflow pipe. The picture right shows the combination piping at the top of Tank #1. The red arrow points to the overflow pipe that terminates near the service room floor. The green arrows point to the tank vent line which terminates outside.

Blue arrow in picture to the left points to the terminus of the overflow pipe. Overflow piping should be positioned in a downward direction for proper drainage to maintain sanitary conditions.

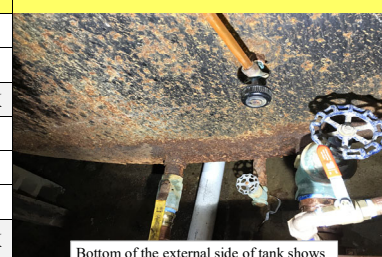
Bottom of the external side of tank shows significant corrosion.

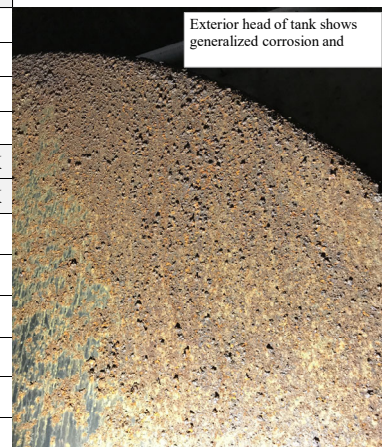
Exterior head of tank shows generalized corrosion and

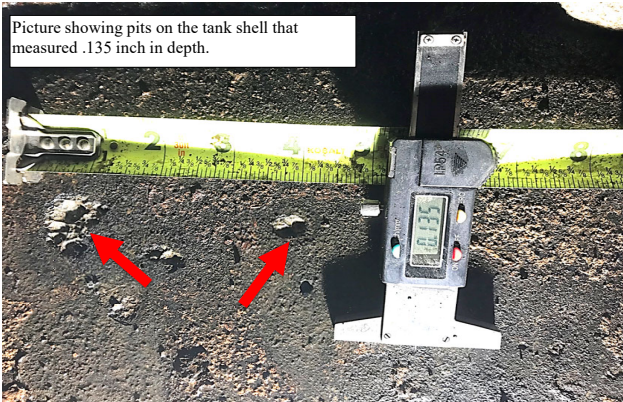
Picture showing pits on the tank shell that measured .135 inch in depth.

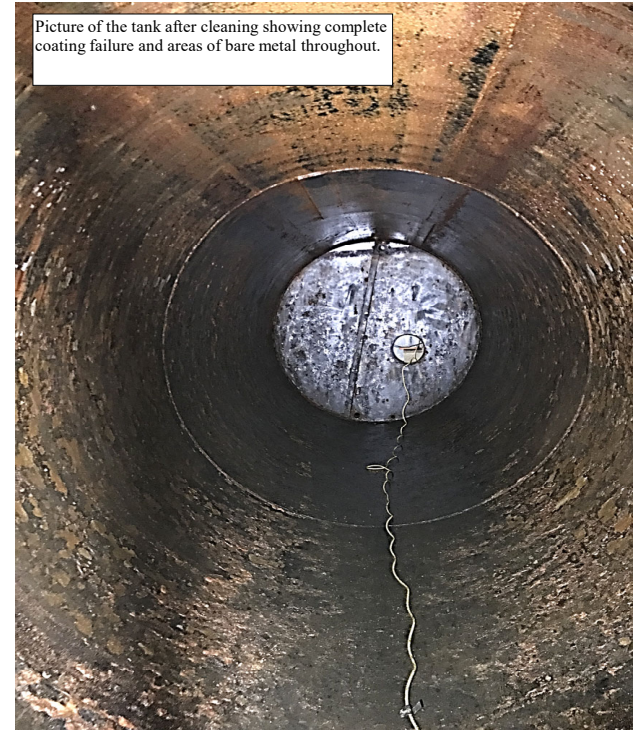
Picture of the tank after cleaning showing complete coating failure and areas of bare metal throughout.

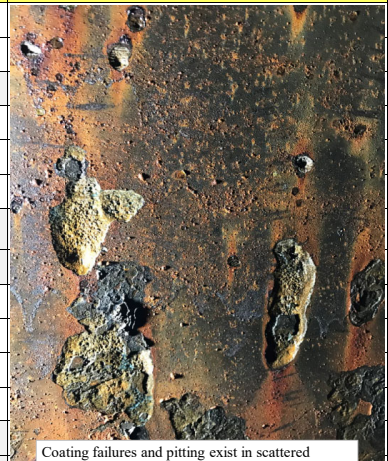
Coating failures and pitting exist in scattered localized areas throughout the internal shell field.

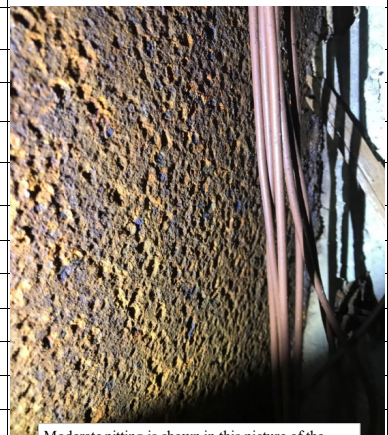
Moderate pitting is shown in this picture of the external shell that extends through the concrete wall.

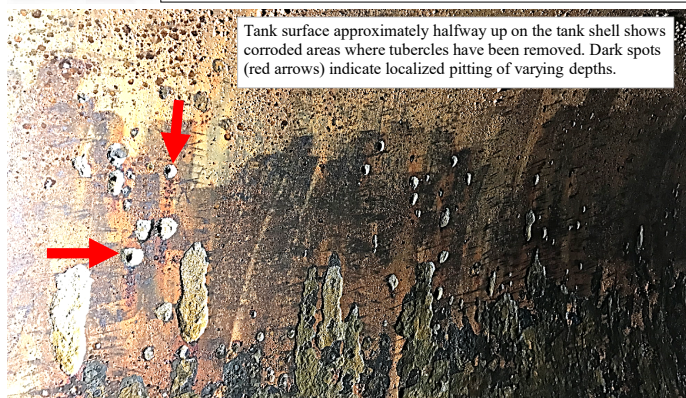
Tank surface approximately halfway up on the tank shell shows corroded areas where tubercles have been removed. Dark spots (red arrows) indicate localized pitting of varying depths.
