Gorham Paper and Tissue, LLC Gorham Gas line installation Project Proposed Scope of Work for Androscoggin Bridge Repairs

The following is a summary of the proposed Androscoggin Bridge Repairs designed and submitted by Fisher Engineering, P.C. on July 22, 2011. The attached drawings S1 and S2 depict the actual locations and repair designs that will need to be accomplished.

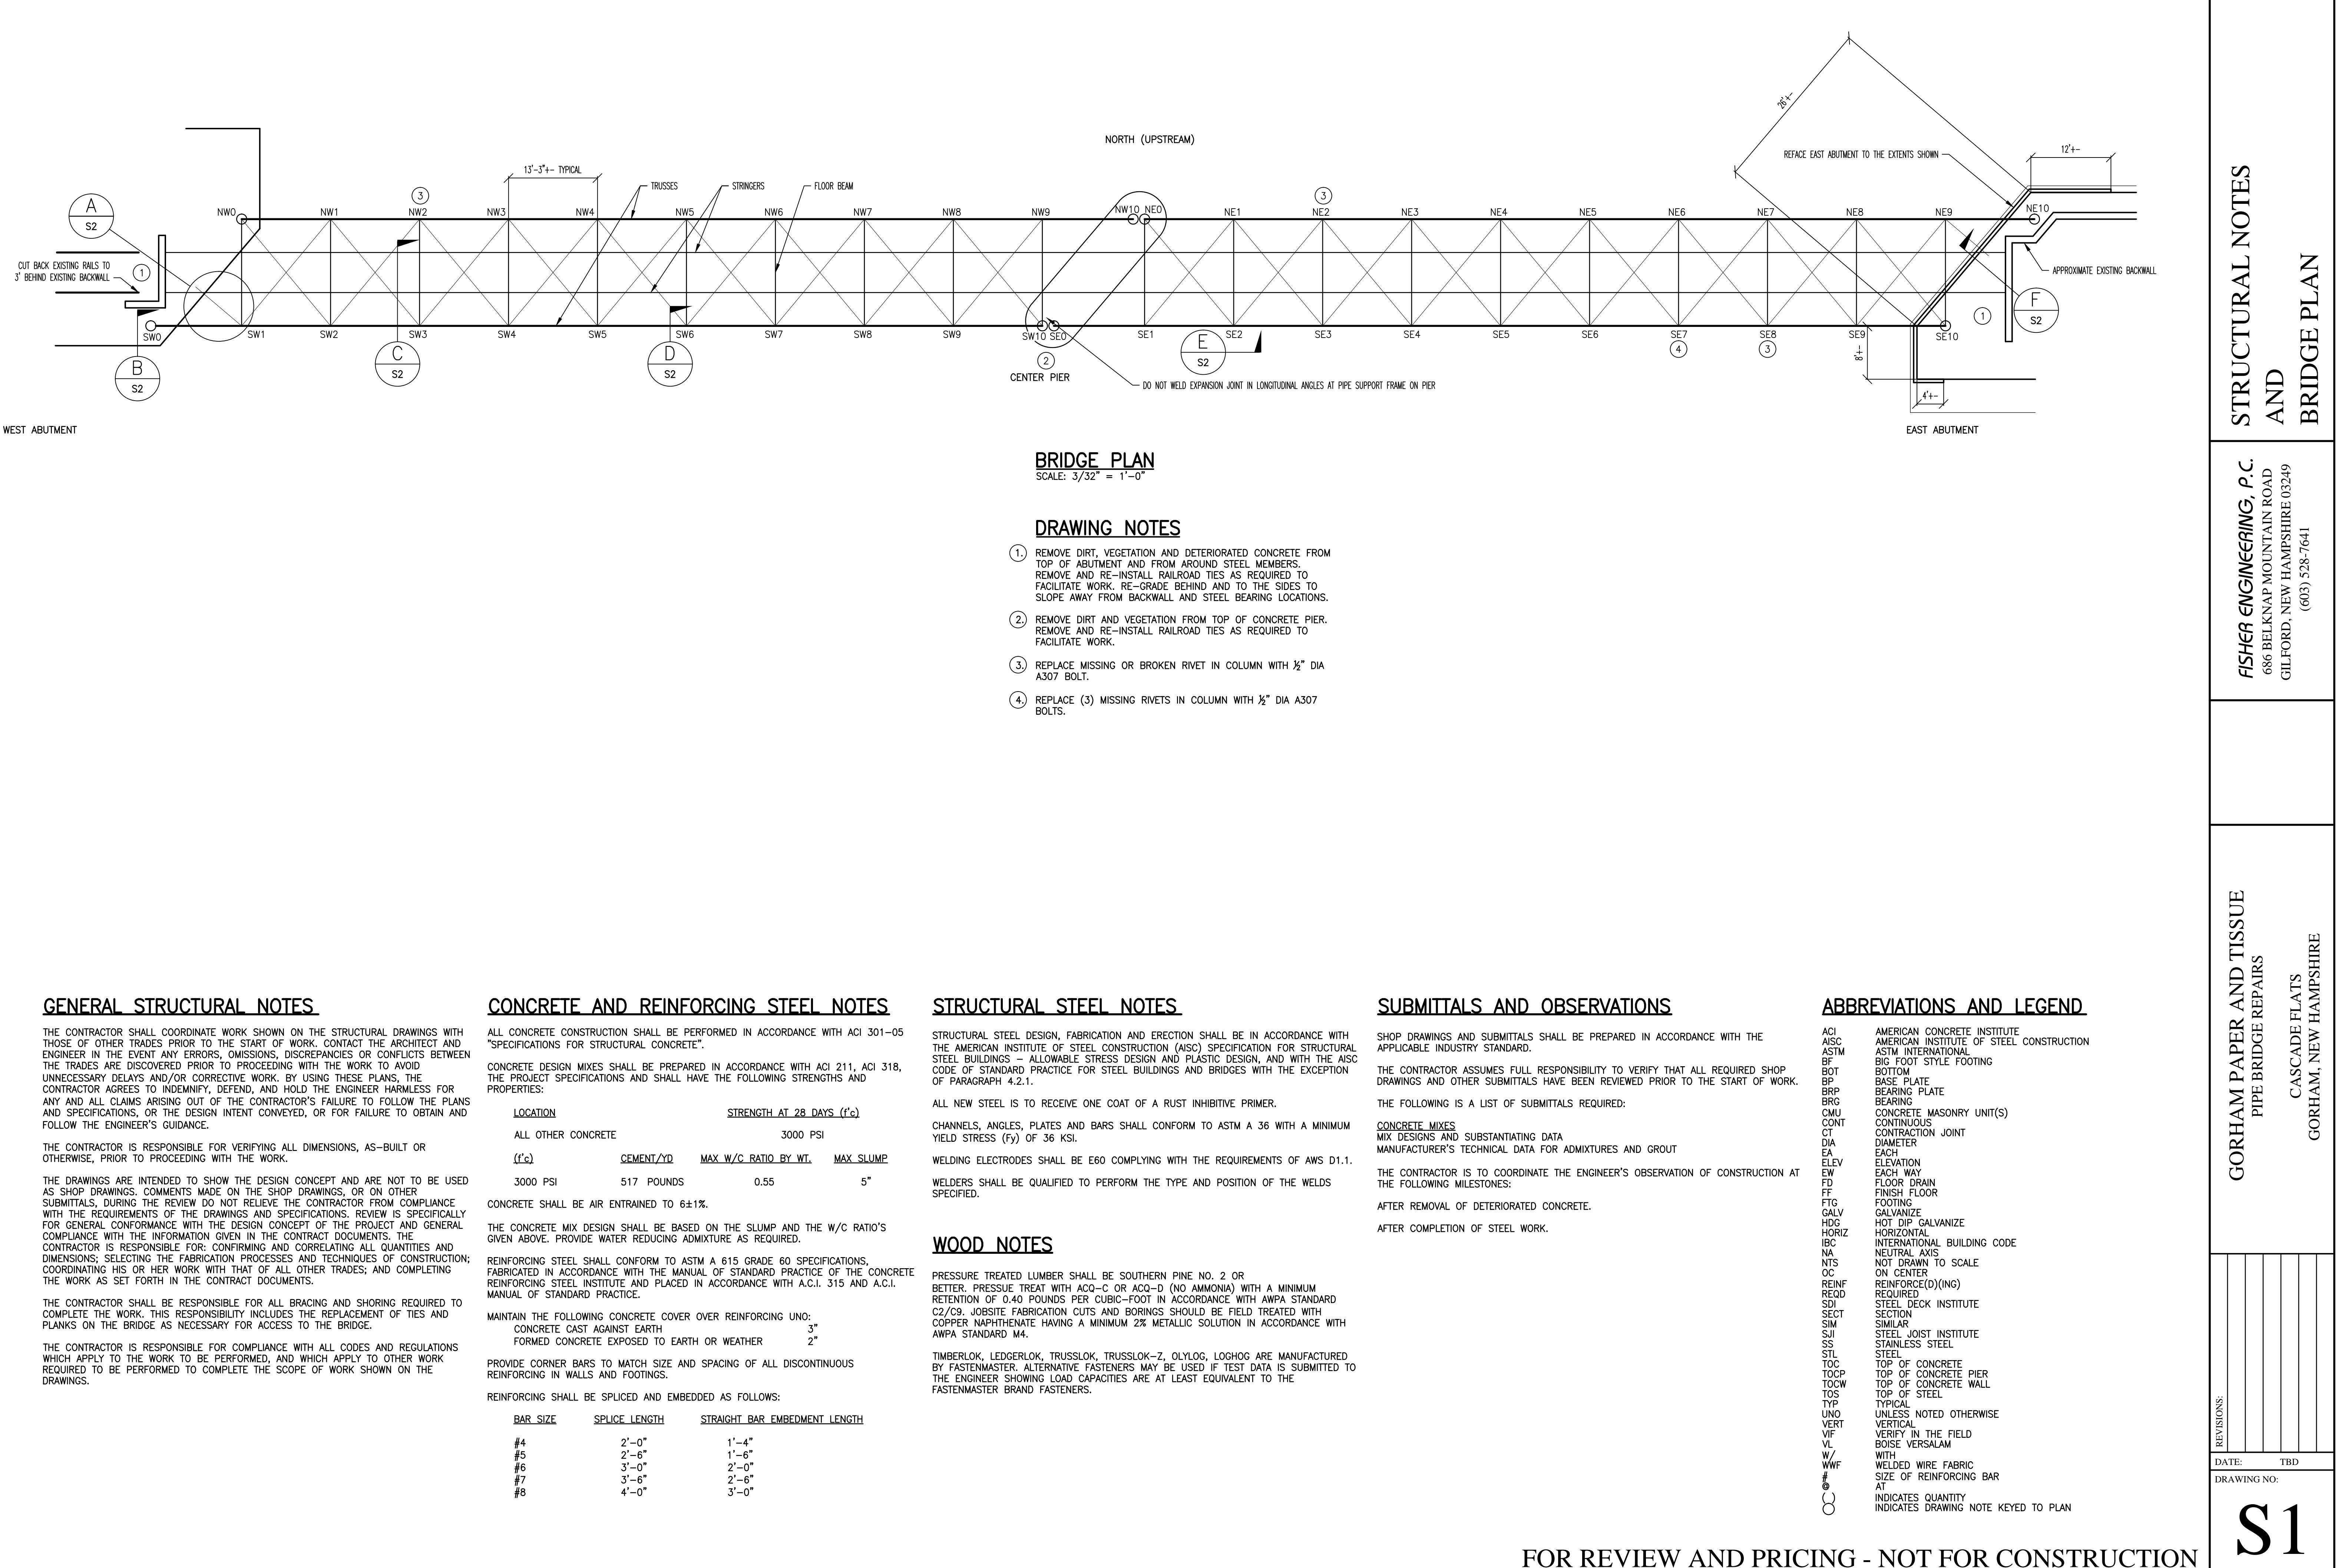
SH\_1\_OF\_2\_

- 9. The top 4'-5' of the exterior of the East abutment appears to have significant deterioration of the existing concrete. Once this area is cleaned, remove and replace approximately 234 cubic feet of concrete. This is includes a 4'-8" high by 50' long by 1' deep area of the existing foundation. Structural Engineer will review demolished area to determine if the removal is sufficient to expose sound concrete. Detail shown on Drawings S1 and S2 Section F.

- 1. Remove dirt, vegetation and deteriorated concrete form the top of the East and West abutments and from around steel members. Remove and replace railroad ties with new as required to facilitate this work. Re-grade behind and to the sides to slope away from the back wall and steel bearing locations.

- 2. Remove dirt and vegetation from the top of the Center Pier and from around steel members. Remove and replace railroad ties with new as required to facilitate this work.

- 3. Replace broken or missing rivets in 3 separate columns (NE2, SE7 and SE8) totaling 5 rivets. Replace with <sup>1</sup>/<sub>2</sub>" Diameter A307 bolts, nuts and washers.

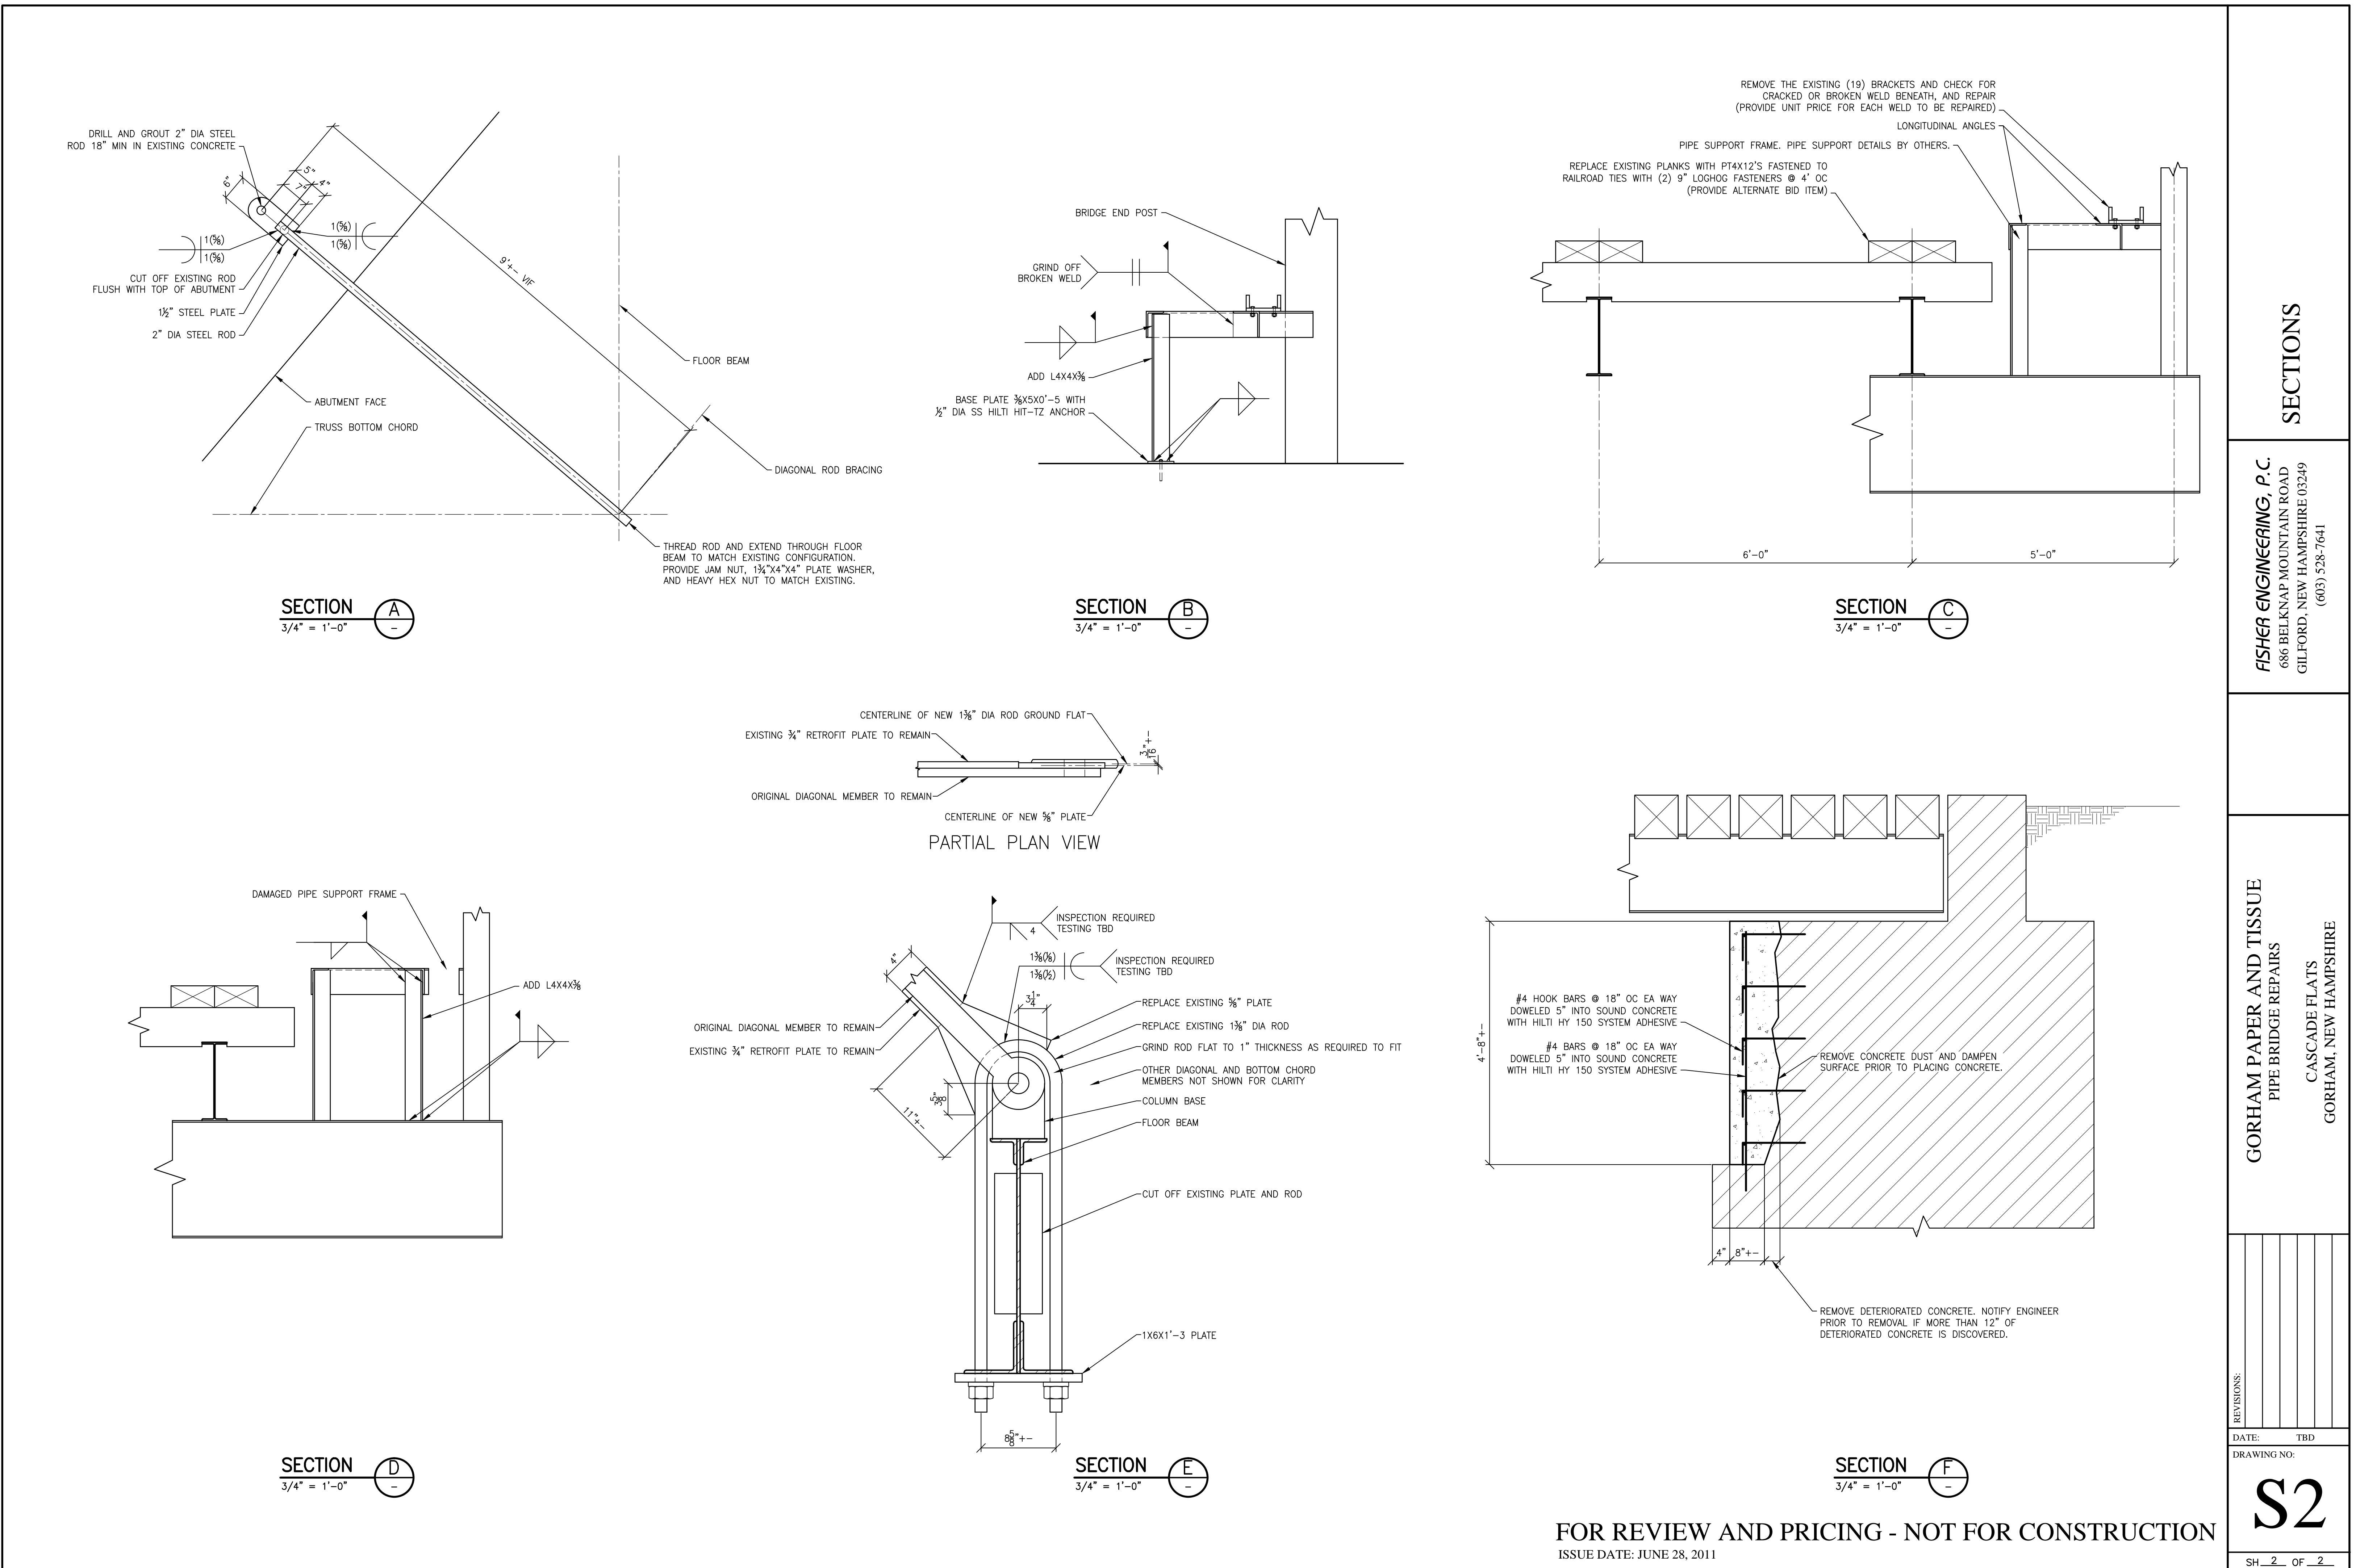
- 4. Replace on 9' long deteriorated diagonal bracing road starting from SW1 location to the West abutment. Details on Drawing S2 Section A.
- 5. Repair the West end of the Utility support structure. This will require the removal of a 2'+/- long bent angle iron brace and installation of a new angle iron support member. Once in place grind up cracked weld and replace with new. Details on Drawing S2 Section B.

- Remove 19 discontinued pipe brackets from the existing Utility Support Structure. Inspect for cracked or broken welds under brackets and repair as needed. Details shown on Drawing S2 – Section C.

- The Utility Support Structure has been cut free of the upright column at location SW6. Add a piece of 4"\*4"\*3/8" angle approximately 2' long from the top member to the existing girder to support the Utility structure. Detail shown on Drawing S2 – Section D.

- 8. The existing U-Bolt connection at location SE2 has significant deterioration and requires replacement. Remove and rebuild the connection as designed. This will require new U-Bolts be fabricated to the dimensions of the old bolts. Field measurement will have to be completed to assure a match. Detail shown on the Drawing S2 Section E.
