Asset Check Up Report

WILDWOOD WATER COMPANY, INC
ALBANY, NEW HAMPSHIRE

01/22/2018

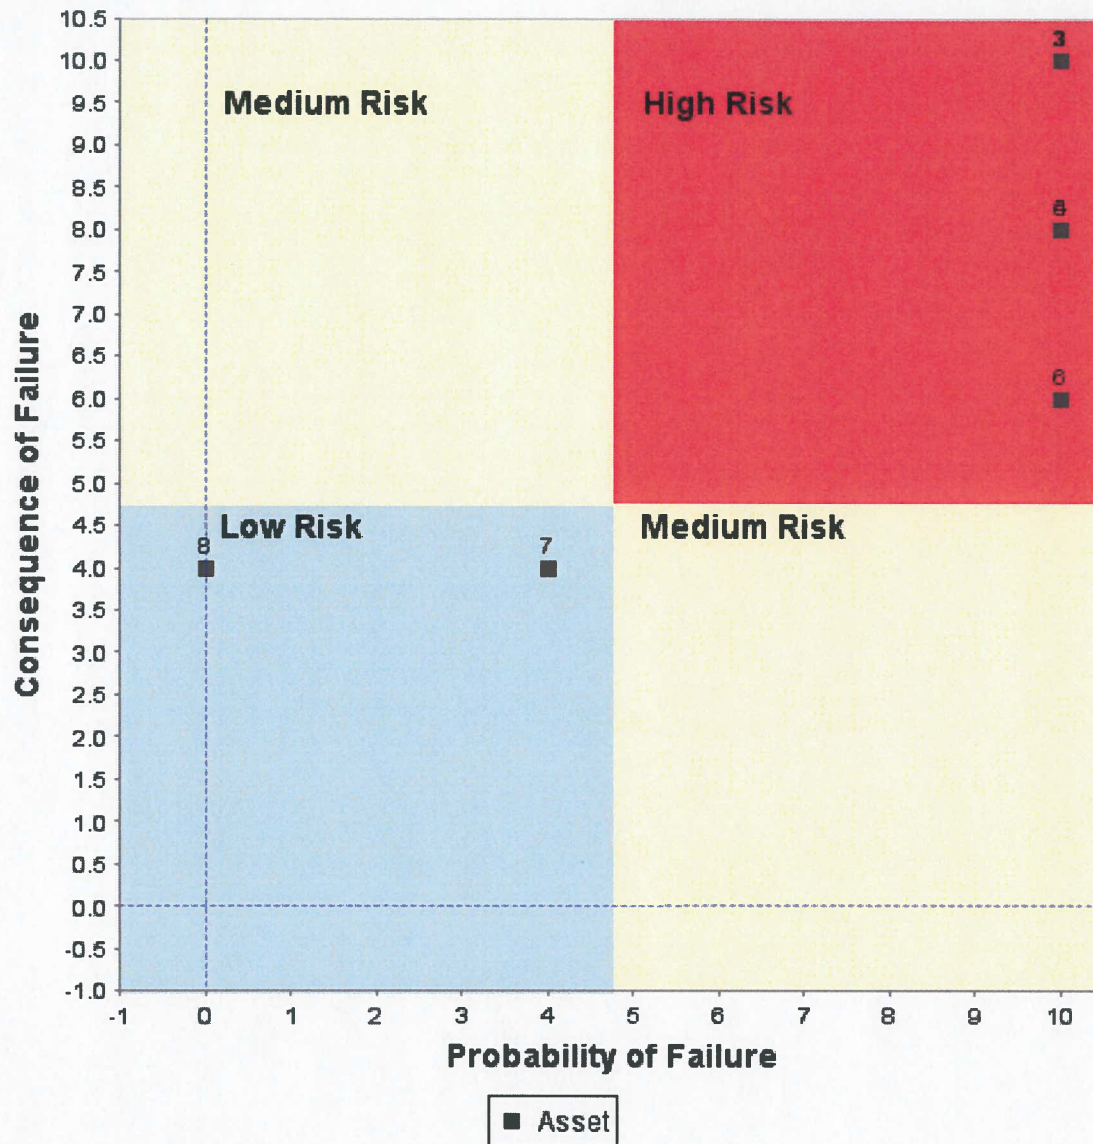
Figure 3.1 Asset Risk Matrix - *NOTE REFER TO TABLE BELOW USING PRIORITY NUMBERS WITHIN THE ASSET RISK MATRIX

Priority	Asset	Category	Asset Type	Risk	Replacement Date
1	Chemical Feed System	Treatment	Treatment Equipment	High Risk – Immediate Attention	Over due
2	Mains	Distribution	Distribution / Collection Mains	High Risk – Immediate Attention	Over due
3	Well	Source	Wells	High Risk – Immediate Attention	Over due
4	Services	Distribution	Service Lines	High Risk – Immediate Attention	Over due
5	Tank 1 (PST)	Storage	Concrete & Metal Storage Tanks	High Risk – Immediate Attention	Over due
6	Structures	Pumping Facility	Buildings	High Risk – Immediate Attention	Over due
7	Well Pump- 35gpm HP	Pumping Facility	Pumping Equipment	Low Risk – Routine Maintenance	02/01/2024
8	BIRM Treatment System	Treatment	Treatment Equipment	Low Risk – Routine Maintenance	02/01/2031
