SEC 2024-02 DE-24-087

kris pastoriza

January 6, 2025

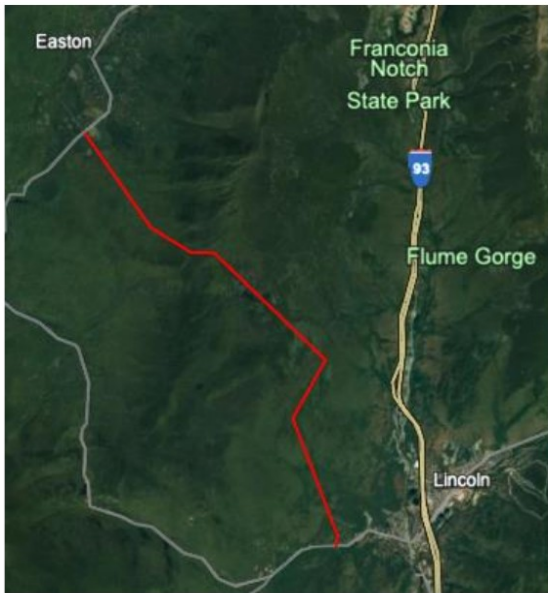
X-178 line crosses White Mountains with limited access points for construction equipment

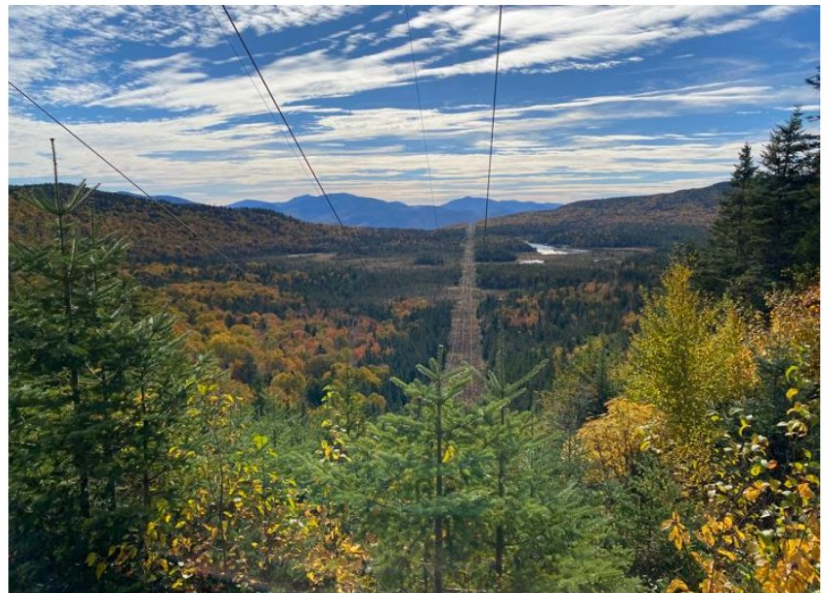
9+ mile section with no crossings/entry points across White Mountain National Forest

Highest point (2,606 ft) at crossing of Appalachian Trail is 4+ miles from closest road in either direction

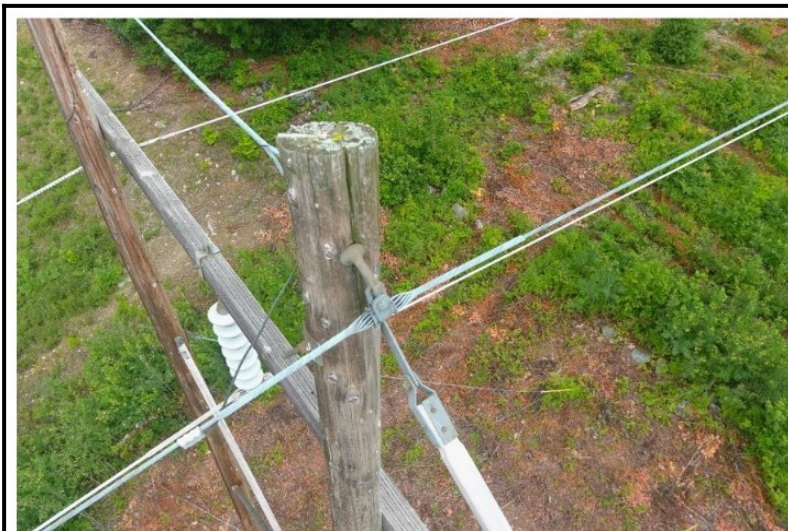
2022 Photo

Photo of dry pole

Cross-arm anchor facing toward viewer

No white marking on r. side of ground wire

Ratio of ground wire attachment 4: 2.4

This ratio difference could be due to the fact that the photos are not comparable. Note that the cross-arm brace anchor appears to end at ground wire in the 2022 photo and the cross-arm brace anchor is clearly seen to end below the ground wire anchor in the 2024 photo.

It is not clear that these photos are even of the same pole.

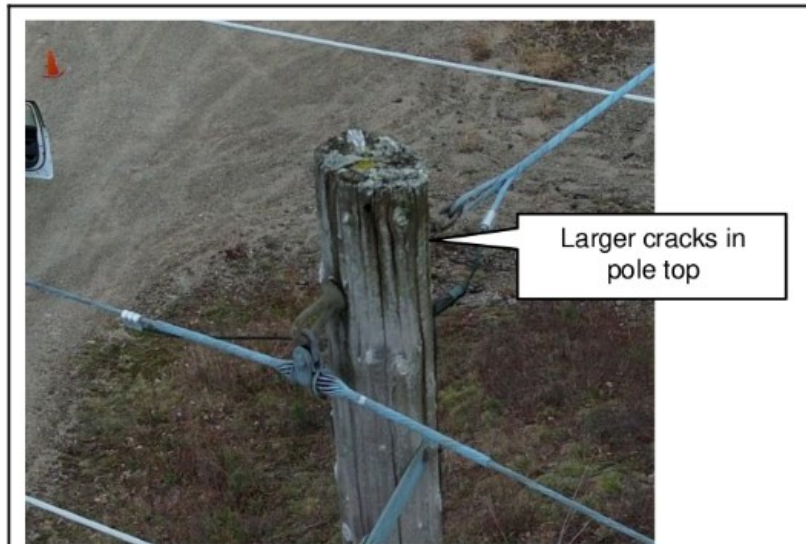
2024 Photo

Photo of wet pole

Anchor facing 90 degrees left

Cracks labeled as larger not visible in 2022 photo

White band on r. side of ground wire

Ratio of ground wire attachment 3: 3.5
