CHAPTER V

Operations, Maintenance, and Vegetation Management

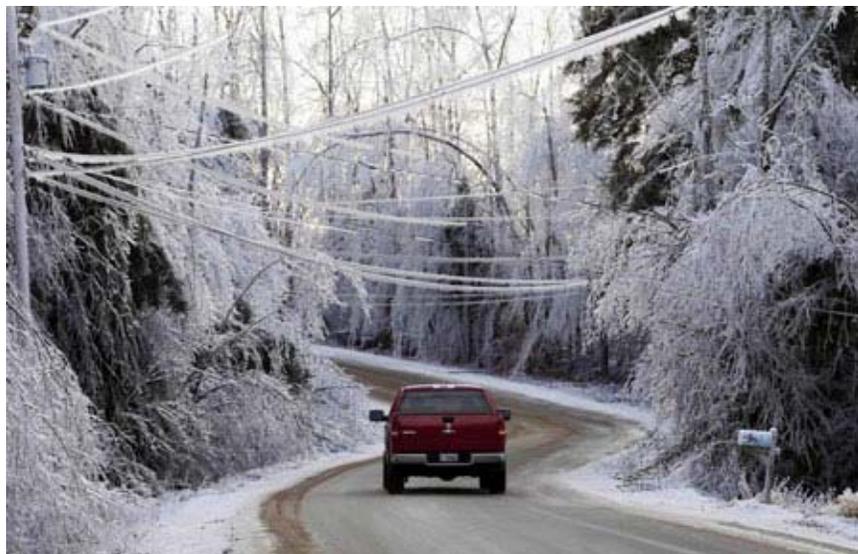
**Figure V-2 - Ice loading on lines during December 2008 ice storm.
(Photo courtesy of PSNH, location unknown.)**

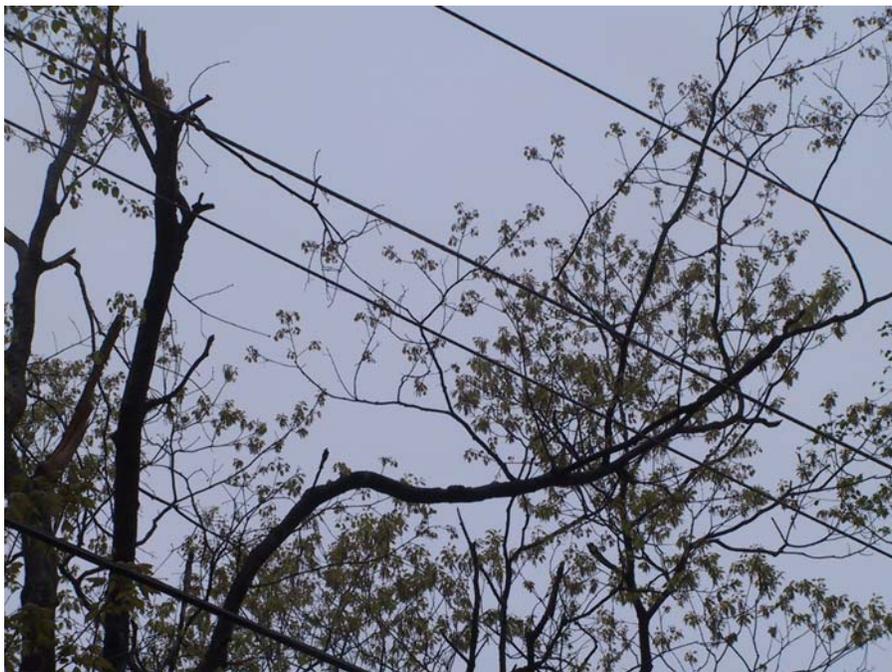
Figure V-5 - Small diameter immature trees broken above conductors in New Ipswich, NH. (Photo by NEI)

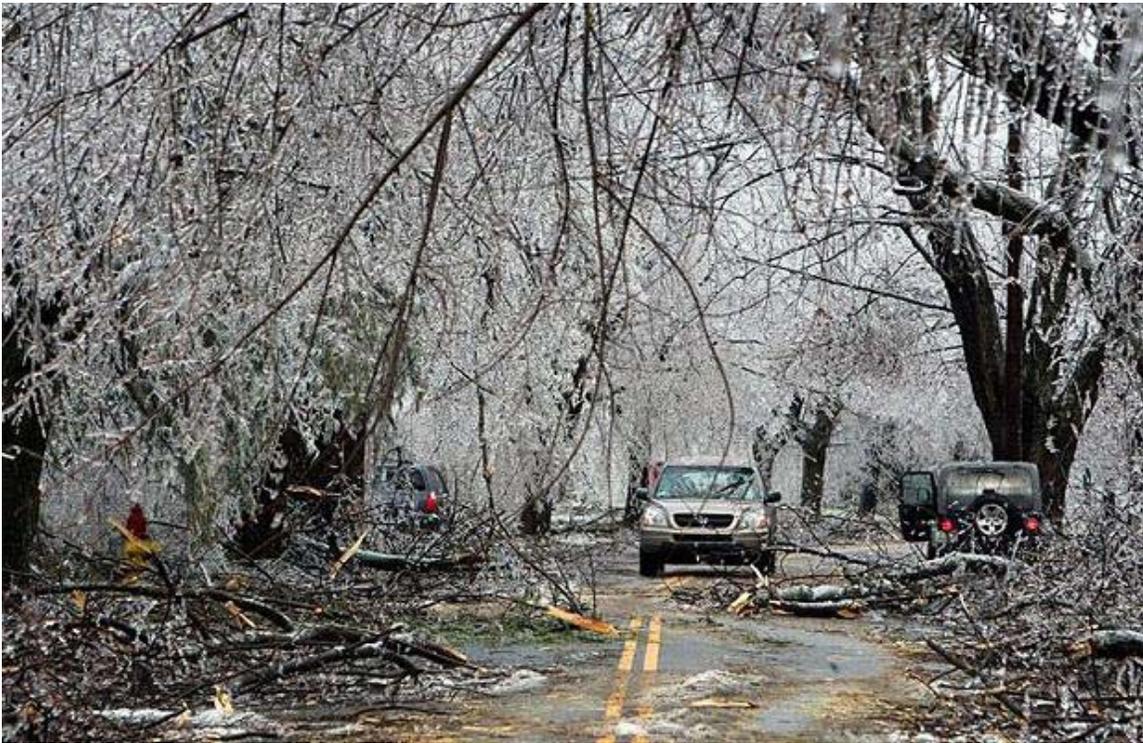
New Hampshire is 90% woodland, and while most residents enjoy the scenic forests of the state, they also remember scenes such as shown in Figure V-7 and the damage done by trees to roads and power lines. In many parts of the state, roads were impassable and power was not restored for up to two weeks due to broken tree limbs and downed trees. Practically all of the damage done to the electric power and telephone systems by the storm was a result of trees damaged by ice.

Figure V-7 - Effects of ice laden trees. (Photo source unknown)

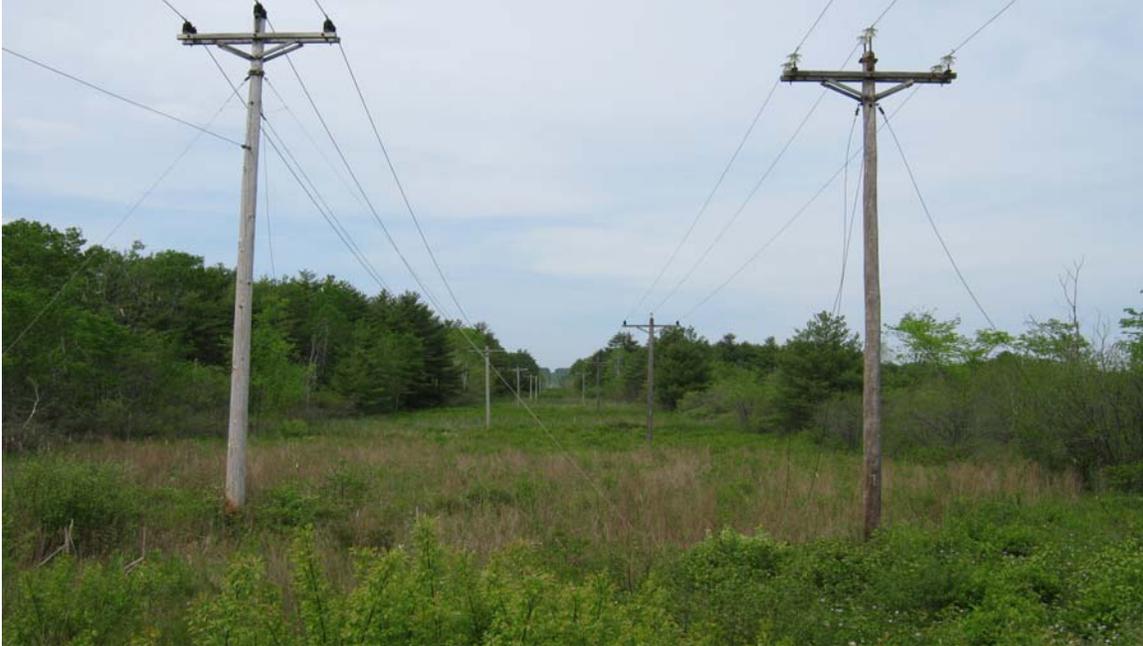
Figure V-9 - Example of 34.5 kV Unitil sub-transmission line ROW. (Photo by NEI)

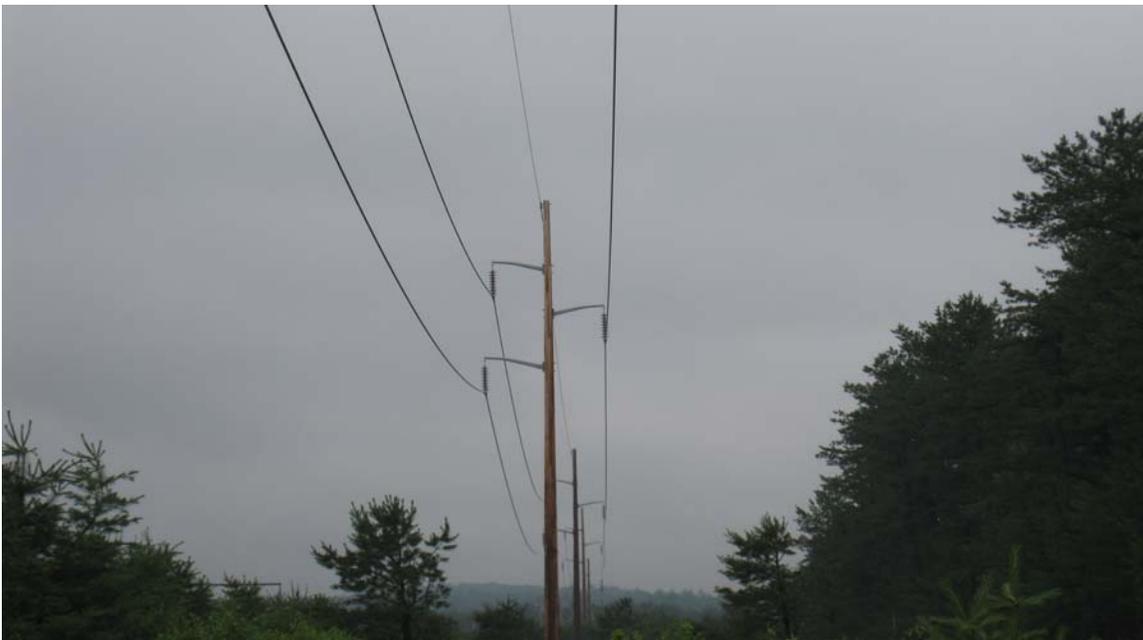
Figure V-10 - PSNH 115kV circuit V182 in Concord, New Hampshire. (Photo by NEI)

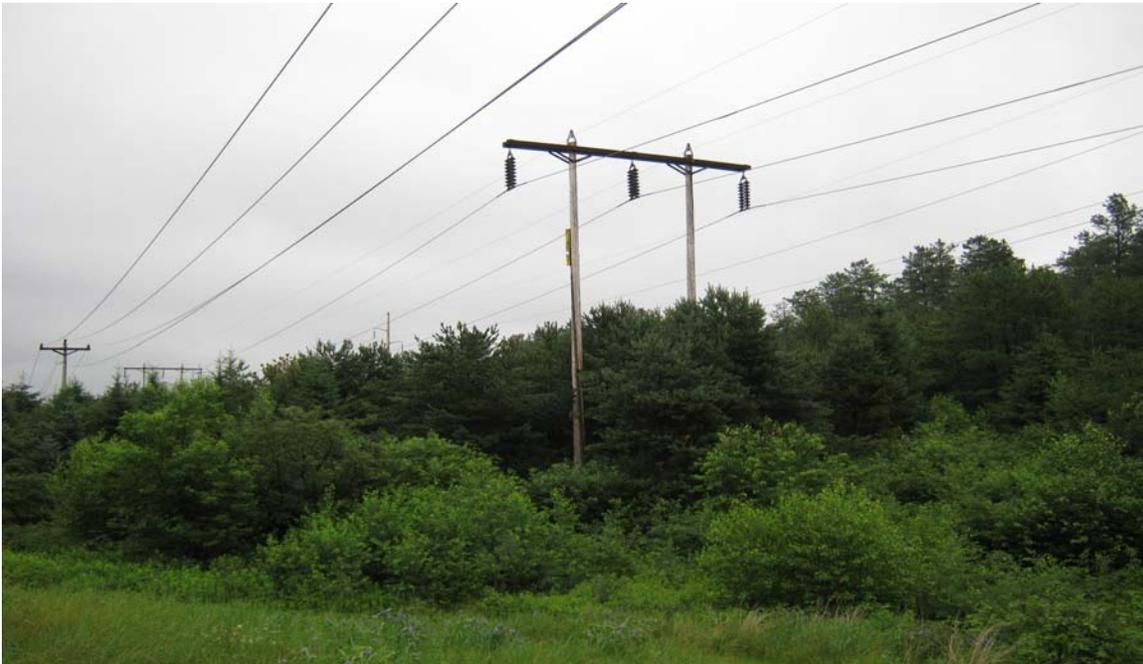
However, Figure V-11 shows an adjacent transmission circuit, circuit P145, which has a number of large trees growing under the lines. Figure V-12 shows another view of circuit P145 where the extent of the vegetation management problem may be seen. The vegetation management

under this circuit is insufficient and if not improved could result in the trees growing into the lines or major damage if a fire were to occur in the ROW.

**Figure V-11 - Northeast view of PSNH 115kV circuit P145 with circuit V182 shown in the background.
(Photo by NEI)**

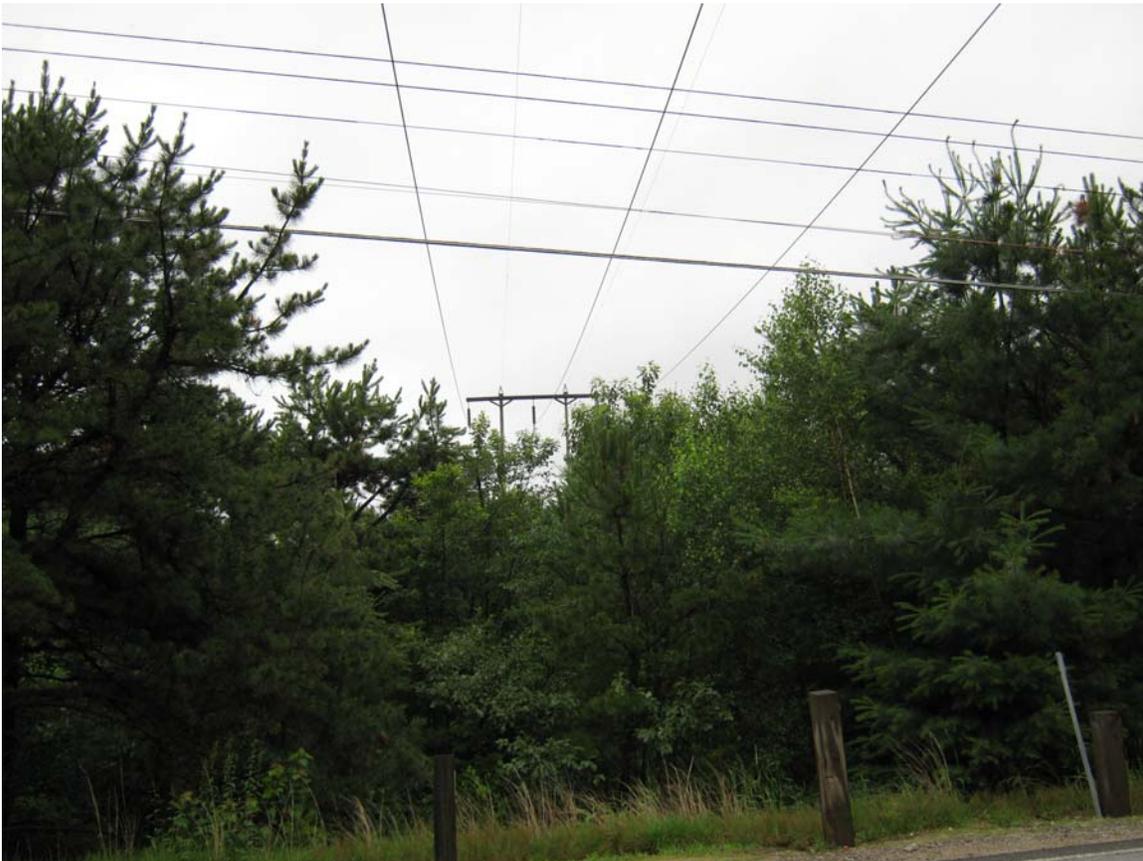
Figure V-12 - South view of circuit P145. (Photo by NEI)

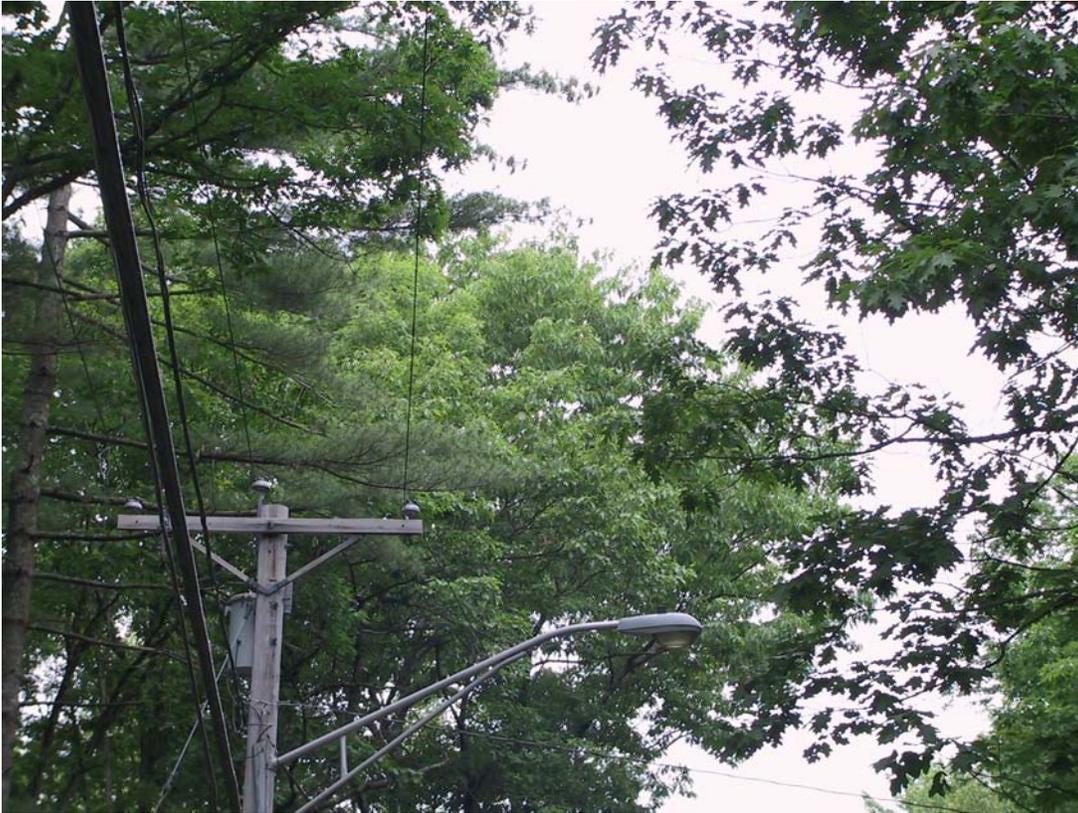
At this time the trimming practices used by PSNH, Unital, and National Grid do not achieve ground to sky clearances around power lines. Ground to sky clearance in a ROW means all trees and branches in the right of way between the earth and the sky are removed during trimming. This would include removing any branches that may be growing over the right of way from trees located outside of the right of way. The trimming practices of PSNH, Unital, and National Grid do not guarantee ground to sky clearances. It was observed that even freshly trimmed line easements along roads still have canopy branches hanging above the line. One reason for this is that tree trimming crews do not have boom trucks capable of reaching the highest canopy layers which may exceed the 70 foot height limit of a typical boom truck. One instance of this can be seen in Figure V-13 which shows a recently trimmed line with considerable foliage above. The overhanging branches shown here could break in a future storm damaging the conductors below.

Figure V-13 - White pine recently trimmed in Pelham, New Hampshire. (Photo by NEI)

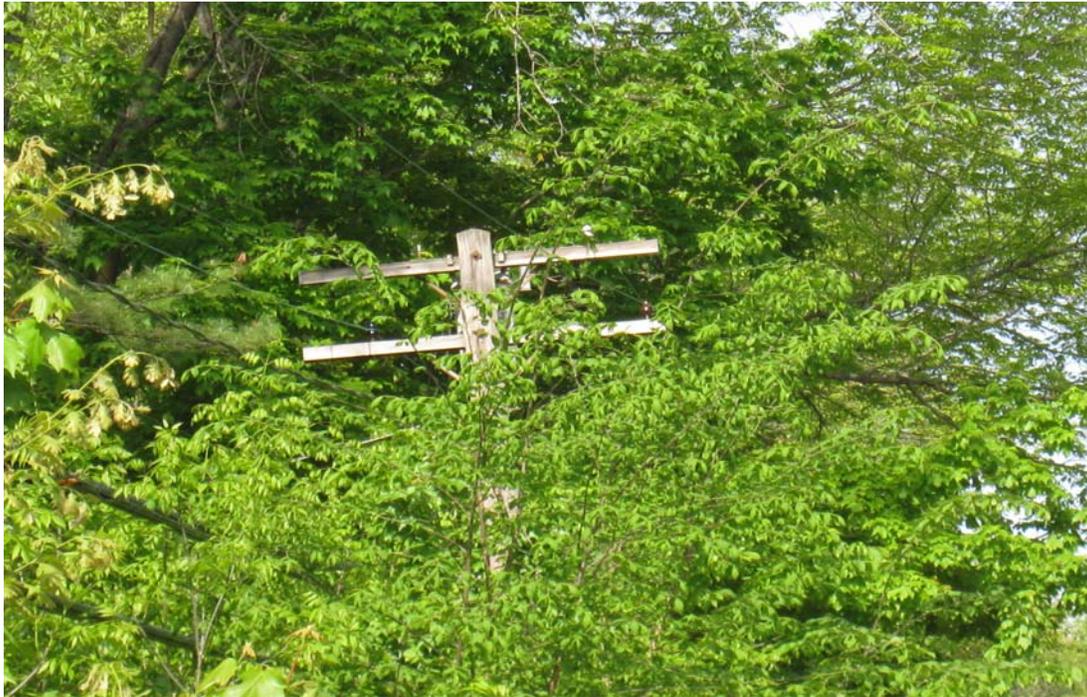
Figure V-14 shows an example of a NESC Rule 218 violation where there is obvious wire to tree contact. This Figure shows substantial, relatively weak, overhang growth above the conductors.

This growth is unsafe, violates the NESC, and is possibly damaging the conductors. While this photograph was taken on Unutil's system, it is not meant to single out Unutil. Similar situations occur on the systems of each utility.

**Figure V-14 – NESC Rule 218 violation in Unutil service area.
(Photo by NEI)**

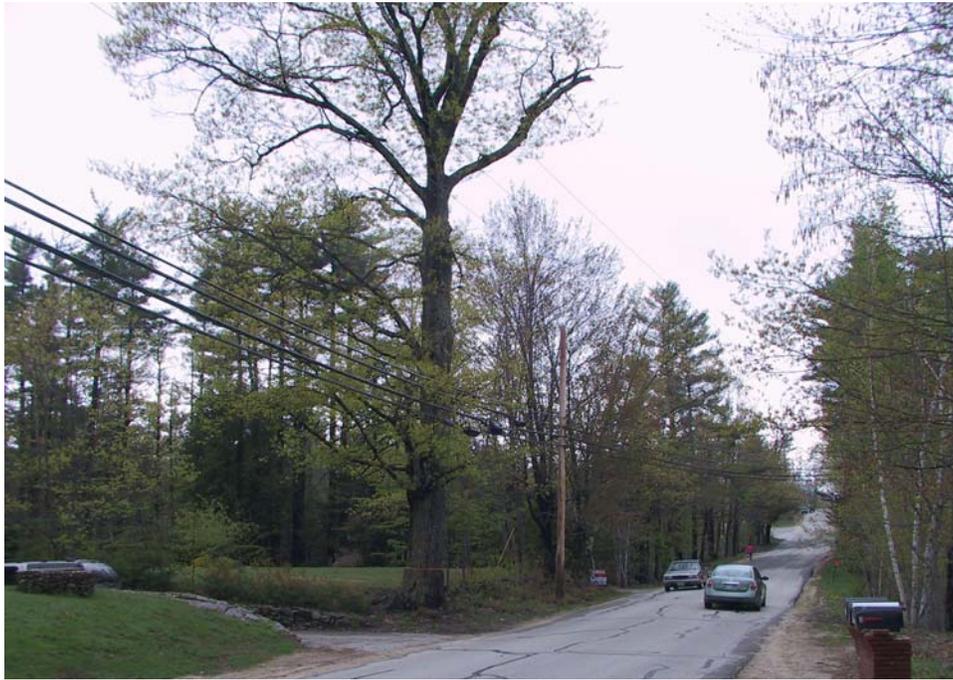
There are a number of trees of advanced age located near distribution lines. Due to their size and close proximity to the line, they cannot be effectively trimmed and pose a risk to the line if the tree were to be damaged or uprooted. The tree shown in Figure V-15 is a prime example of a large tree in decline near a power line. Due to its size, it cannot be effectively trimmed using the

equipment most utilities have available. This particular tree was marked for removal as a "hazard tree." However, this was not done merely due to its proximity to the power line. In New Hampshire, placing the line at risk is not sufficient cause for a tree to be labeled as a hazard. To be classified as a hazard tree, it must also be either infected or dying in addition to its proximity to the line. Within the state, there are many large healthy trees which pose a hazard to power lines and should be considered for removal.

Figure V-15 - Mature oak to be removed in New Ipswich, New Hampshire. (Photo by NEI)
