Appendix A

PUC Safety Division

Maps of Electrical

PSNH Keene Fatality - 4/19/2014

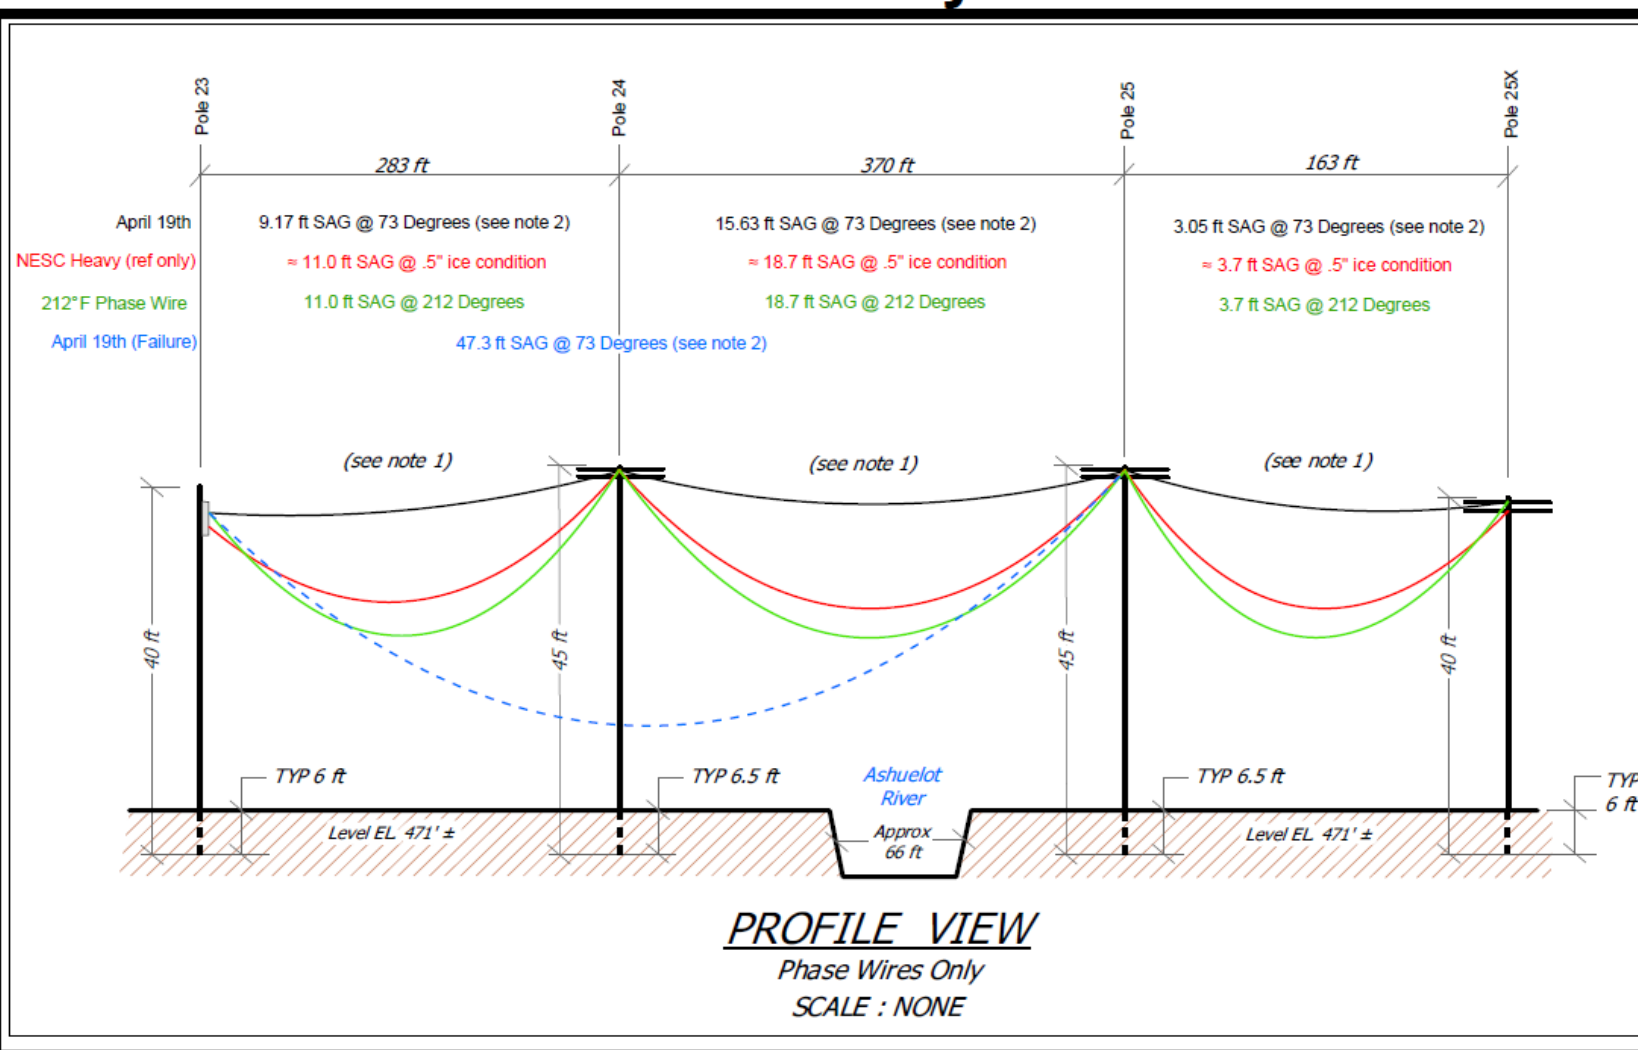
Profile View for Phase Wires

- Incident Location -

1. Neutral wires not shown - Typ 5 - 6 ft below crossarm.
2. 73 degrees is based on a 57 degree ambient temperature.
3. Data and dimensions were obtained from PSNH report received by the NHPUC

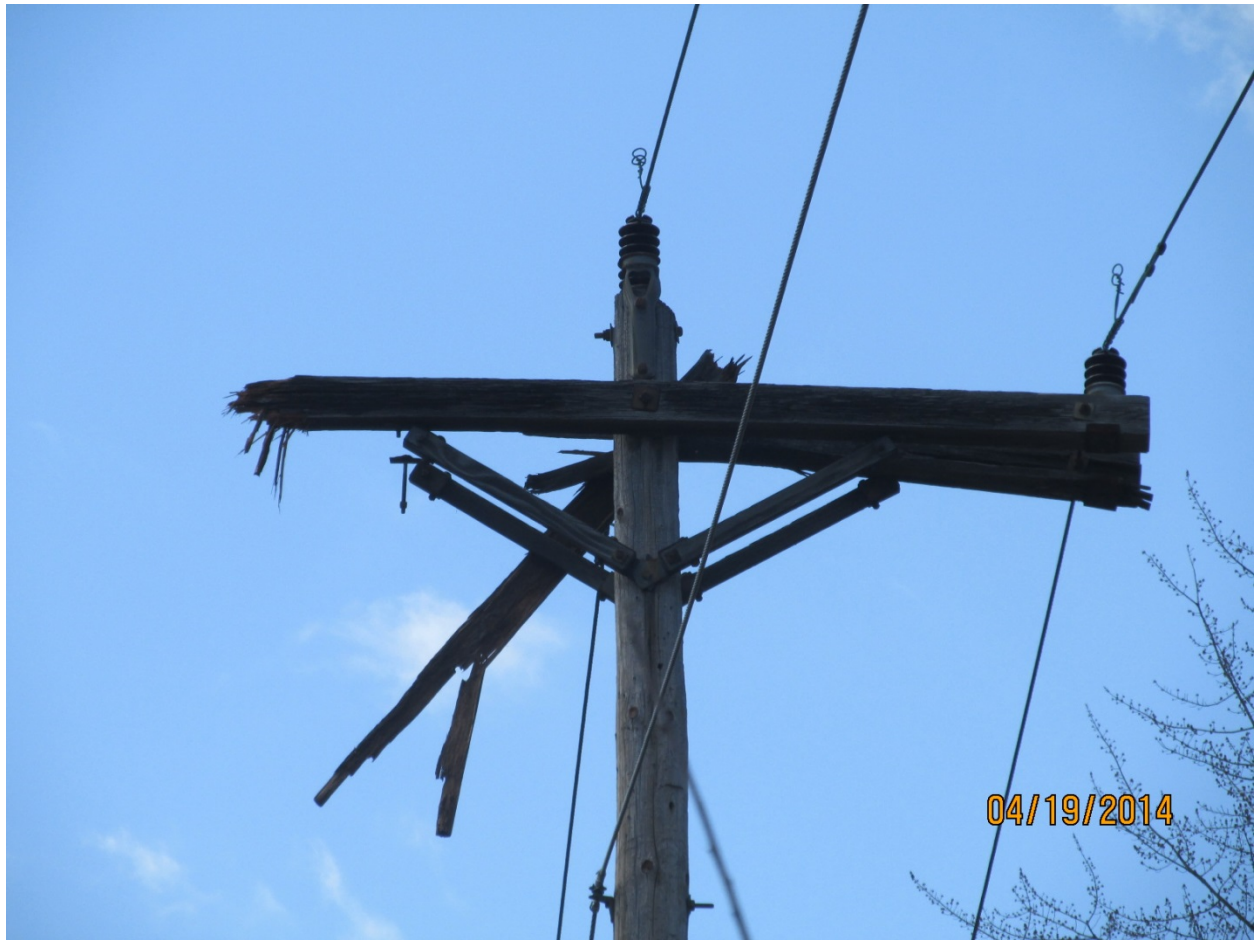
Photo B 1-1 Taken April 19, 2014 prior to electrical contact being made and recovered from deceased's camera. Looking westerly, this is Pole 24 of W185; the broken cross arm is hanging in the air. Phase 1 conductor is missing as well as insulators. Lowest wire is the neutral. Phases 2 and 3 are remain intact. The double cross arm is supported by the metal V shape supports.

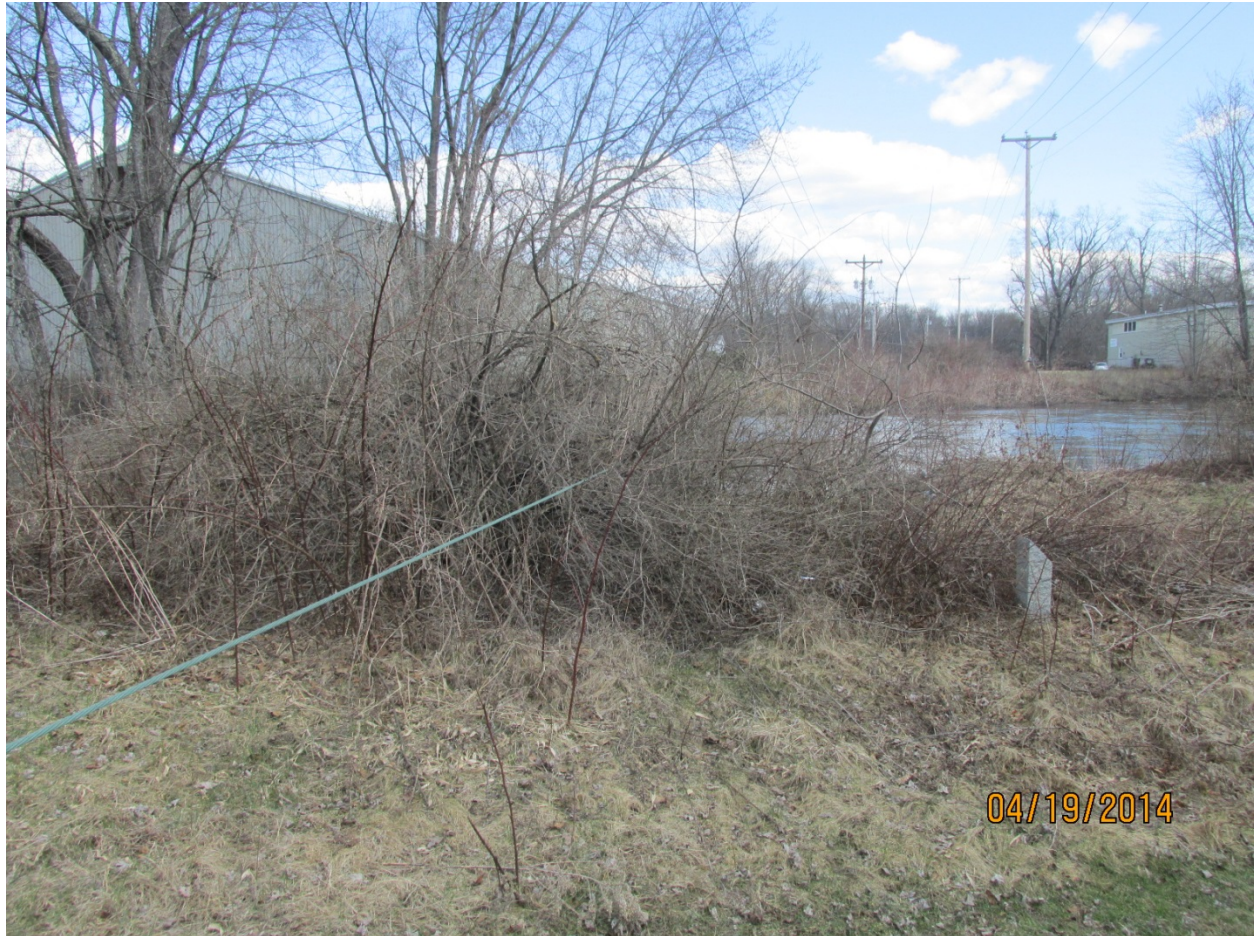
Photo B 1-2 Taken April 19, 2014 prior to electrical contact being made and recovered from deceased's camera. Looking easterly phase 1 conductor of W185 is low to the ground but is above the Ashuelot River. Mile Marker Post of the walking trail is located nearby. The remaining poles of Circuit W185 are shown beyond the river and W 15 is shown to the right. The building to the left is the Indoor Tennis Courts and the building in the rear right is the American School of Gymnastics.

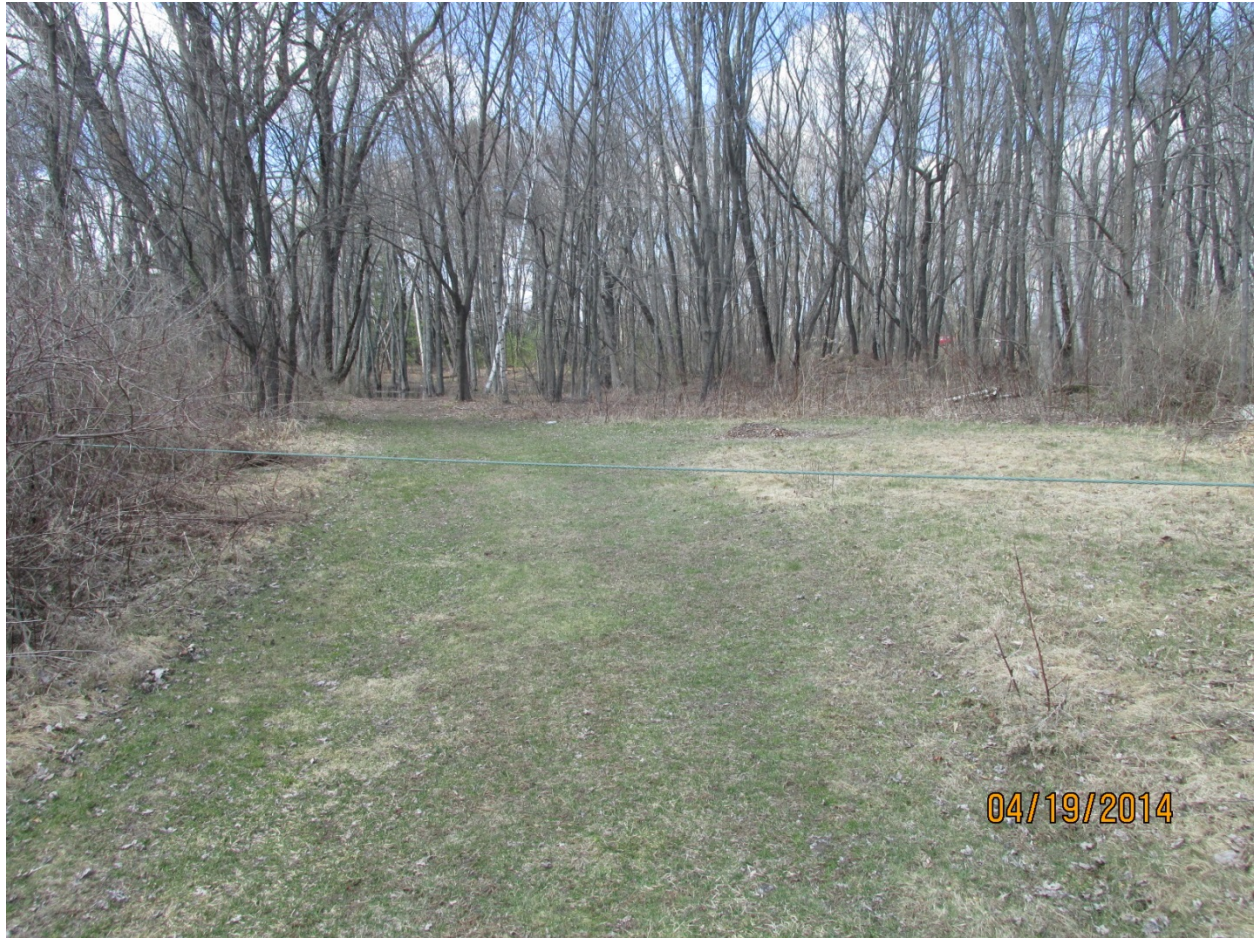
Photo B 1-3

Photo B-1-3 Taken April 19 2014 prior to electrical contact and recovered from deceased's camera. One can see the green colored conductor 4/0 wire approximately 2 feet above the ground. Photo is looking northerly. Ashuelot River is to the east and PSNH Pole 24 is outside the picture looking west.

With the consent of the Mrs. Rebecca DeMond several digital photographs were copied from the digital camera found with victim. Three photos contained on the camera showed that the victim had taken pictures of the downed power line and the broken pole prior to the incident. The camera and a Keene State College employee identification found with the victim were returned to Mrs. DeMond on May 12, 2014 at her residence.

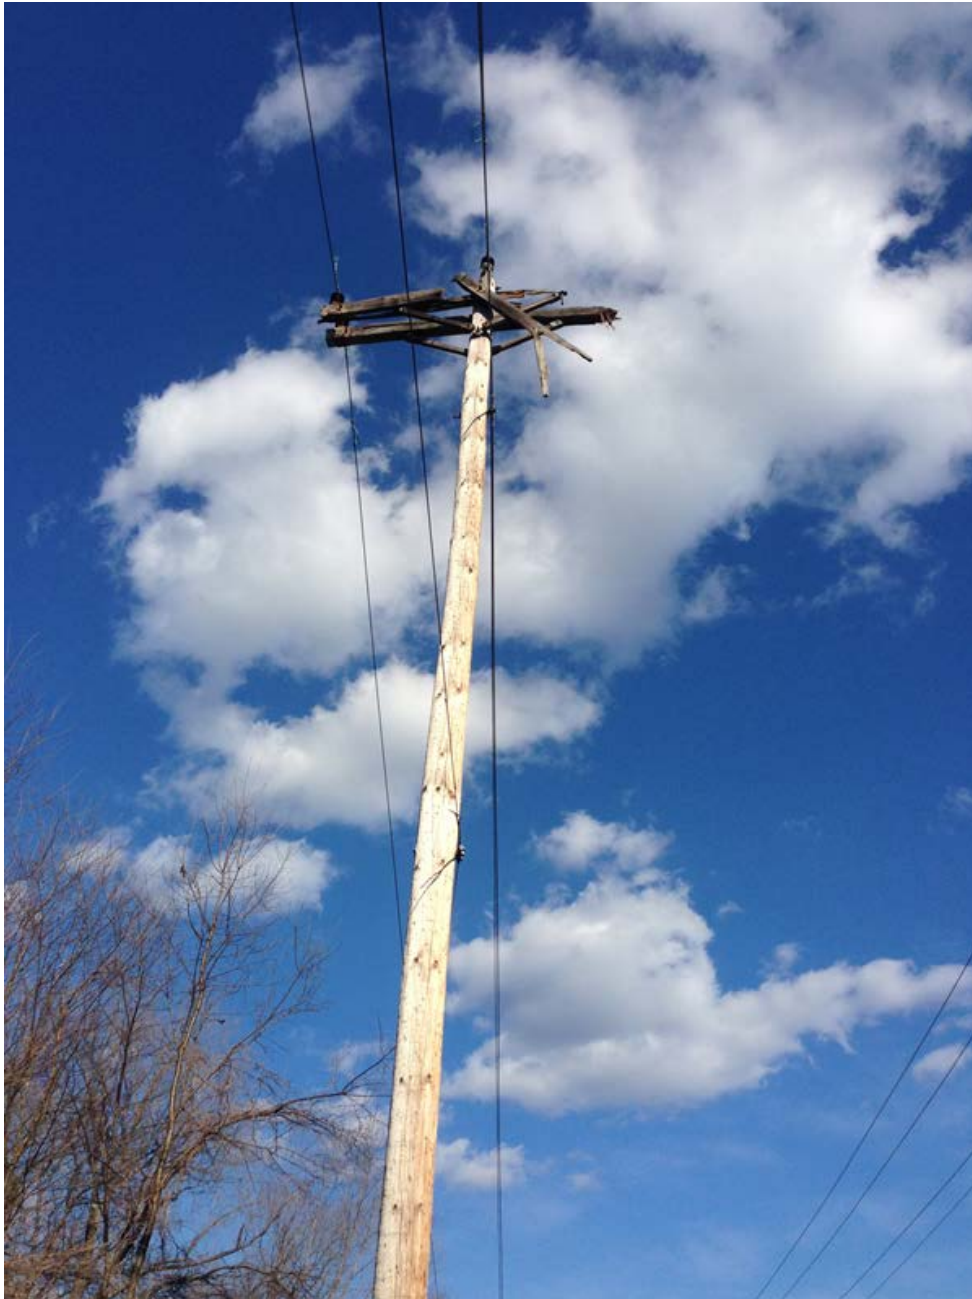
Photo B 2-4 This photo taken on the day of the electrical contact after the Fire Marshal arrived shows the W185 phase 1 conductor is missing from the double crossarm (attached to both sides of poles) that is completely broken and rotted. The conductor and supporting insulator is missing from the photo as it laying near the ground (see Photo B 2-5). *Photo courtesy of NH State Fire Marshal's Office taken April 19 2014*

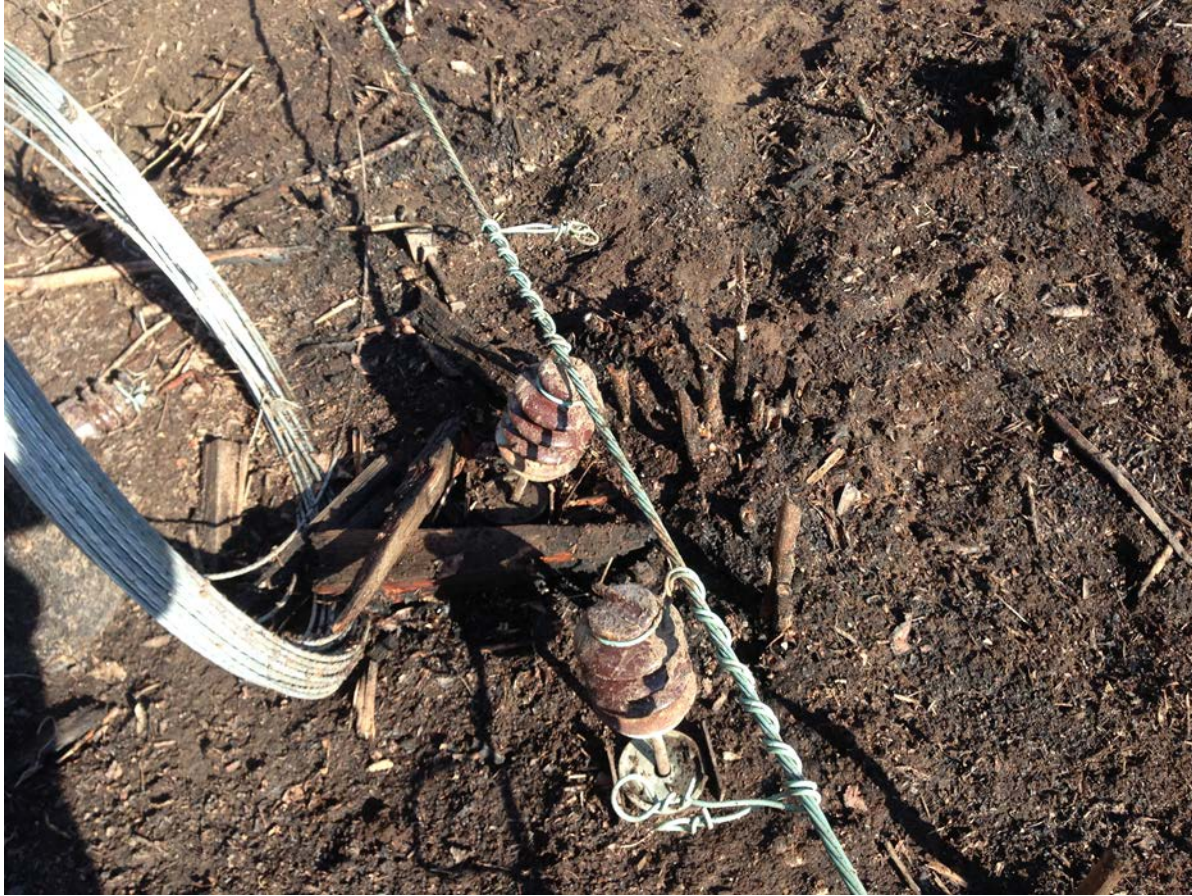
Photo B 2-5

Photo B 2- 5 Close up of insulators from W185 phase 1 and portion of cross arm and conductor laying near bottom of pole 24. Insulators still attached to conductor but have completely pulled out from wooden cross arms. Spool of wire used for repair of guy wire is shown at left. *Photo courtesy of NH State Fire Marshal's Office taken April 19 2014*

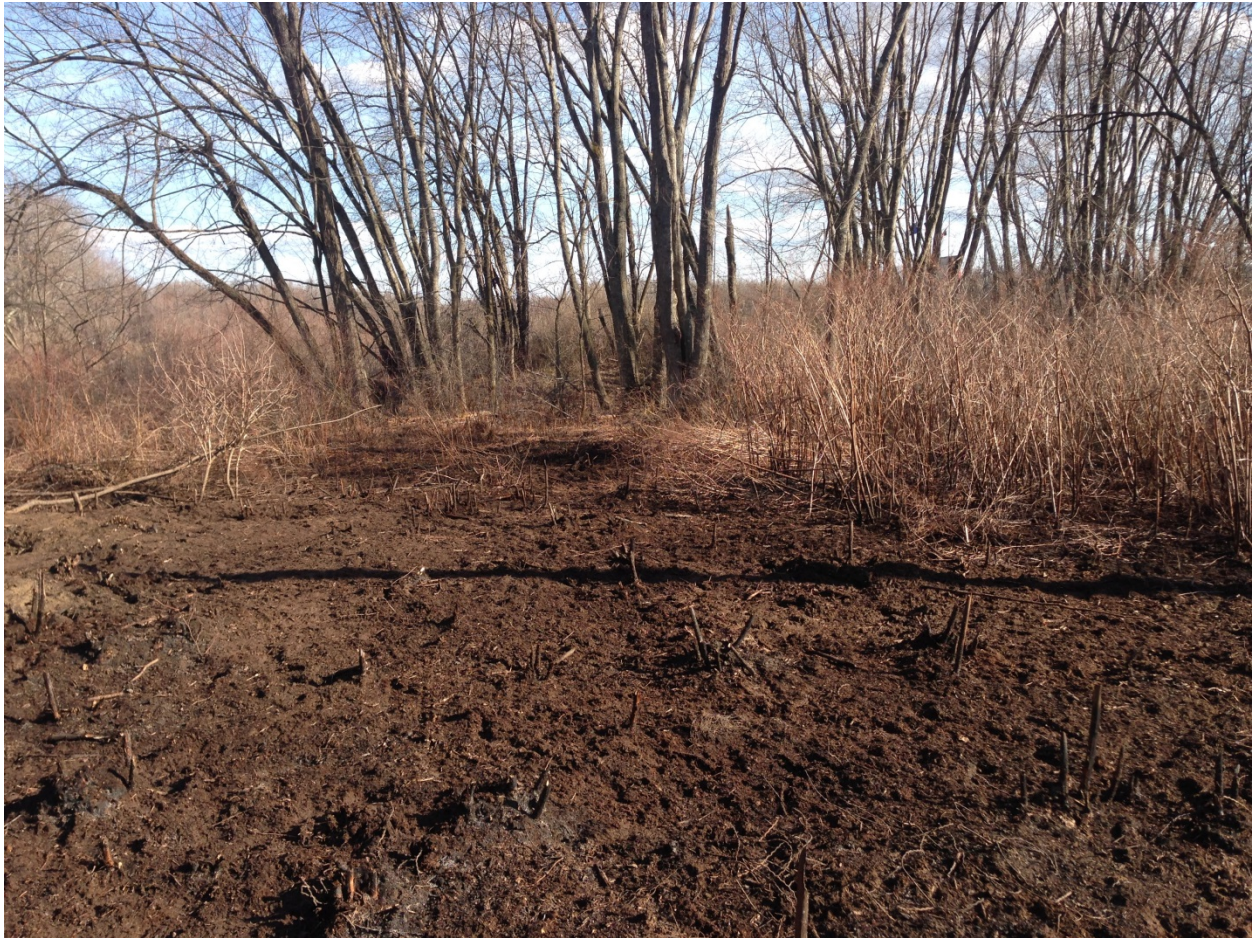
Photo B 2-6 Taken day of electrical contact April 19 2014. Looking southerly displaying area of brush fire. *Photo courtesy of NH State Fire Marshal's Office taken April 19 2014*

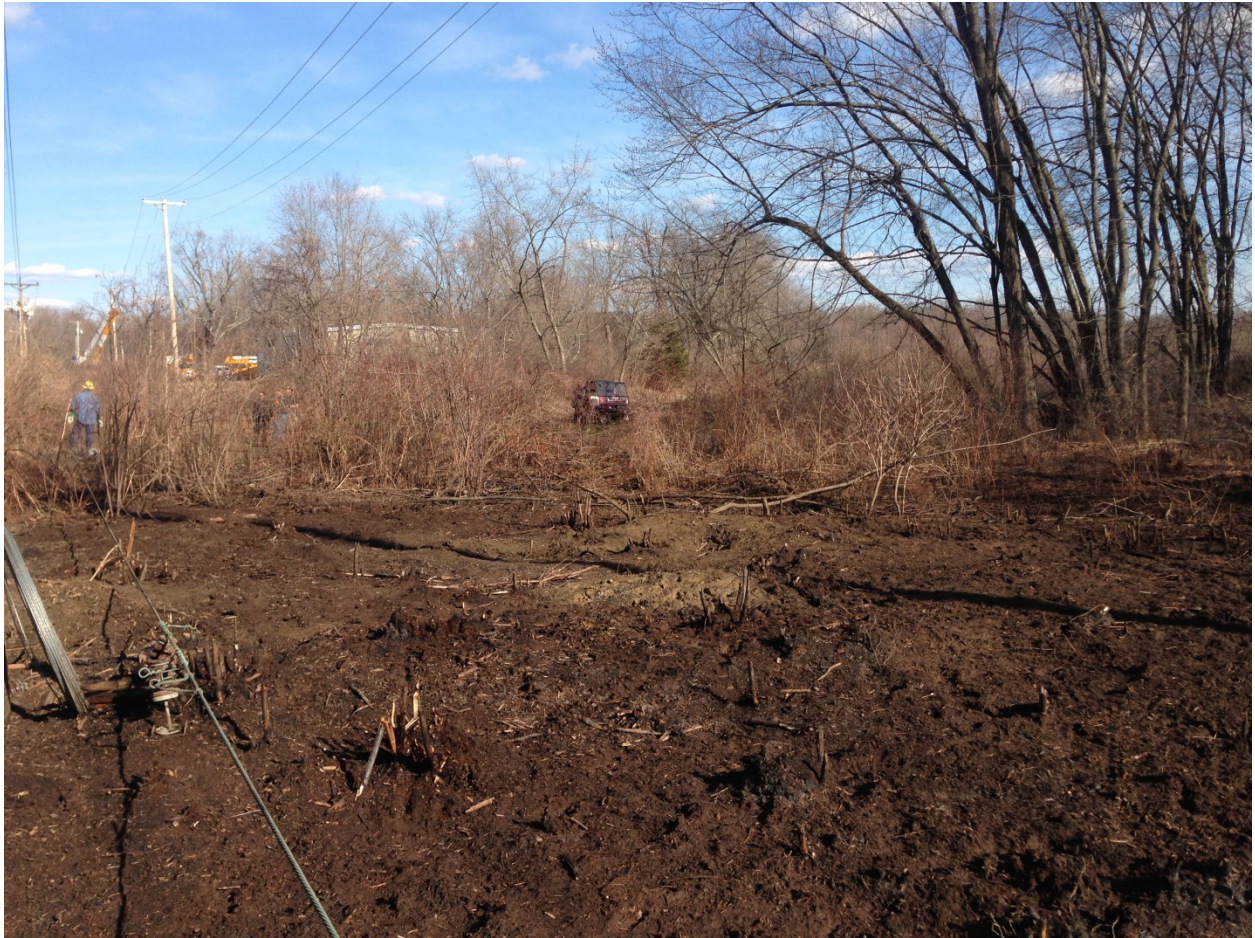
Photo B 2-7 Taken day of electrical contact April 19 2014. Looking easterly; displaying area of brushfire. Phase 1 conductor at the ground level. PSNH Work Crew had arrived on scene after contact occurred. Boom Truck is background. Insulators are on ground at base of Pole 24 of W185. Circuit W 15 is shown with all 3 phases intact. *Photo courtesy of NH State Fire Marshal's Office*

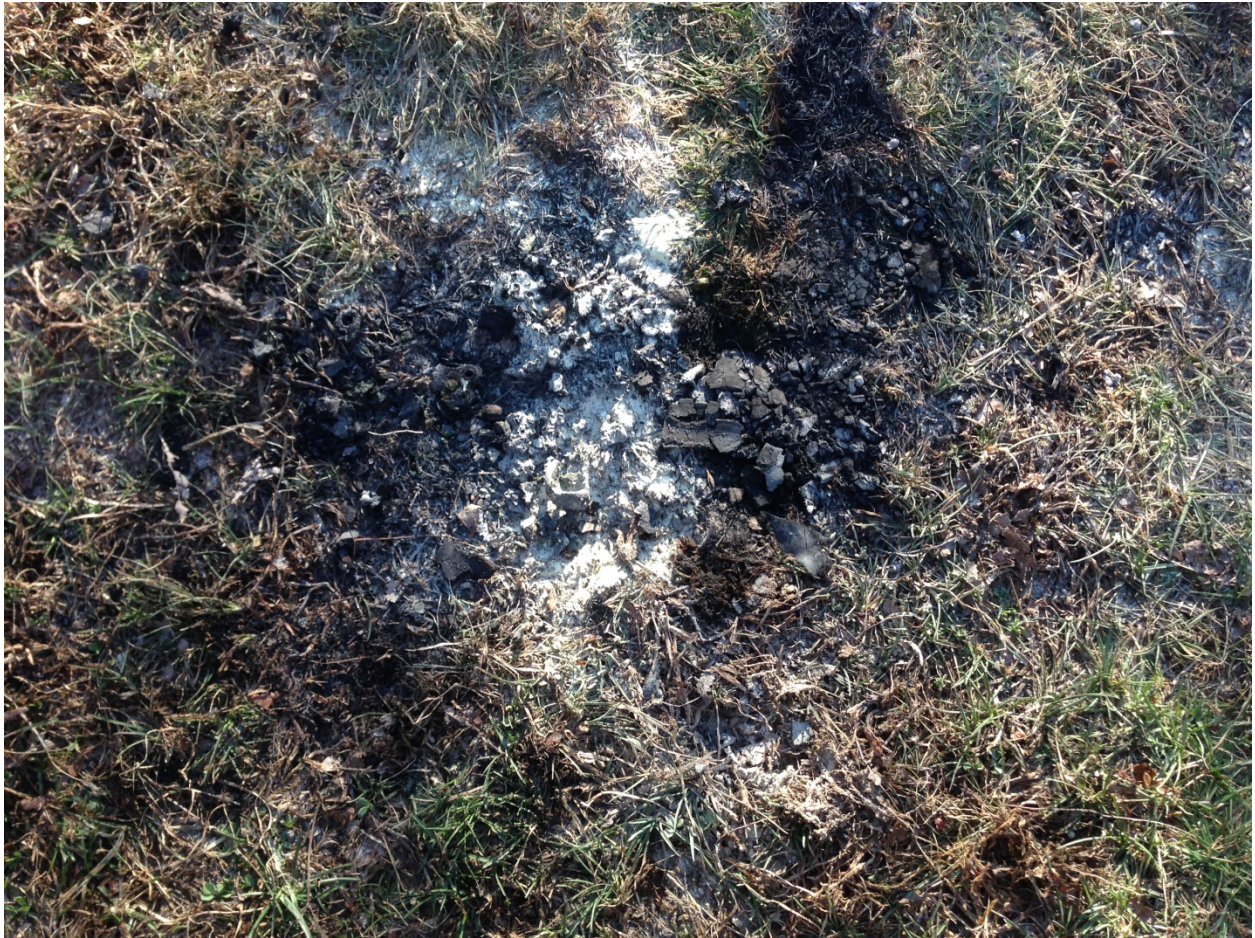
Photo B 2-8 Taken day of electrical contact April 19 2014. Electrical Contact Area near the trail opening between brush area 1 and brush area 2. *Photo courtesy of NH State Fire Marshal's Office taken April 19 2014*

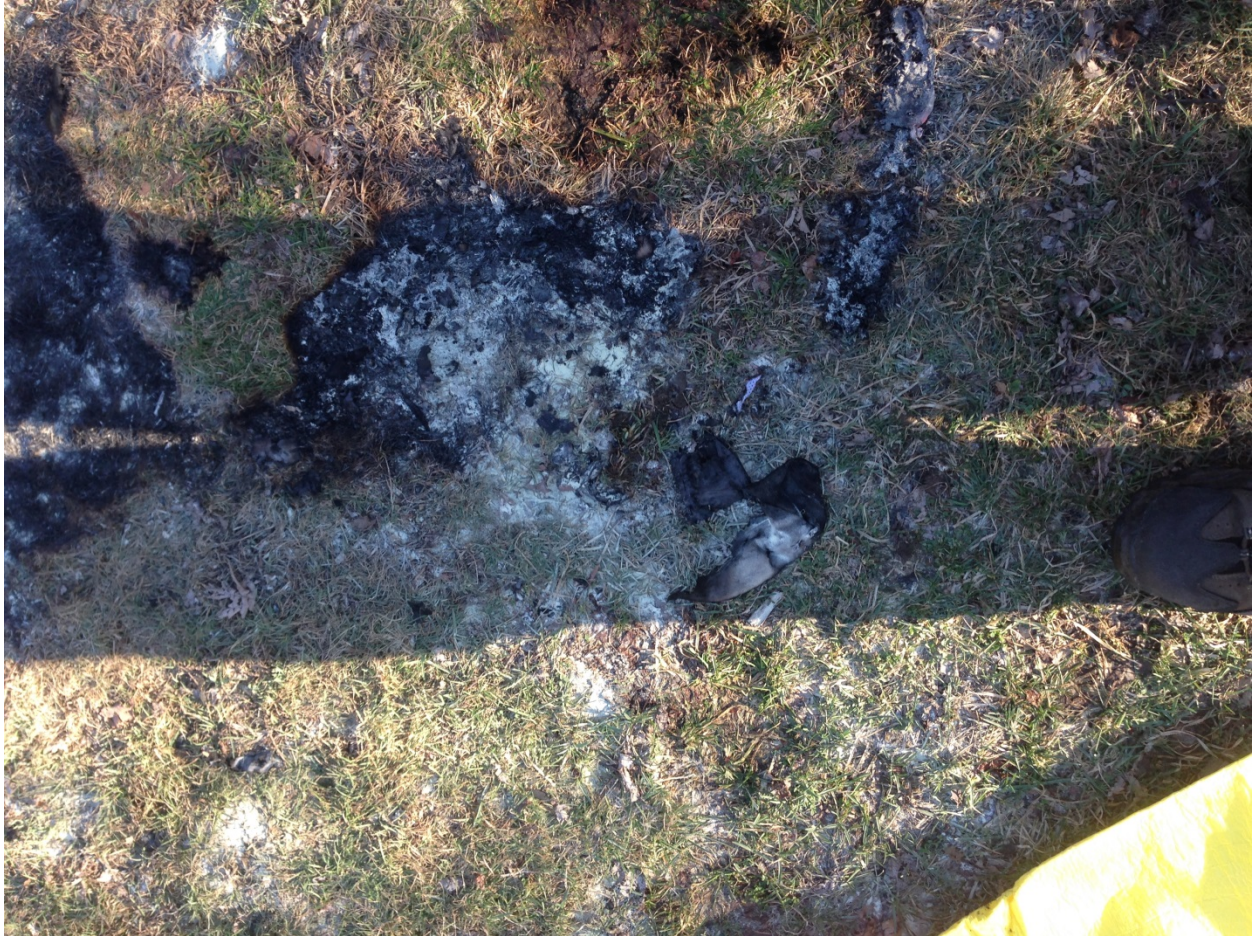
Photo B 2-9 Taken day of electrical contact April 19 2014. Another view of Electrical Contact Area near the trail opening between brush area 1 and brush area 2. *Photo courtesy of NH State Fire Marshal's Office taken April 19 2014*

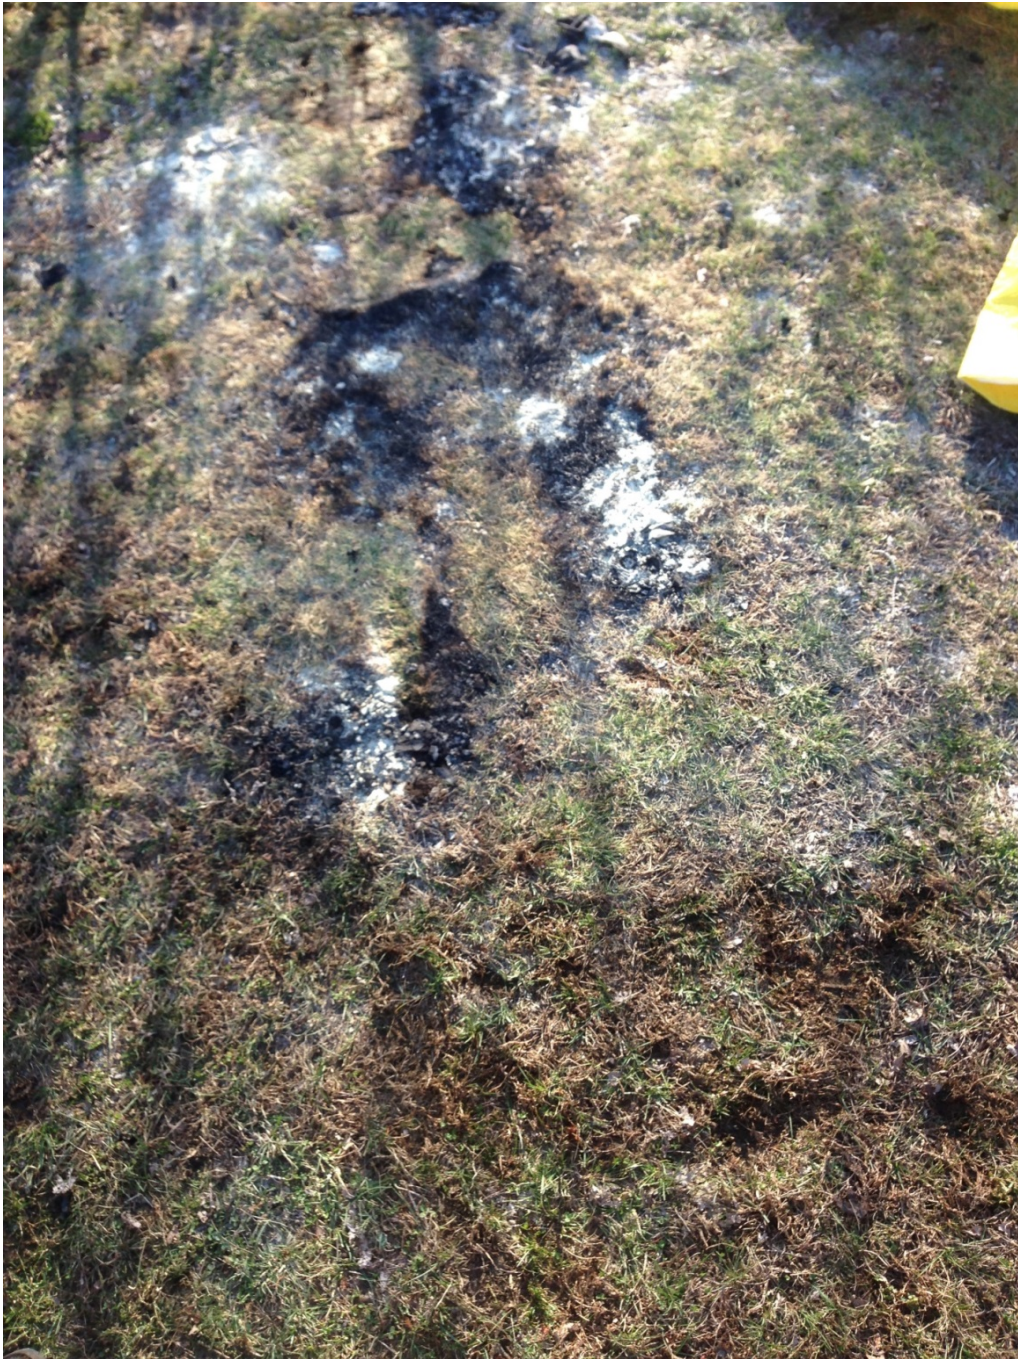
Photo B 2-10 Taken day of electrical contact April 19 2014. Third photo of Electrical Contact Area near the trail opening between brush area 1 and brush area 2 . *Photo courtesy of NH State Fire Marshal's Office taken April 19 2014*

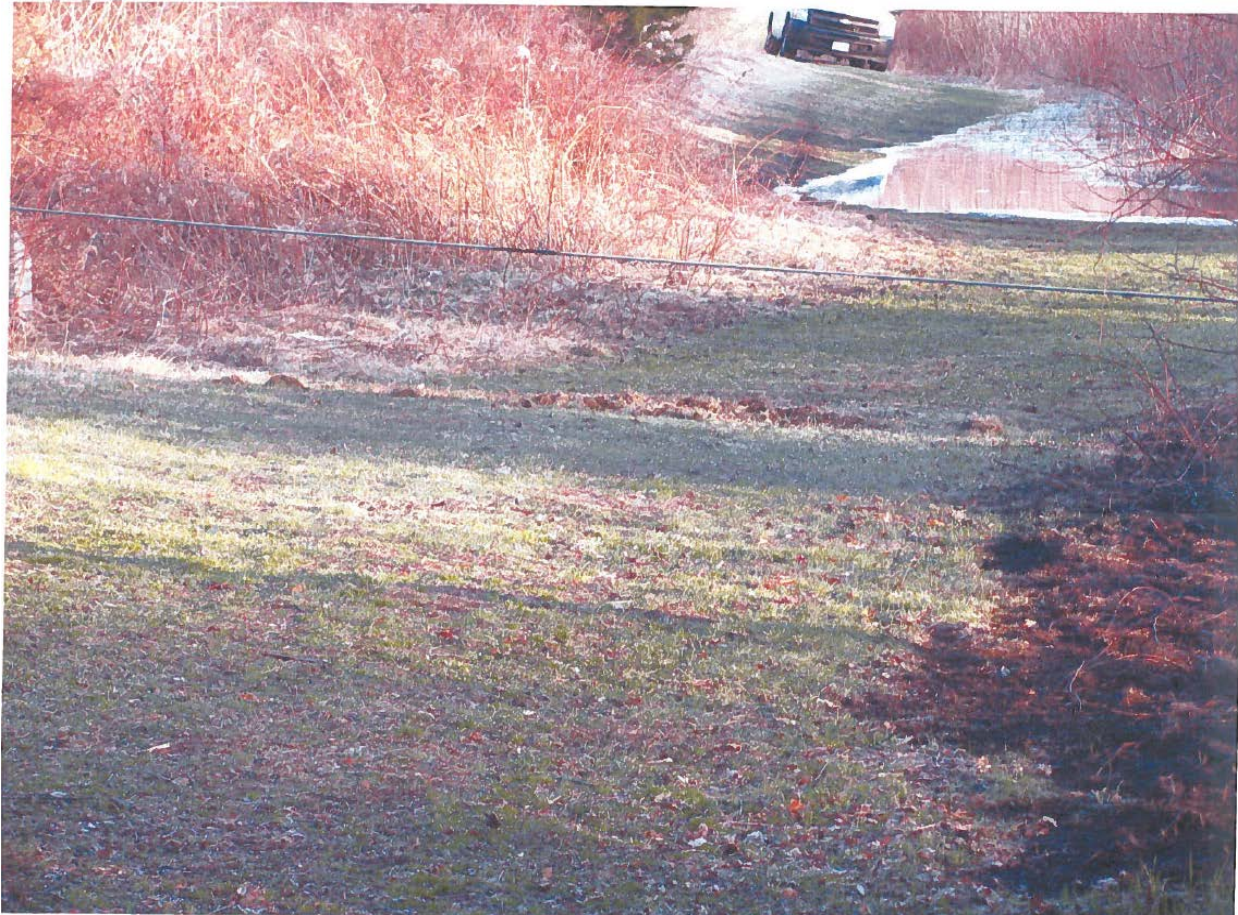
Photo B 3-11 Taken April 19, 2014 after contact was made. Looking South on the trail area brush area 2 is shown on the left while brush area 1 is on the right. The marker post is shown on the left side. The contact area is in the middle. *Photo provided by Public Service Co of New Hampshire*

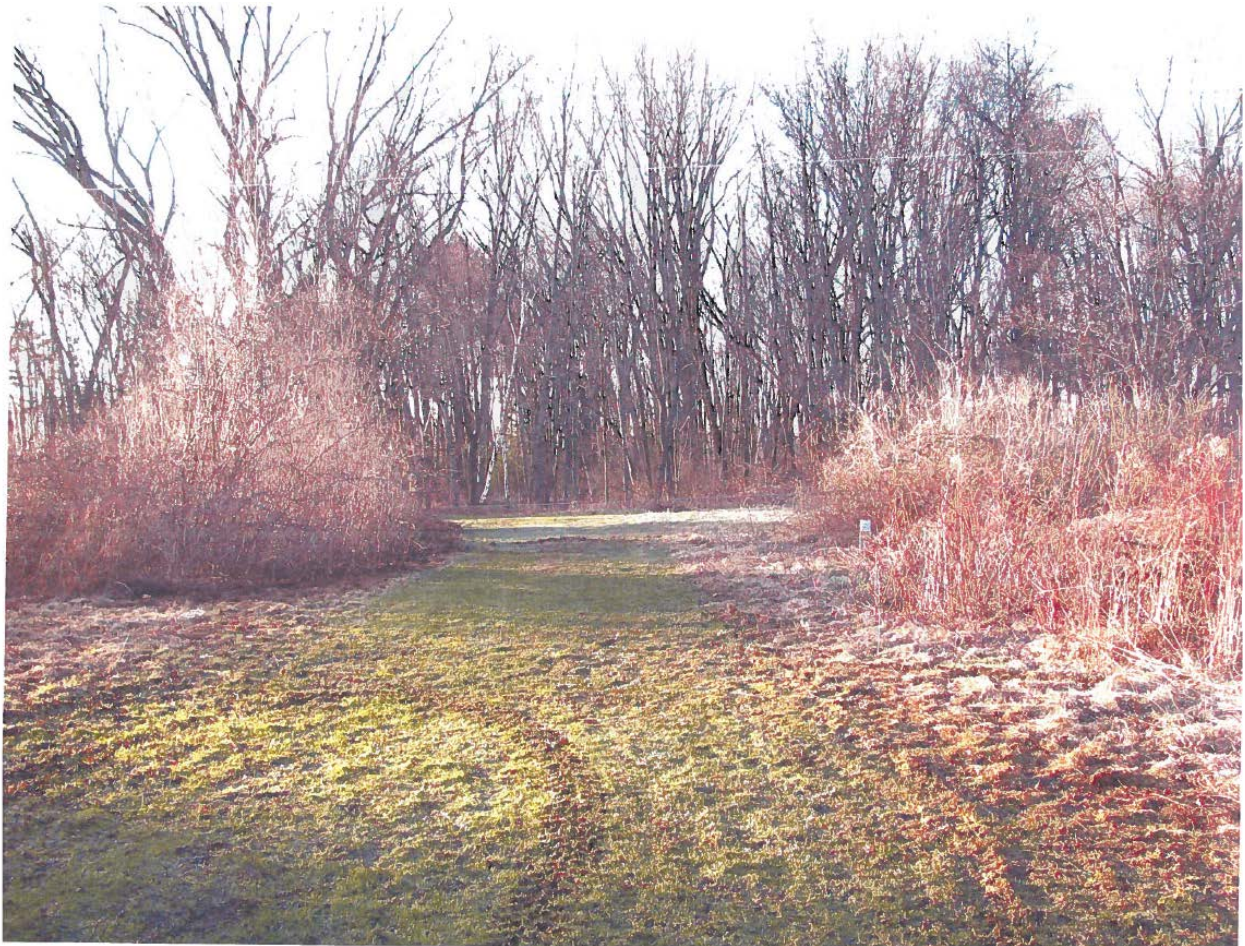
Photo B 3-12 Taken April 19, 2014 after contact was made. Looking North on the trail area brush area 1 is shown on the left while brush area 2 is on the right. The marker post is shown on the right side. The contact area is in the middle. *Photo provided by Public Service Co of New Hampshire*

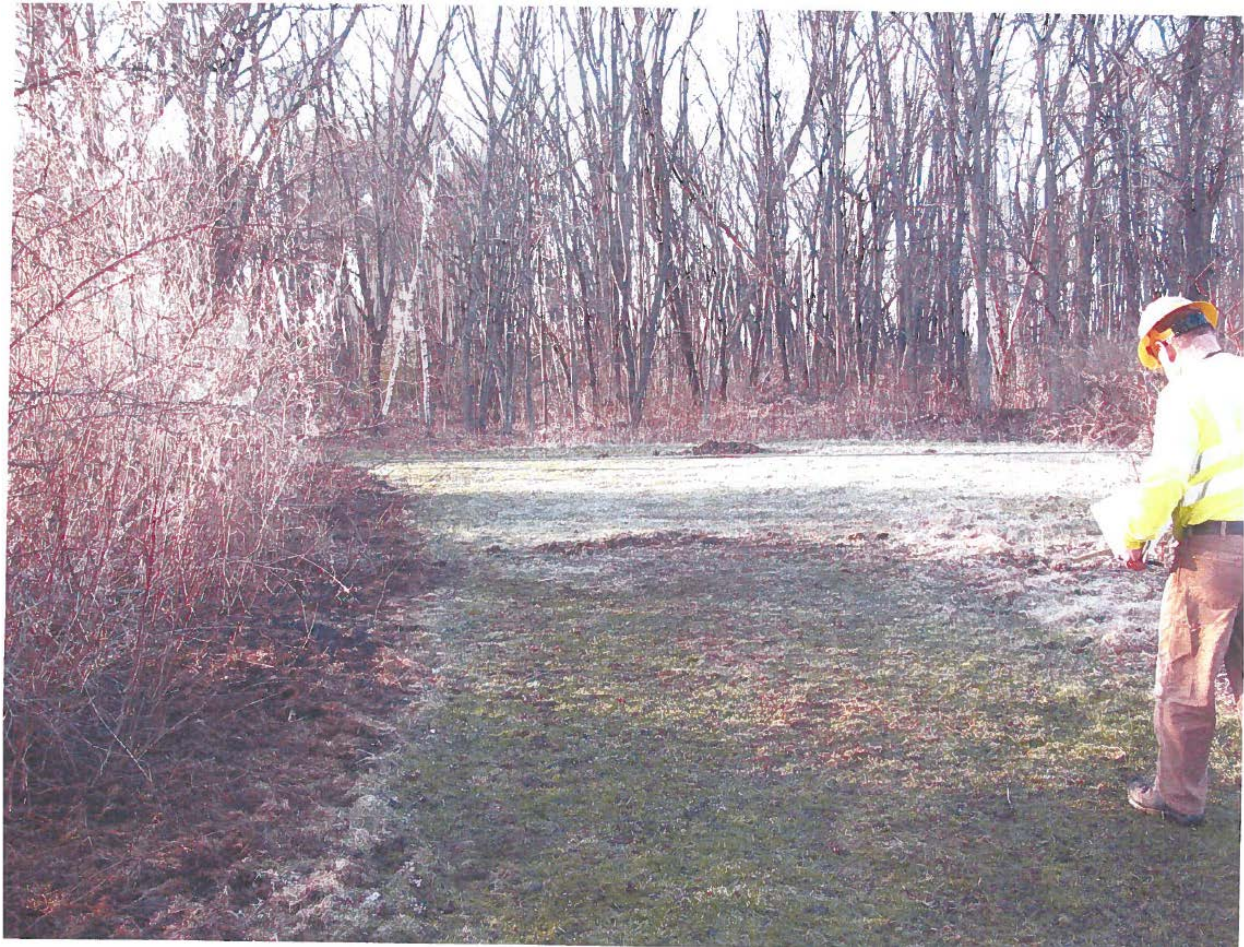
Photo B 3-13 Taken April 19, 2014 after contact was made. Looking North on the trail area approaching the contact area. The contact area is in the darker area in the middle. *Photo provided by Public Service Co of New Hampshire*

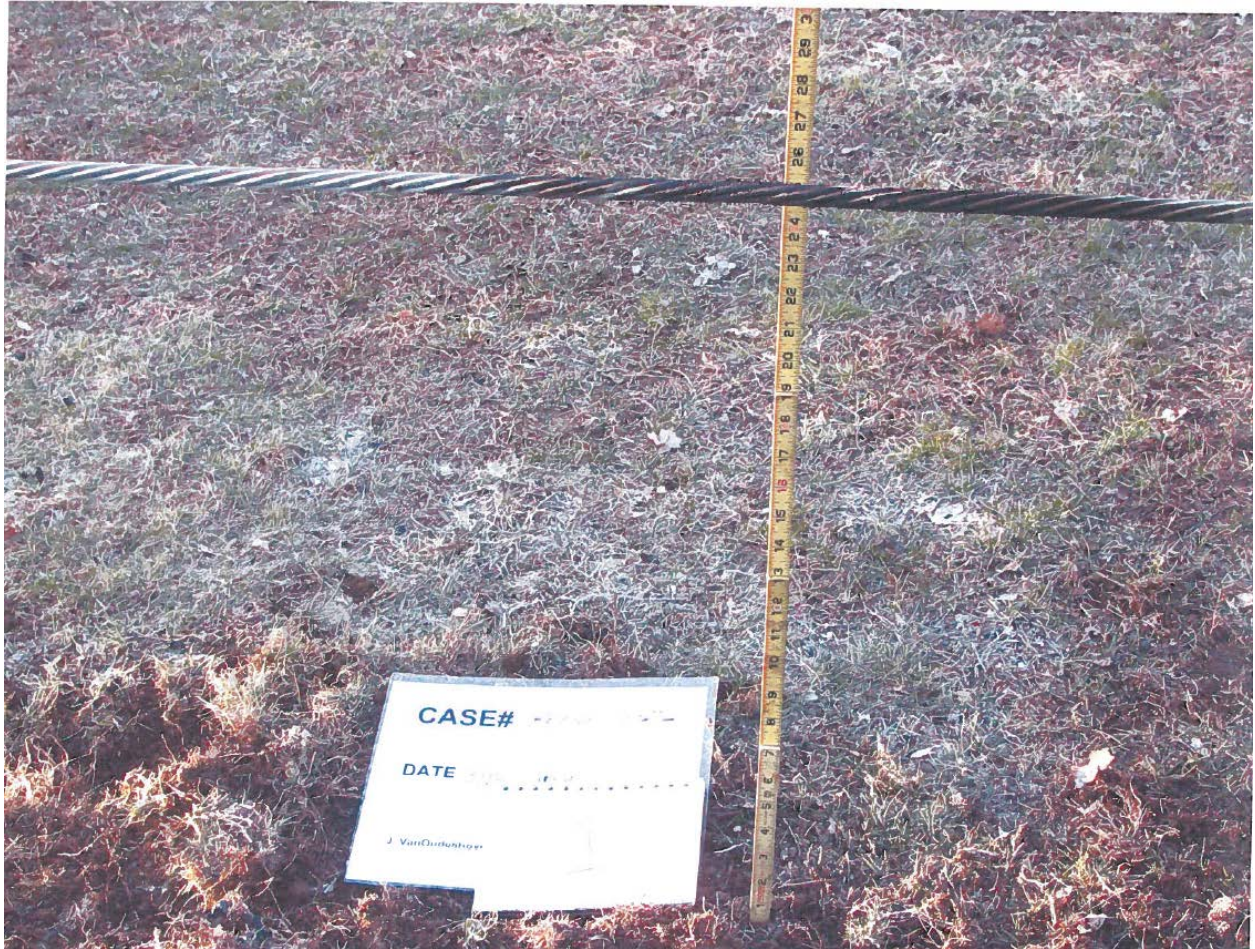
Photo B 3-14 Taken April 19, 2014 after contact was made. Closeup of the contact area. The primary conductor is of Phase 1 for W185 is approximately 24 inches above ground level. *Photo provided by Public Service Co of New Hampshire*

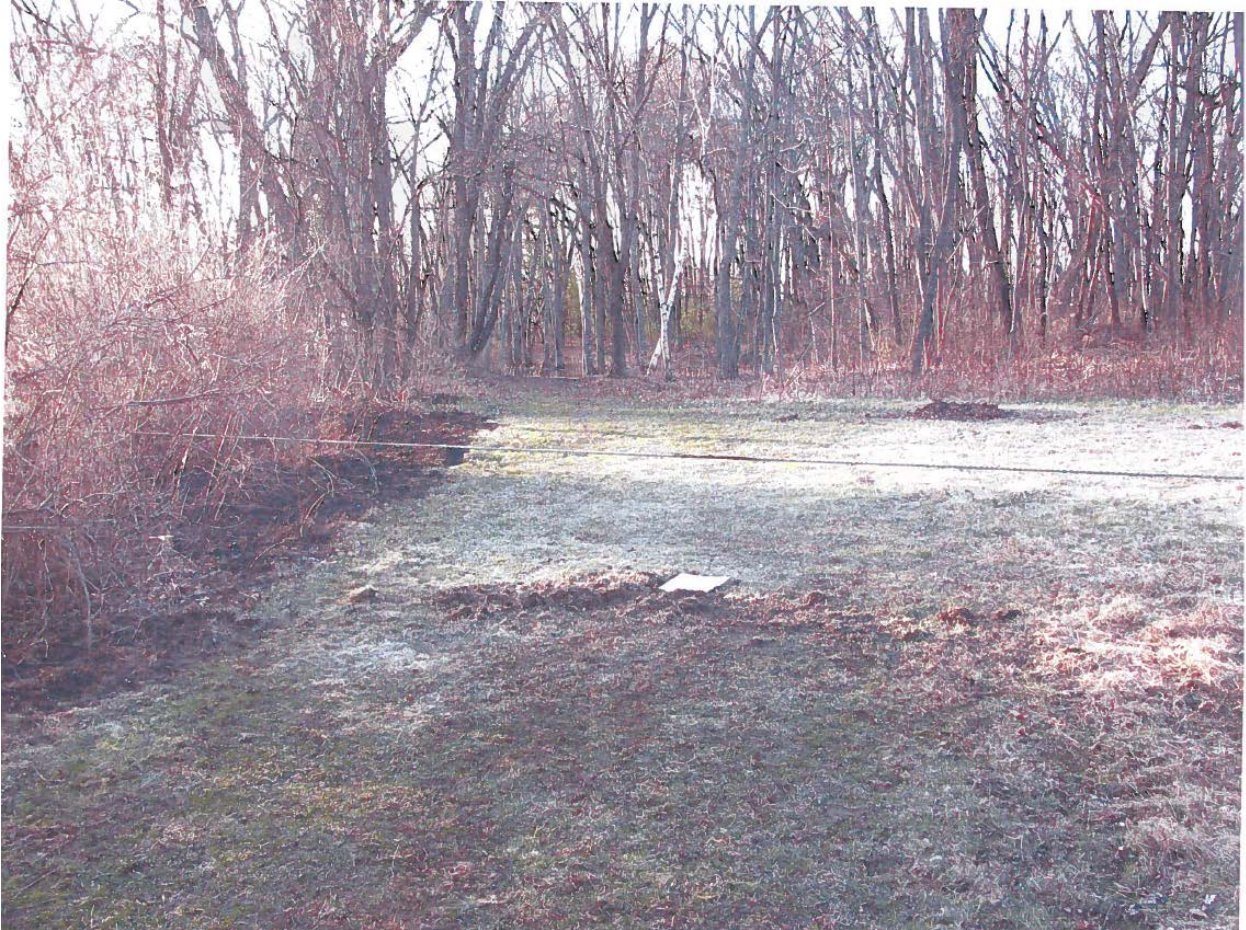
Photo B 3-15 Taken April 19, 2014 after contact was made. Closeup of the contact area and the primary conductor is of Phase 1 for W185. Discolored area of conductor is where contact was made.
Photo provided by Public Service Co of New Hampshire

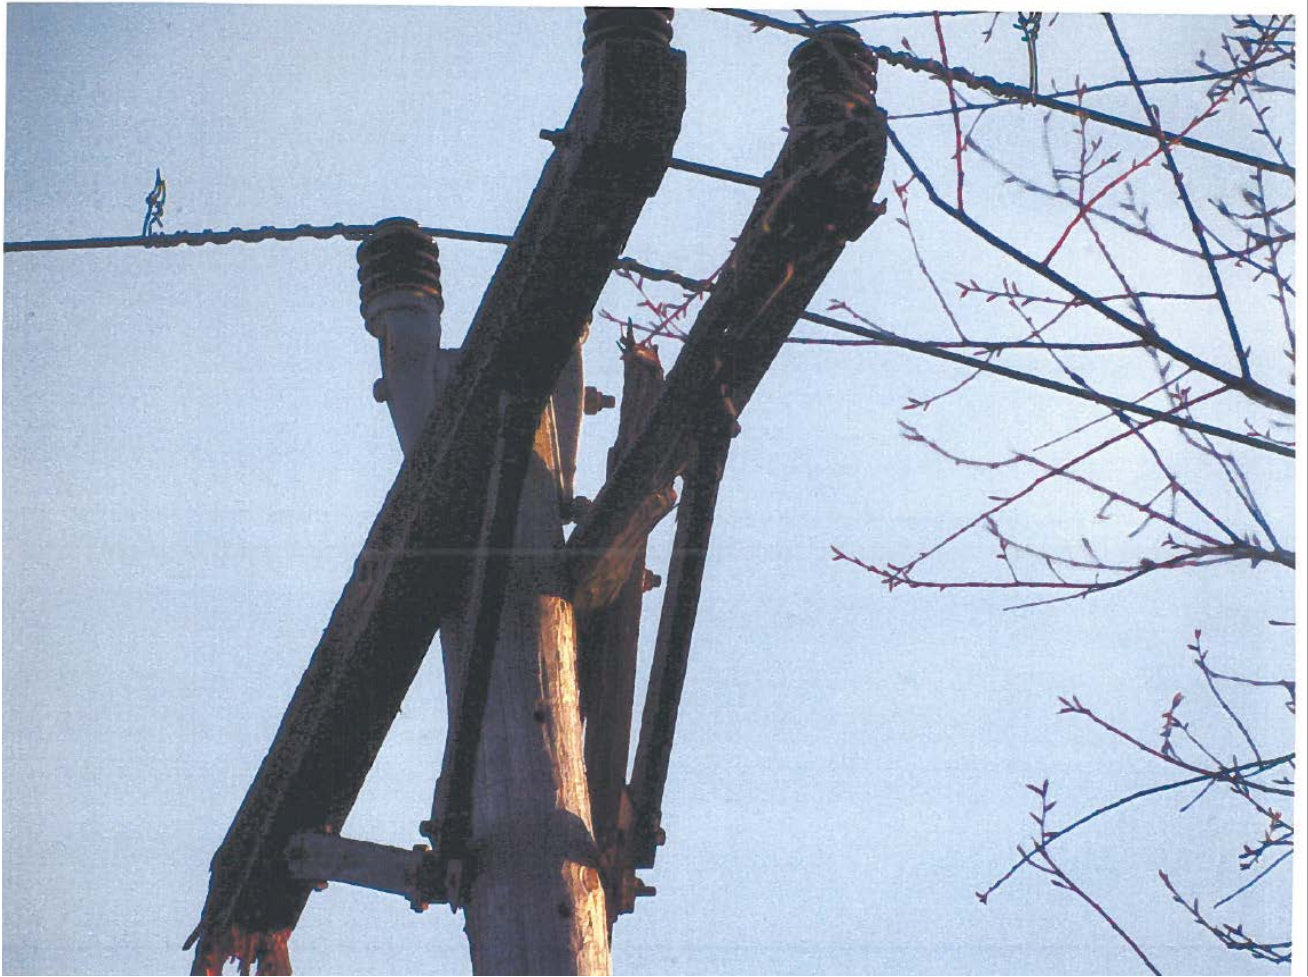
Photo B 3-16 Taken April 19, 2014 after contact was made. Collapse and failure of cross arm for Pole 24 of W185. Phase 2 and 3 conductors and insulators are intact. *Photo provided by Public Service of New Hampshire*

and that the victim was covered with a yellow colored powder. Fire Fighters at the scene stated that they had utilized a dry chemical fire extinguisher to put out the fire on the victim. To the left of the victim, we were able to observe a large area of brush that had been burned also as a result of the downed wire. Keene Fire Department estimated the area at approximately a half an acre. Also located in the same area was a wooden power line pole with wooden cross arms at the top. The cross arms to the south side of the pole appeared to have broken; thus causing the power line to fall towards the ground.
