Appendix A

PUC Safety Division

Maps of Electrical

PSNH Keene Fatality - 4/19/2014

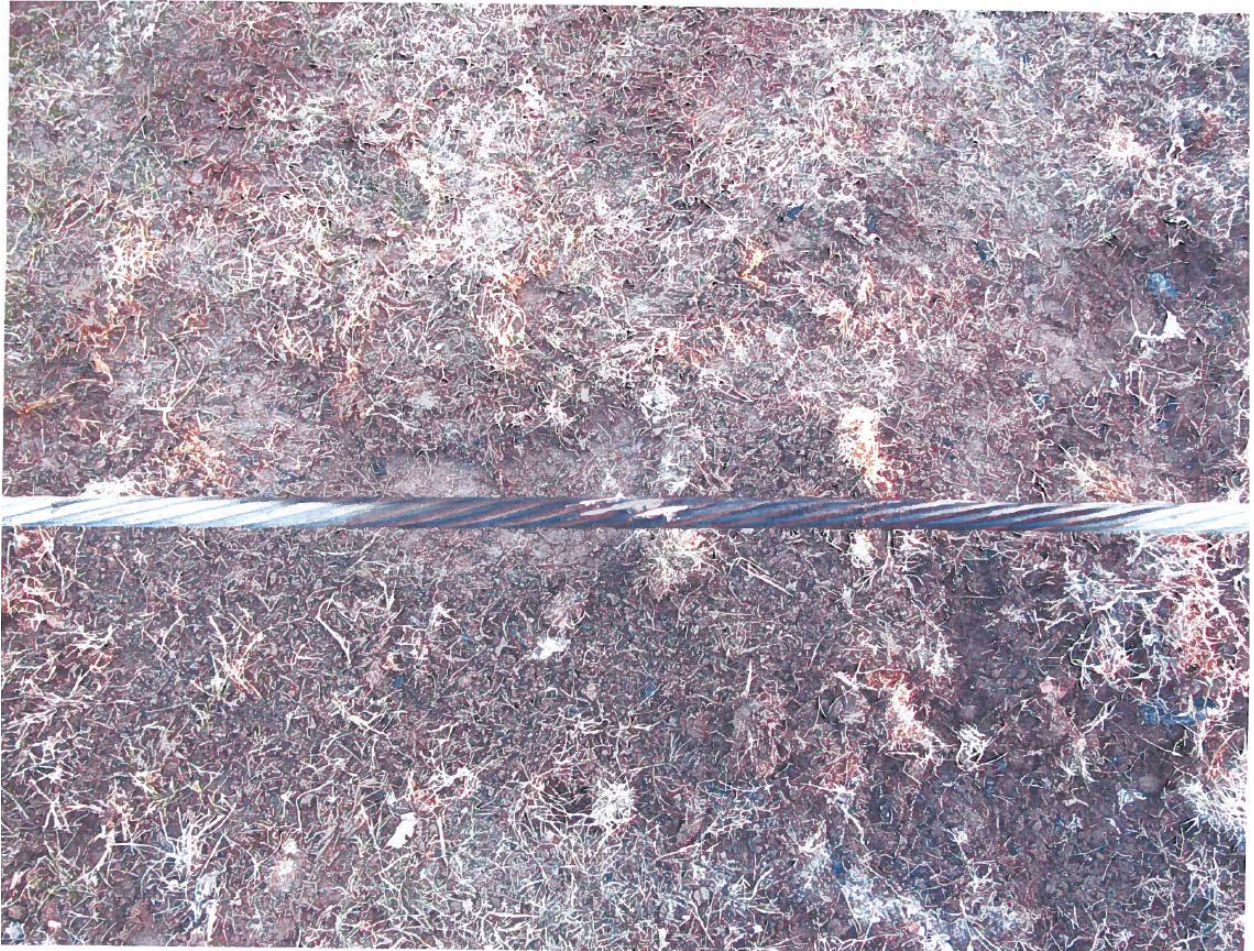
Photo B 3-17 Taken April 19, 2014 after contact was made. Close up of primary conductor rated for 7,200 volts and contact area. *Photo provided by Public Service of New Hampshire*

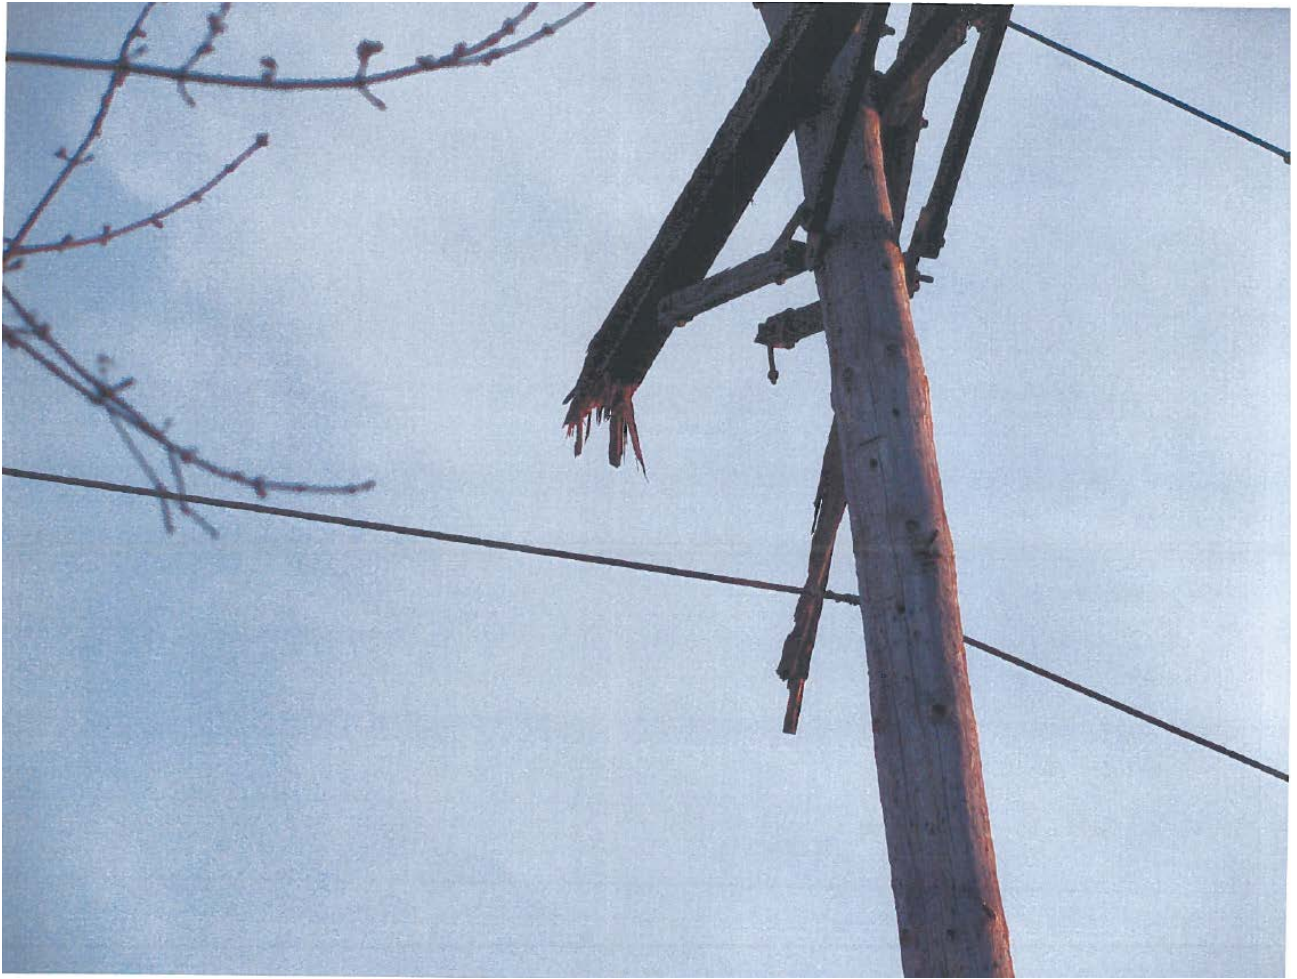
Photo B 3-18 Taken April 19, 2014 after contact was made. Eastern side of cross arm for Pole 24 of W185. Phase 1 conductor and insulator are near the base of the wooden pole. Lower wire is the neutral wire. Upper wire is the phase 2 conductor. *Photo provided by Public Service of New Hampshire*

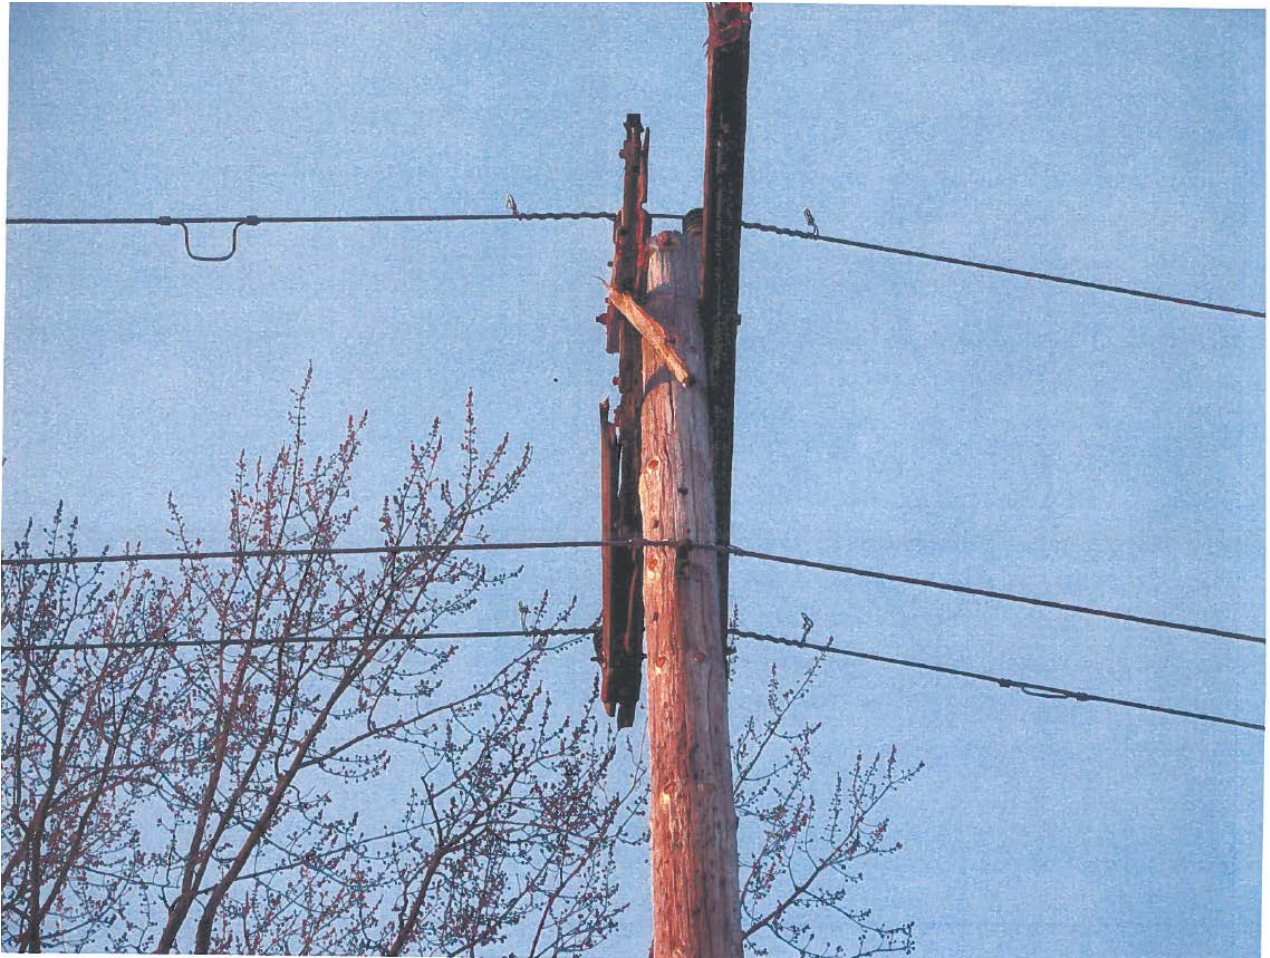
Photo B 3-19 Taken April 19, 2014 after contact was made. Taken from below Pole 24 of W185. Looking northerly, phase 1 conductor and insulator are near the base of the wooden pole. Based on angle of camera the upper wire is phase 2 conductor, the middle wire is neutral and the lowest wire is the phase 3 conductor. *Photo provided by Public Service of New Hampshire*

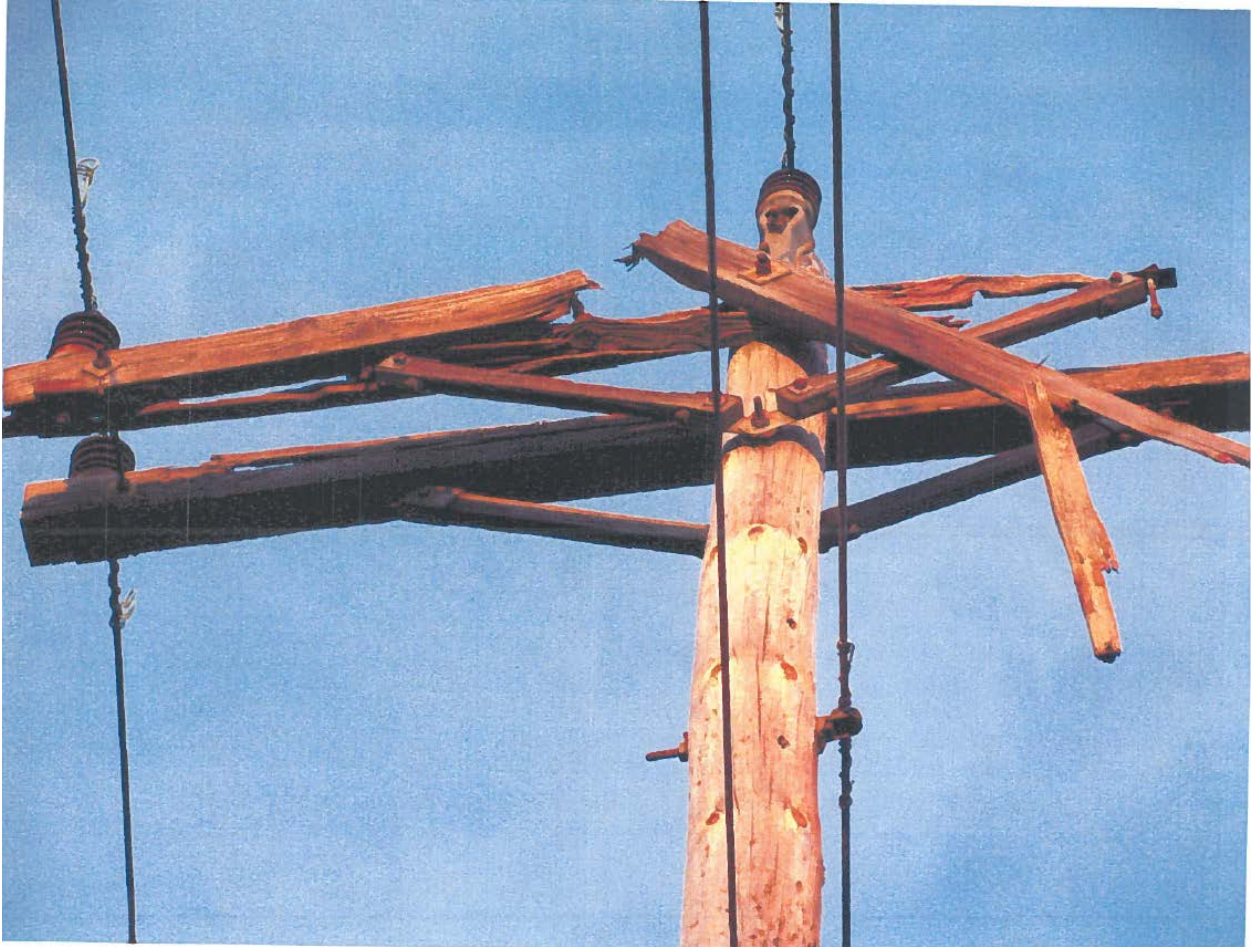
Photo B 3-20 Taken April 19, 2014 after contact was made. Western side of cross arm for Pole 24 of W185. Phase 1 conductor and insulator are near the base of the wooden pole. Phase 3 conductor is on the left side. Guy wire is second most left wire as shown. Neutral is on the foremost right side.

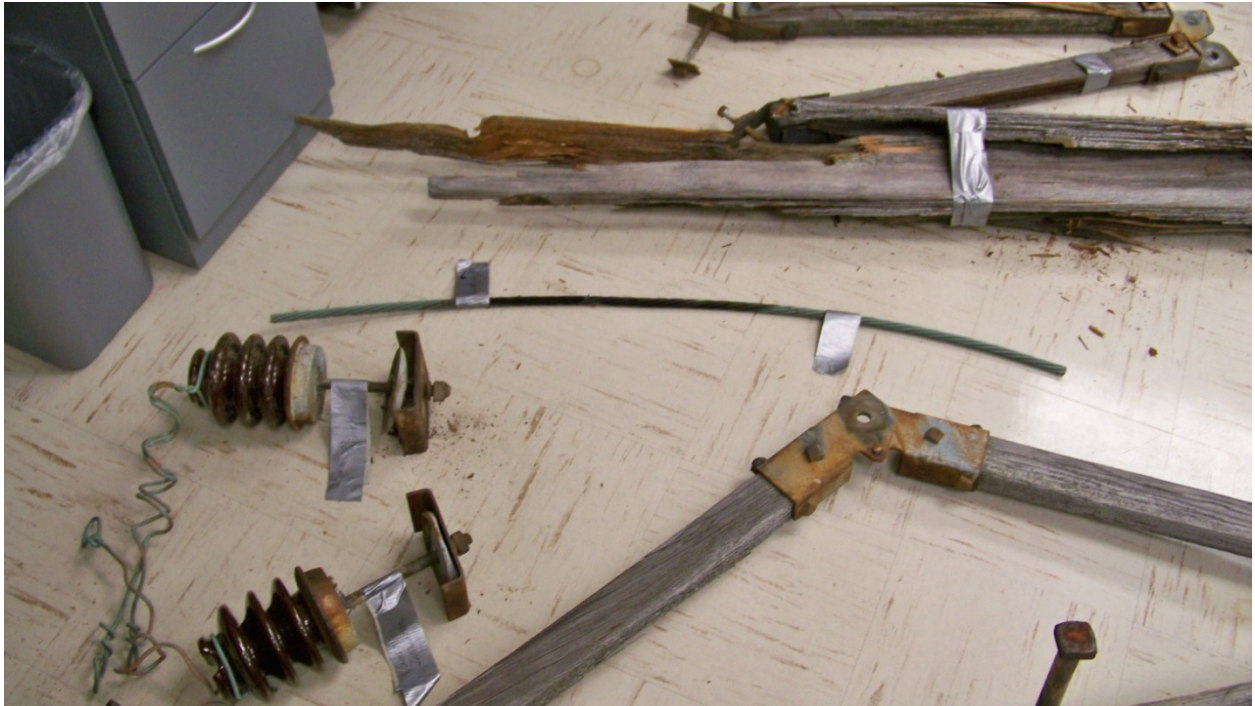
Photo B 4-22 Taken April 21, 2014. Components of failed double cross arm on Pole 24 of W185 on floor of Keene Area Work Center. Insulators, removed conductor (3 ft), broken cross arm and supports *Photo taken by NHPUC Safety Division*

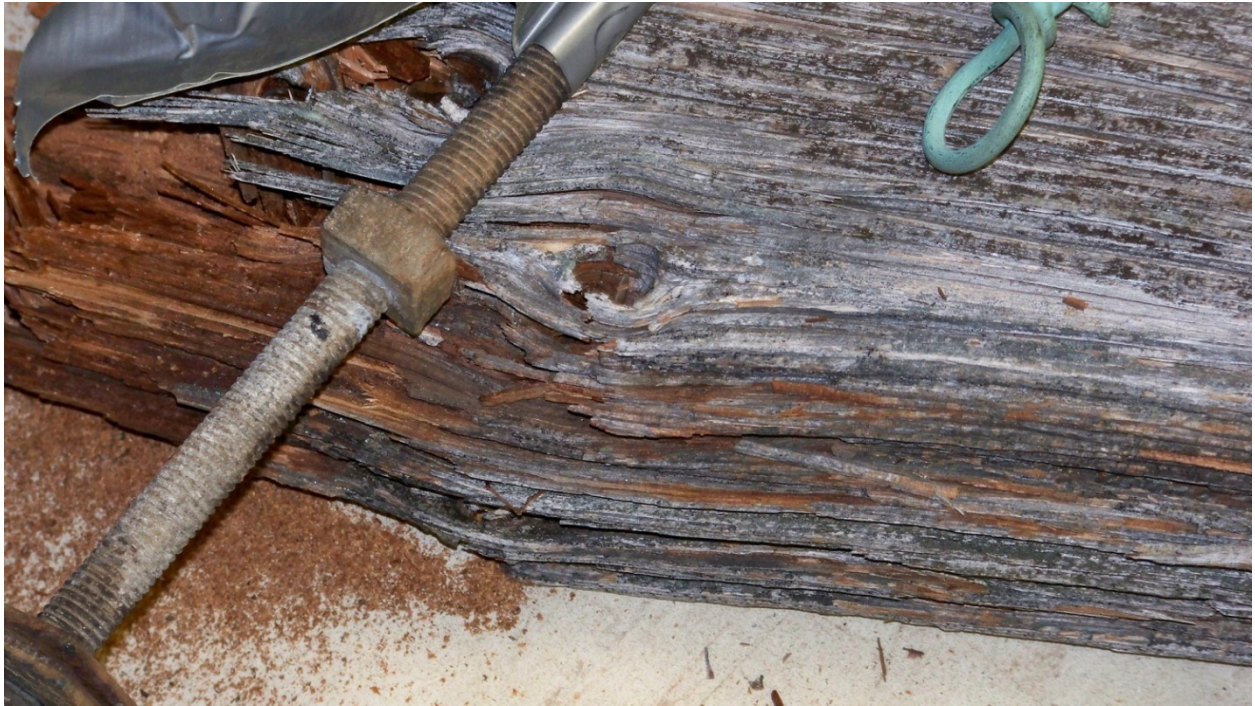
Photo B 4-23 Taken April 21, 2014. Remnants of failed double cross arm on Pole 24 of W185 on floor of Keene Area Work Center. Wood Rot is evident, bolts will no longer hold brackets on broken cross arm and supports *Photo taken by NHPUC Safety Division*

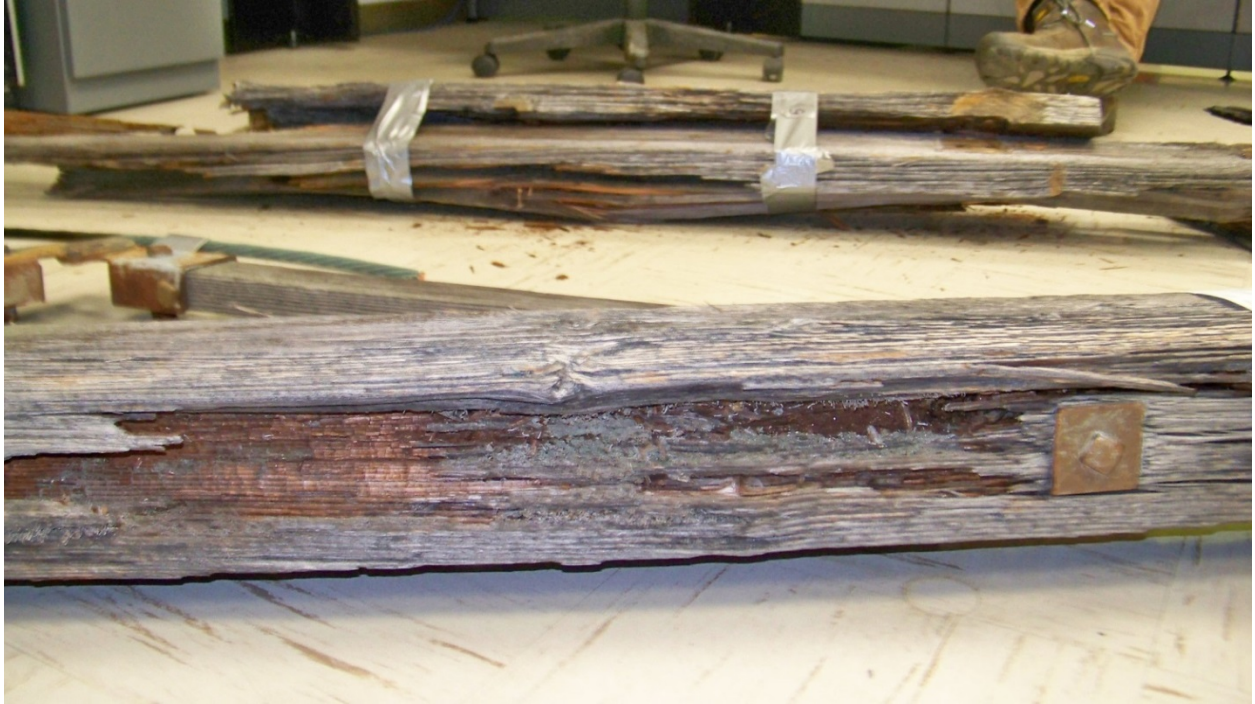
Photo B 4-24 Taken April 21, 2014. Remnants of failed double cross arm on Pole 24 of W185 on floor of Keene Area Work Center. Insect damage and wood rot witnessed on decayed broken cross arm and supports *Photo taken by NHPUC Safety Division*

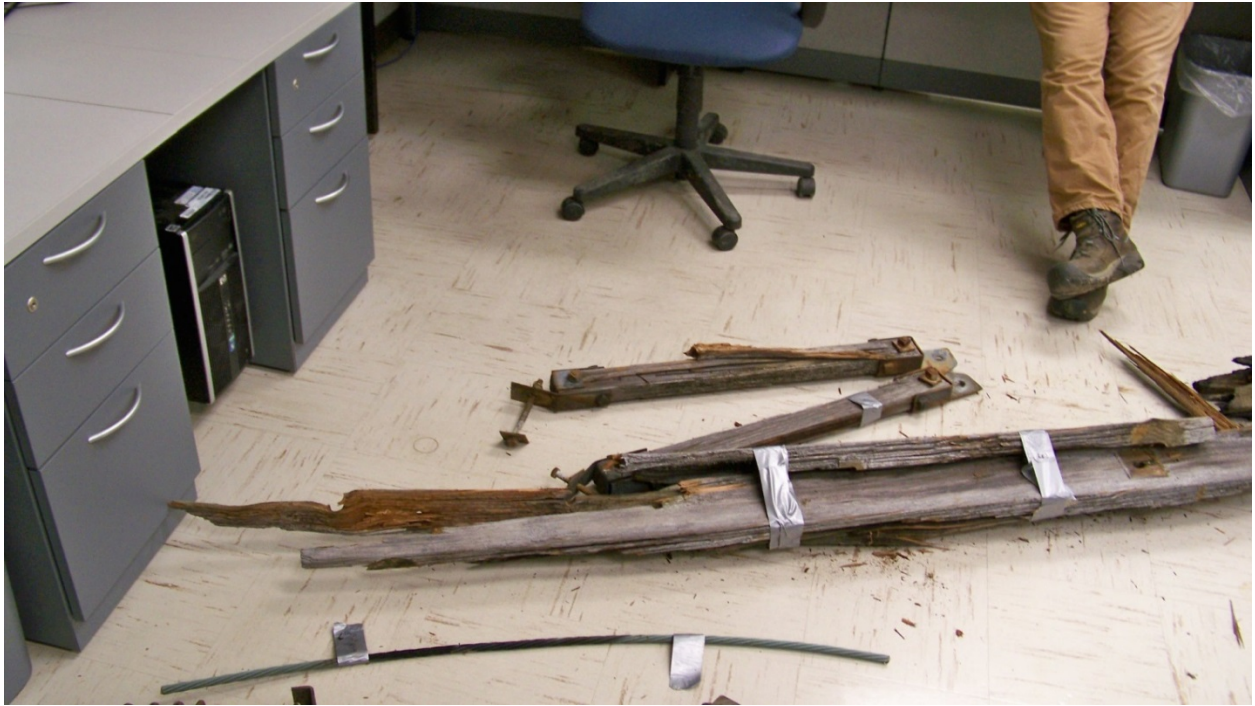
Photo B 4-25 Taken April 21, 2014. Removed failed double cross arm on Pole 24 of W185 on floor of Keene Area Work Center. *Photo taken by NHPUC Safety Division*

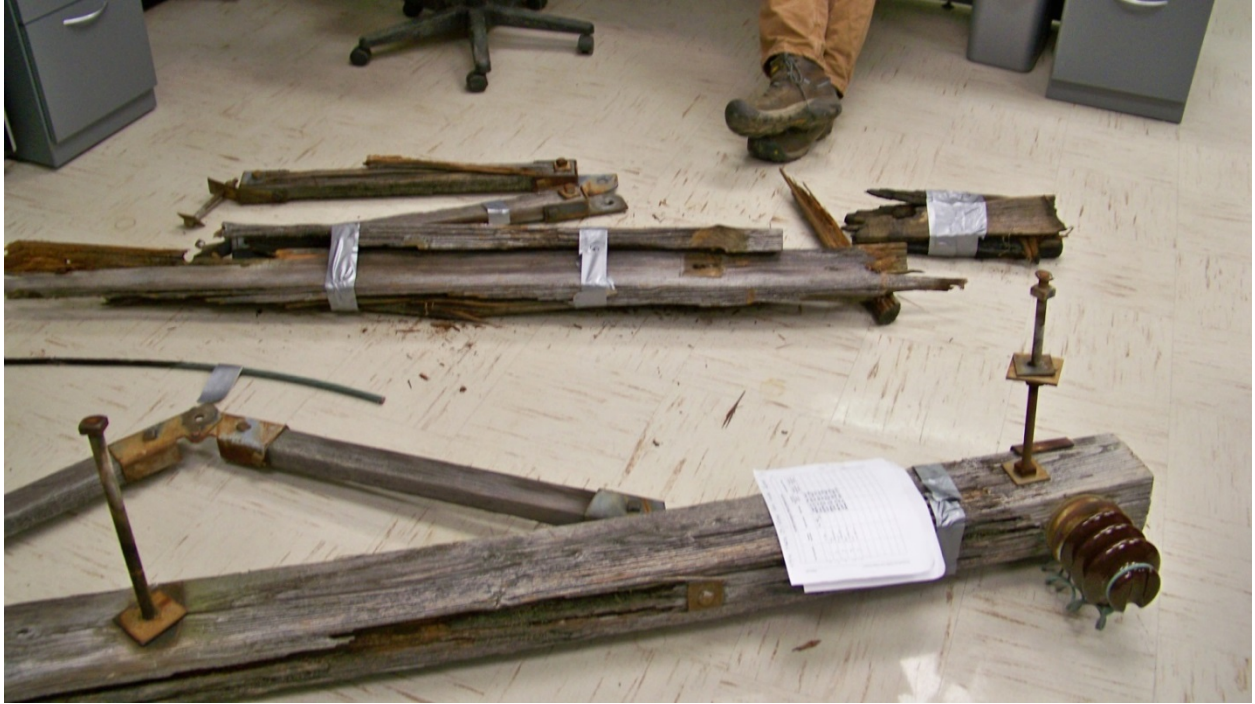
Photo B 4-27 Taken April 21, 2014. Removed failed double cross arm on Pole 24 of W185 on floor of Keene Area Work Center. *Photo taken by NHPUC Safety Division*
