Re: Eversource Issue - Evaluation of Electrical Equipment

A site visit was conducted at the 100 Market Street building in Portsmouth, NH, on June 20, 2016. Purpose of the visit was to evaluate possible damage to electrical equipment resulting from the utility company energizing one phase at a time (known as single-phasing) for the entire building, with the building's main circuit breaker in the "on" position.

**Re: Eversource Issue - Evaluation of Damage to Electronic Equipment**

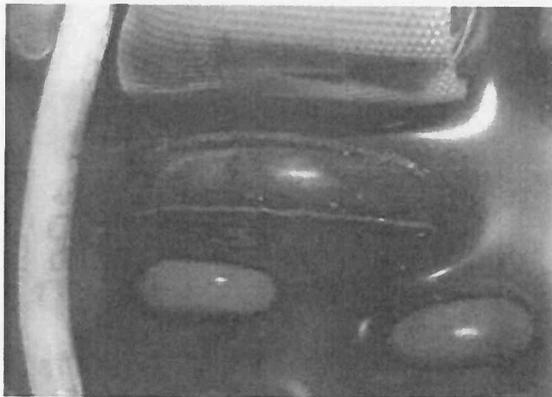
Figure 6. MOV partially embedded in potting material; MOV is split as a result of a TOV (fuse is also opened but not shown here).

Figure 6 shows an example of an MOV failure in end-use equipment. This MOV is partially potted and the line fuse is fully potted (not shown). The blue capacitors below the MOV and the common mode inductor above the MOV are both part of the EMI filter for this equipment. This MOV failed as a result of a TOV incident upon the AC line input. The potting material helped to absorb heat from the MOV and helped prevent the MOV from disintegrating. The MOV failure resulted in the epoxy coating of the MOV being pushed away from the surge absorbing material. This fuse and MOV failure resulted in full equipment failure resulting in the necessity of returning the equipment to the manufacturer.

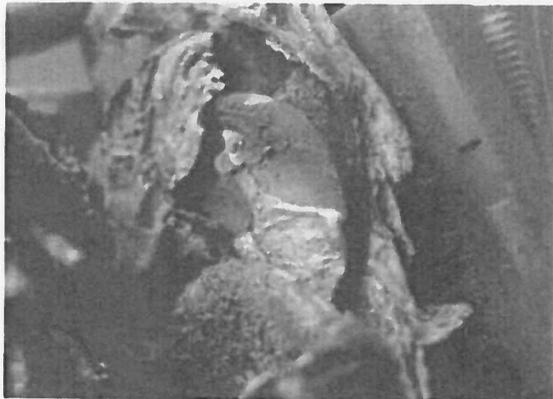
Figure 8. MOV failure caused by thermal runaway and internal equipment fire in another surge protective device.

MCOV rating with respect to the areas in a voltage magnitude-duration plot where surges and TOVs typically occur. In this situation, the MOV is likely to experience thermal runaway (see Figures 7 and 8) and to be damaged, possibly causing a fire inside the equipment. Thus, selecting an MOV with a high CSV and MCOV rating will help avoid line fuse and MOV failures caused by high line voltage conditions and TOVs. On the other hand, the equipment designer must select the clamping voltage low enough to clamp surges before they damage other internal components such as noise capacitors inside an EMI filter and the bridge rectifier. In 120-volt applications, selecting an MOV with a CSV of 395 and a MCOV of 150 will be sufficient. In 277-volt applications, selecting an MOV with a CSV of 845 and a MCOV of 320 will be sufficient.

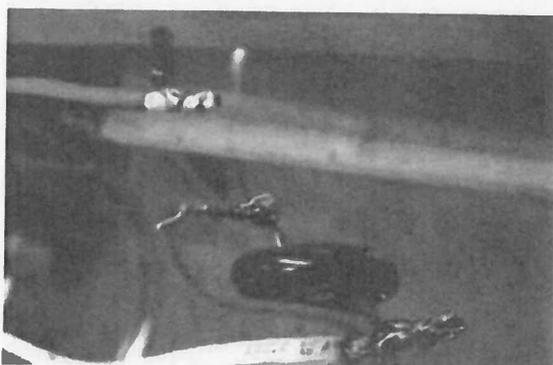
Figure 13. A 3-amp, slow-blow 350-volt line fuse and 510-volt MOV after one 1.71 p.u. (473.4 V<sub>rms</sub>) 64-cycle duration TOV: disintegrated fuse and MOV damaged (epoxy surfaces lifted).

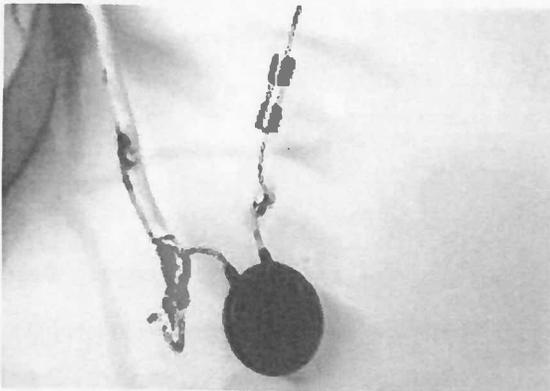
Figure 15. A 3-amp, slow-blow, 350-volt line fuse and 510-volt MOV after one 2.5-kV surge: opened fuse, no damage to MOV.
