IR 21-024
Department of Energy, Division of Enforcement
INVESTIGATION REPORT
OF
WATER PRESSURE REDUCTION MATTER
IN ROSEBROOK WATER SYSTEM
August 31, 2021
Abenaki Water Company, Inc – Carroll, New Hampshire

The investigation focused on a system pressure design issue within the Rosebrook water system. The Division of Enforcement Safety Staff reviewed the root causes of the pressure issue identified in Docket DW 17-165, the Company's efforts to resolve that issue, and alternative engineering options considered by the Company to address pressure concerns. Staff reviewed prior Company filings, conducted in-person investigations of the system and interviews of Company personnel, evaluated system operations, analyzed the source of the pressure issue, and proposed options put forth by AWC to address the existing water pressure issues. Safety Staff's review noted a number of deficiencies in the Company's operation and maintenance of the Rosebrook system.

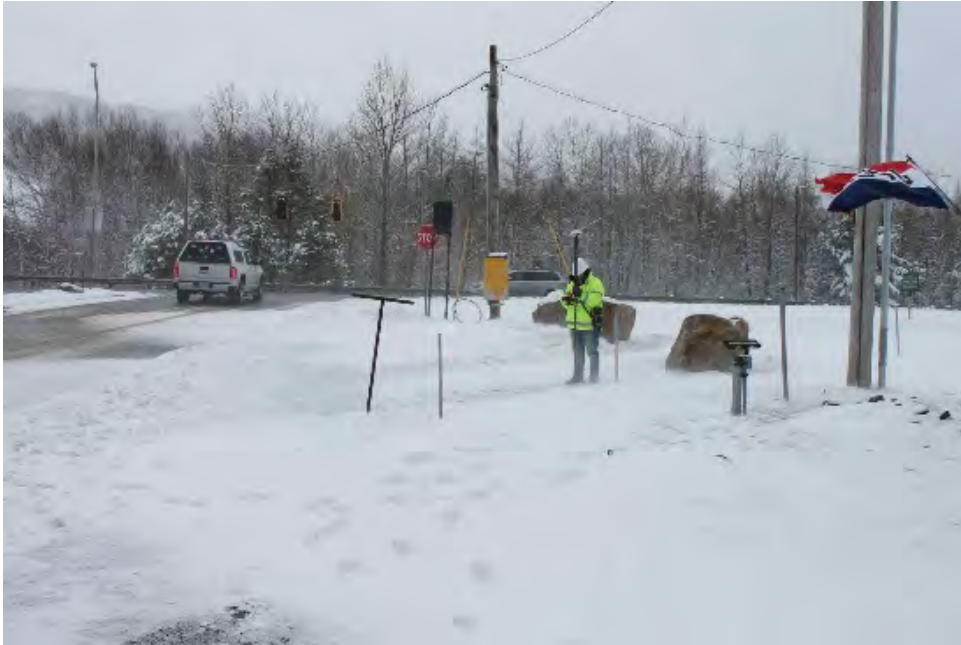
Photo #5-08 View of Safety Staff personnel utilizing GPS data equipment to verify location of water infrastructure.

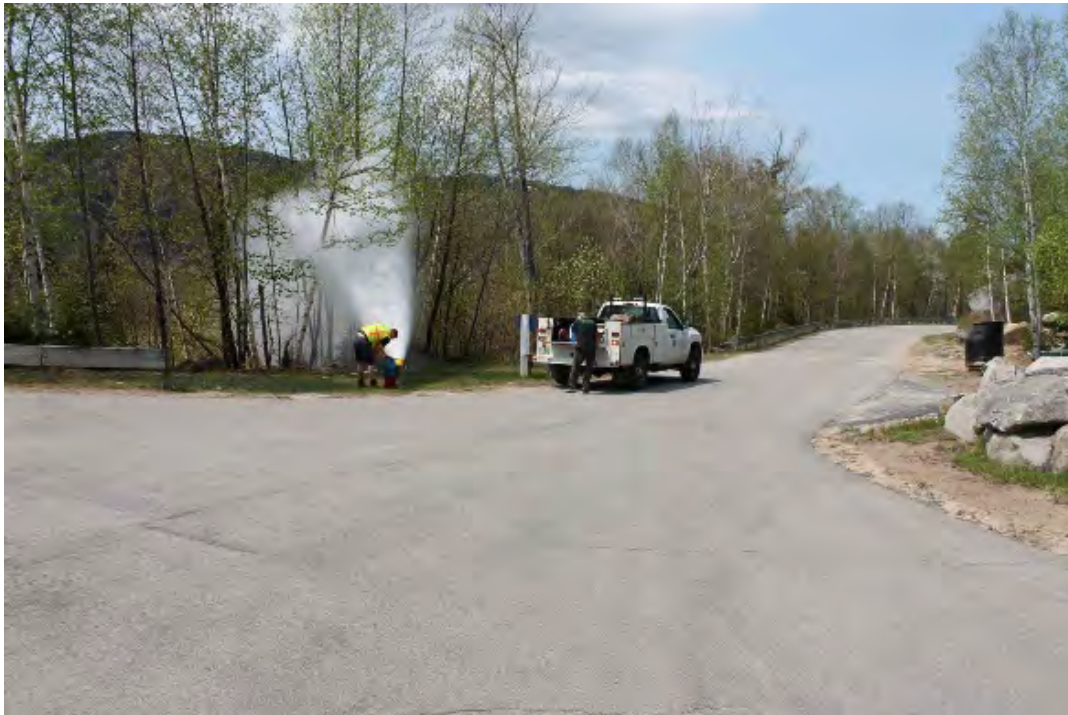
Photo 5-9 View of fire hydrant flow testing as conducted by AWC personnel and their engineering consultant Horizons Engineering.

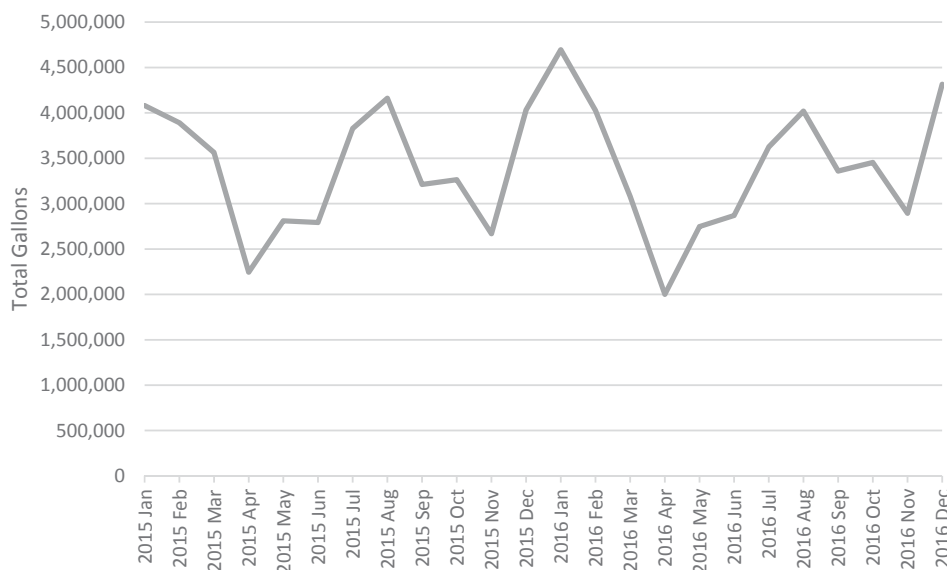
Figure 1 Rosebrook Water System Monthly Water Production

The average total gallons per day (gpd) were 111,086 in 2015 and 112,248 in 2016, which shows consistent water demands between the years. **Figure 1** shows peak demands occur in the winter and the late summer, which reflects the seasonal nature of the community. The peak months were December through March and July through October. During the peak months, the average total gallons per day were 123,070 in 2015 and 124,779 in 2016.
