**Re: DG 14 - 233 Report on status of Repowering Concord Steam**

RE: Fire Marshal's Inspection Report, December 30, 2016  
Concord Steam Plant  
Concord, NH

Subject: Correction of Alleged Deficiencies Found During a State Fire Marshall Inspection

PROJECT: CONCORD STEAM AND POWER

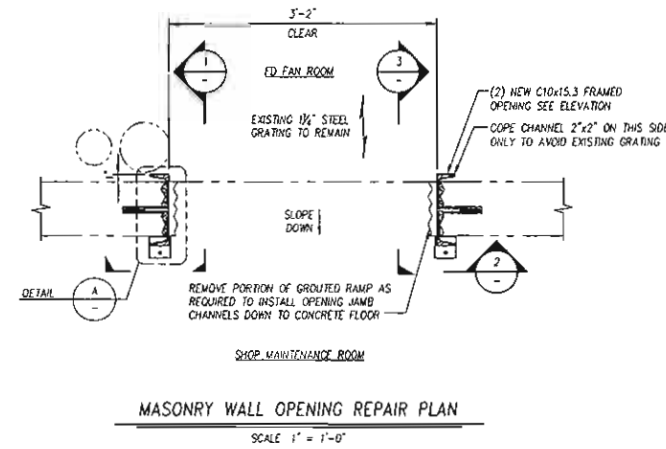
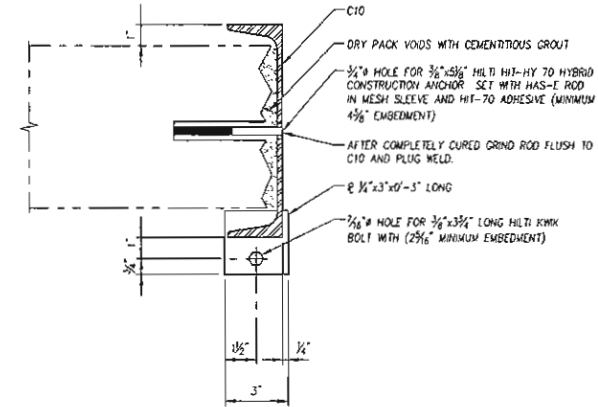
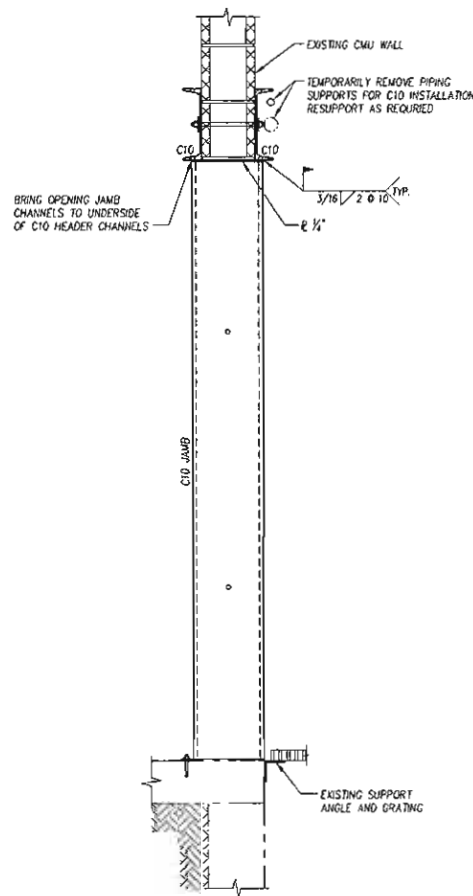
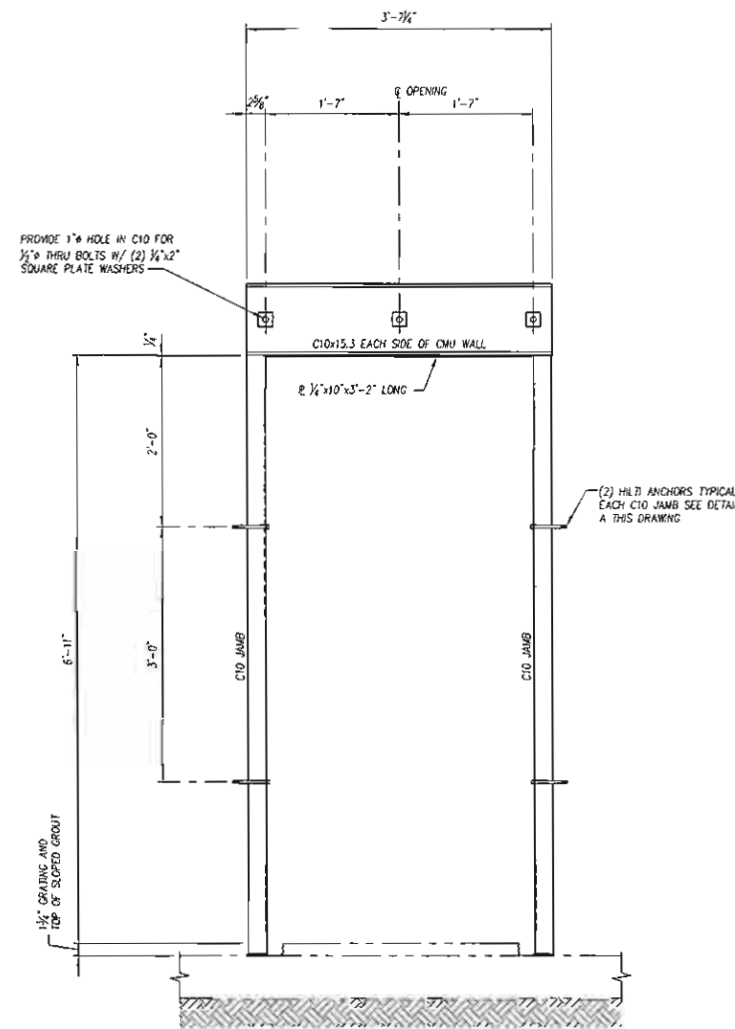
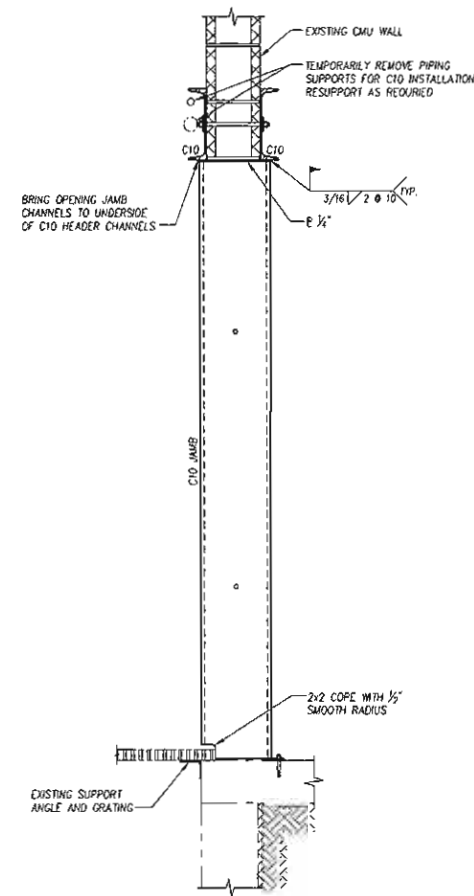
1. No header above man door leading from FD Fan Room to maintenance garage resulting in a crack in CMU wall above the door.

1. The man door opening cut through the hollow CMU wall has resulted in a crack above the header. We recommend installing a steel channel header above the door and steel channel door jambs on each side of the opening to support the header. This will provide support to the wall above the opening with no further danger of wall cracking. (see drawing S-100 for details.)
