*New England Pipeline Safety Representatives
Annual Seminar – Hyannis, Massachusetts
San Bruno, CA – Lessons Learned*

Randy Knepper
Director of Safety
New Hampshire Public Utilities Commission
1 Oct 27, 2011

San Bruno, CA Overview

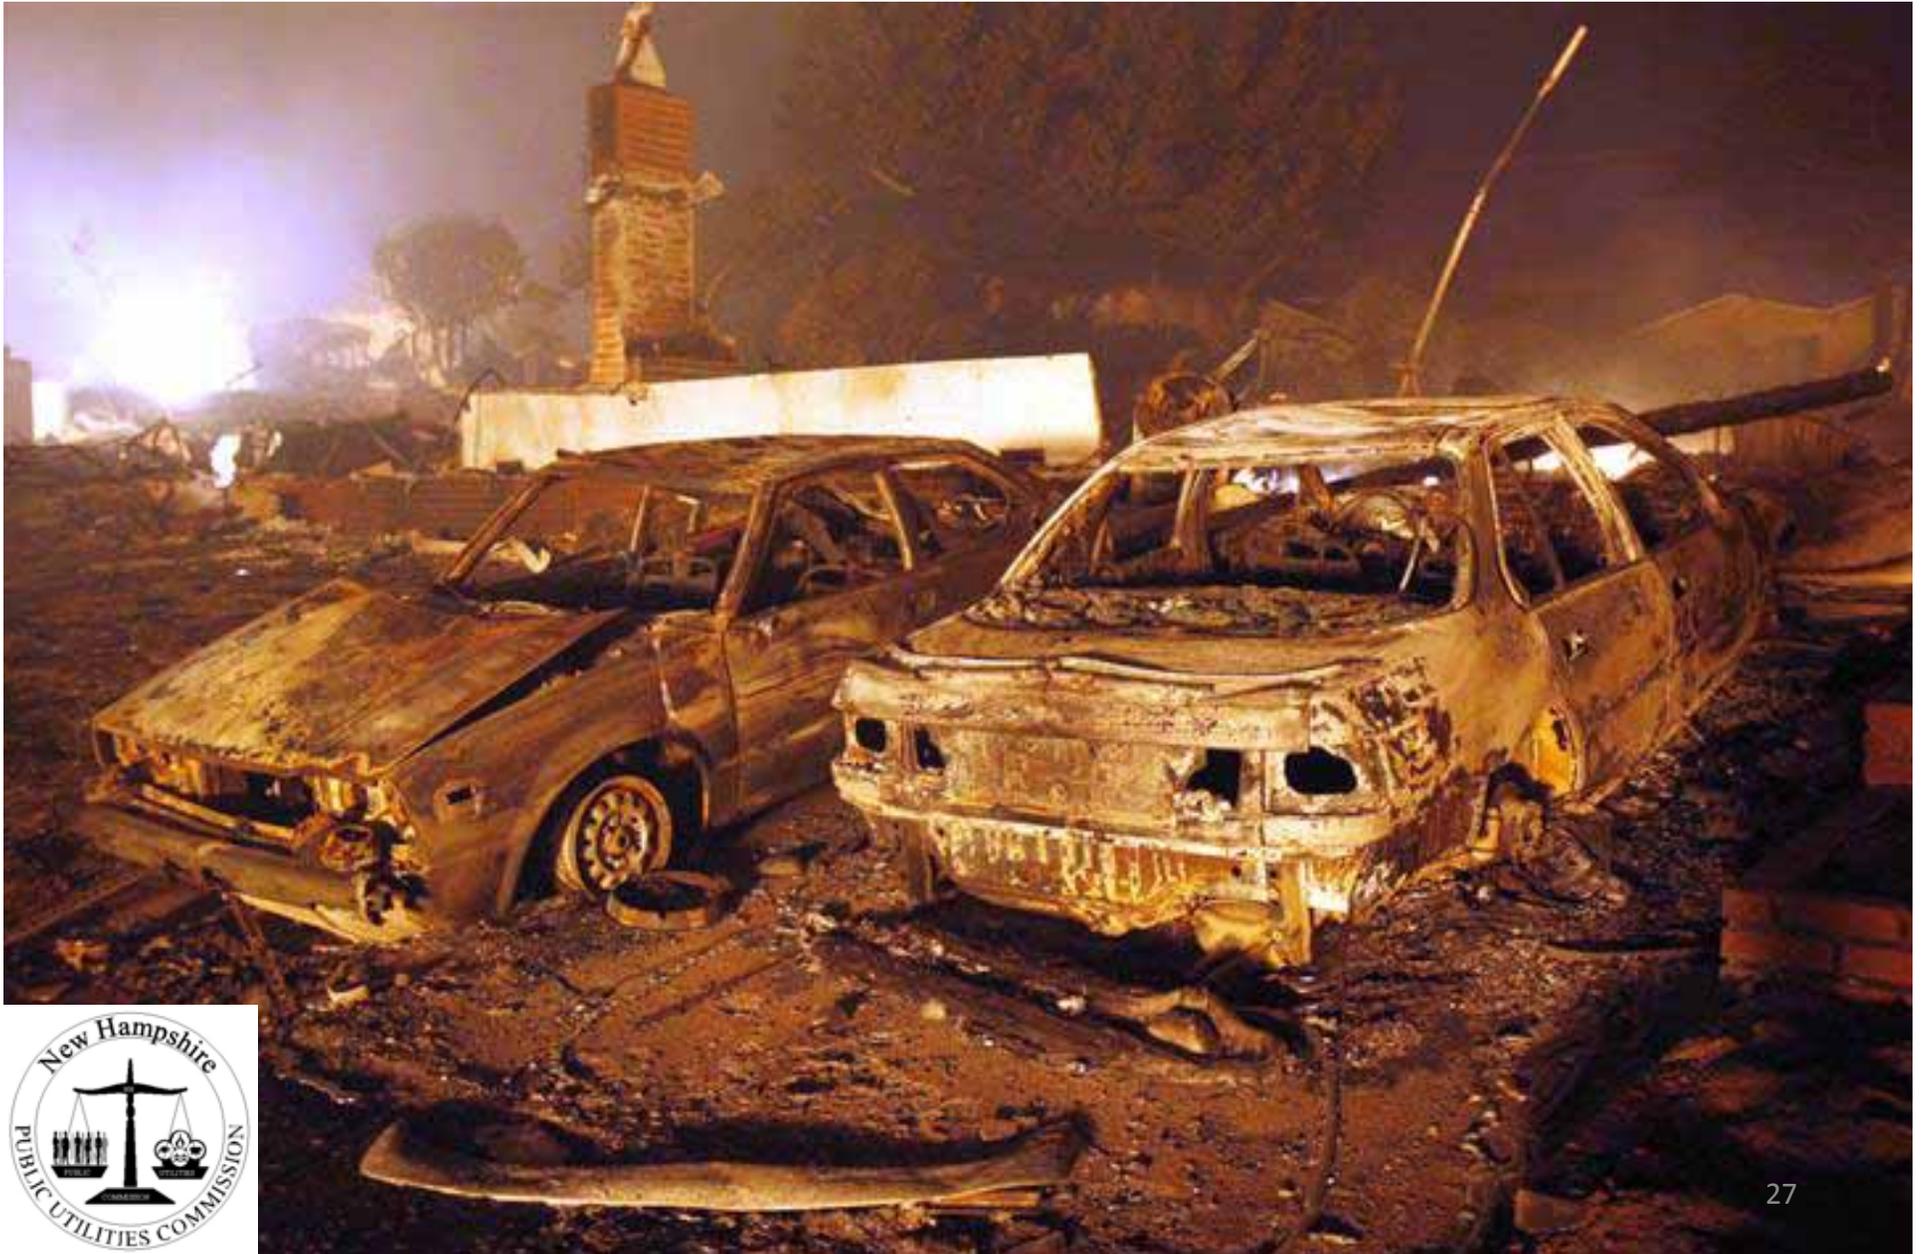
San Bruno, CA – Incinerated Remains of Vehicles

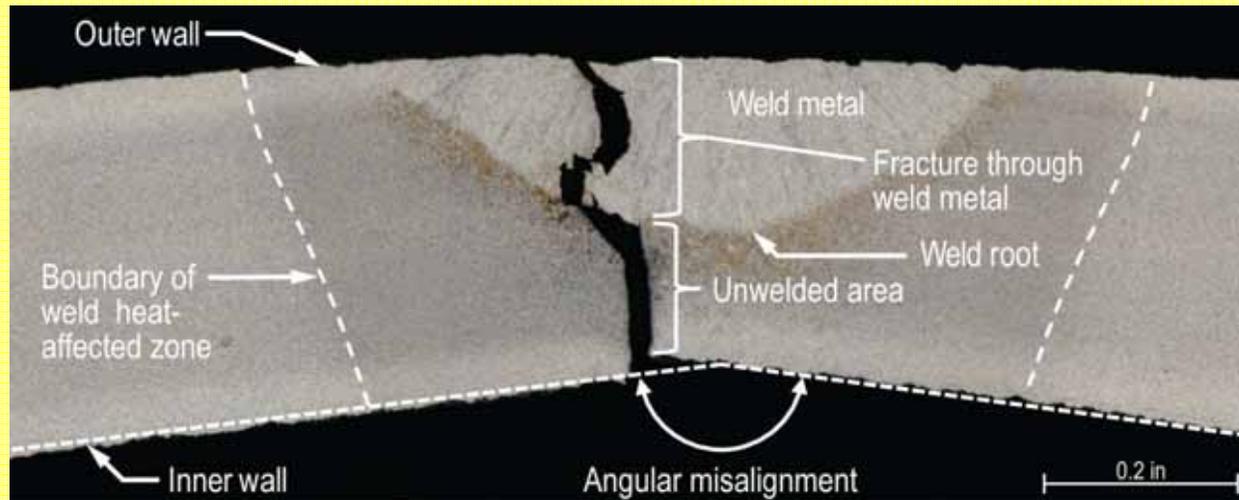
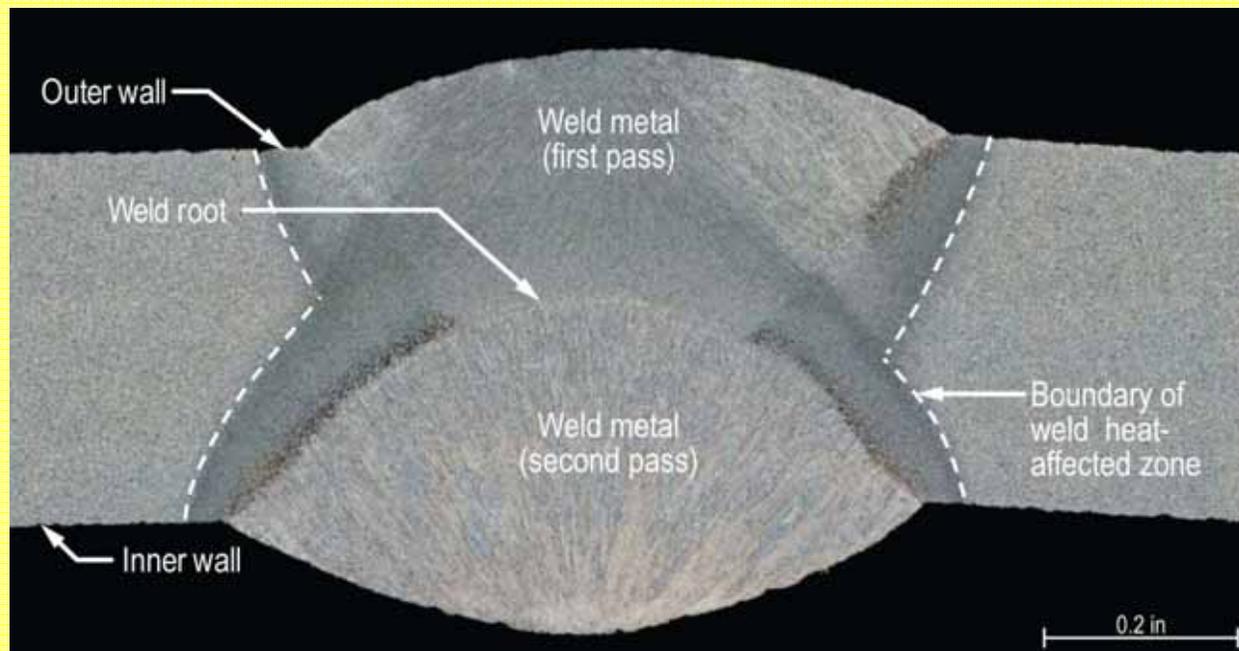
Rupture Examination Welding

- Welds showed indications of different Welding Methods such as Fusion Welding Process, Manual Arc Welding, Shielded Metal Arc Welding on Girth Welds (Field)
- Double Submerged Arc Welding (Factory)
- Evidence of Porosity, incomplete fusion, undercutting, Lack of Penetration, slag inclusion
- Squared Ends versus Beveled Ends

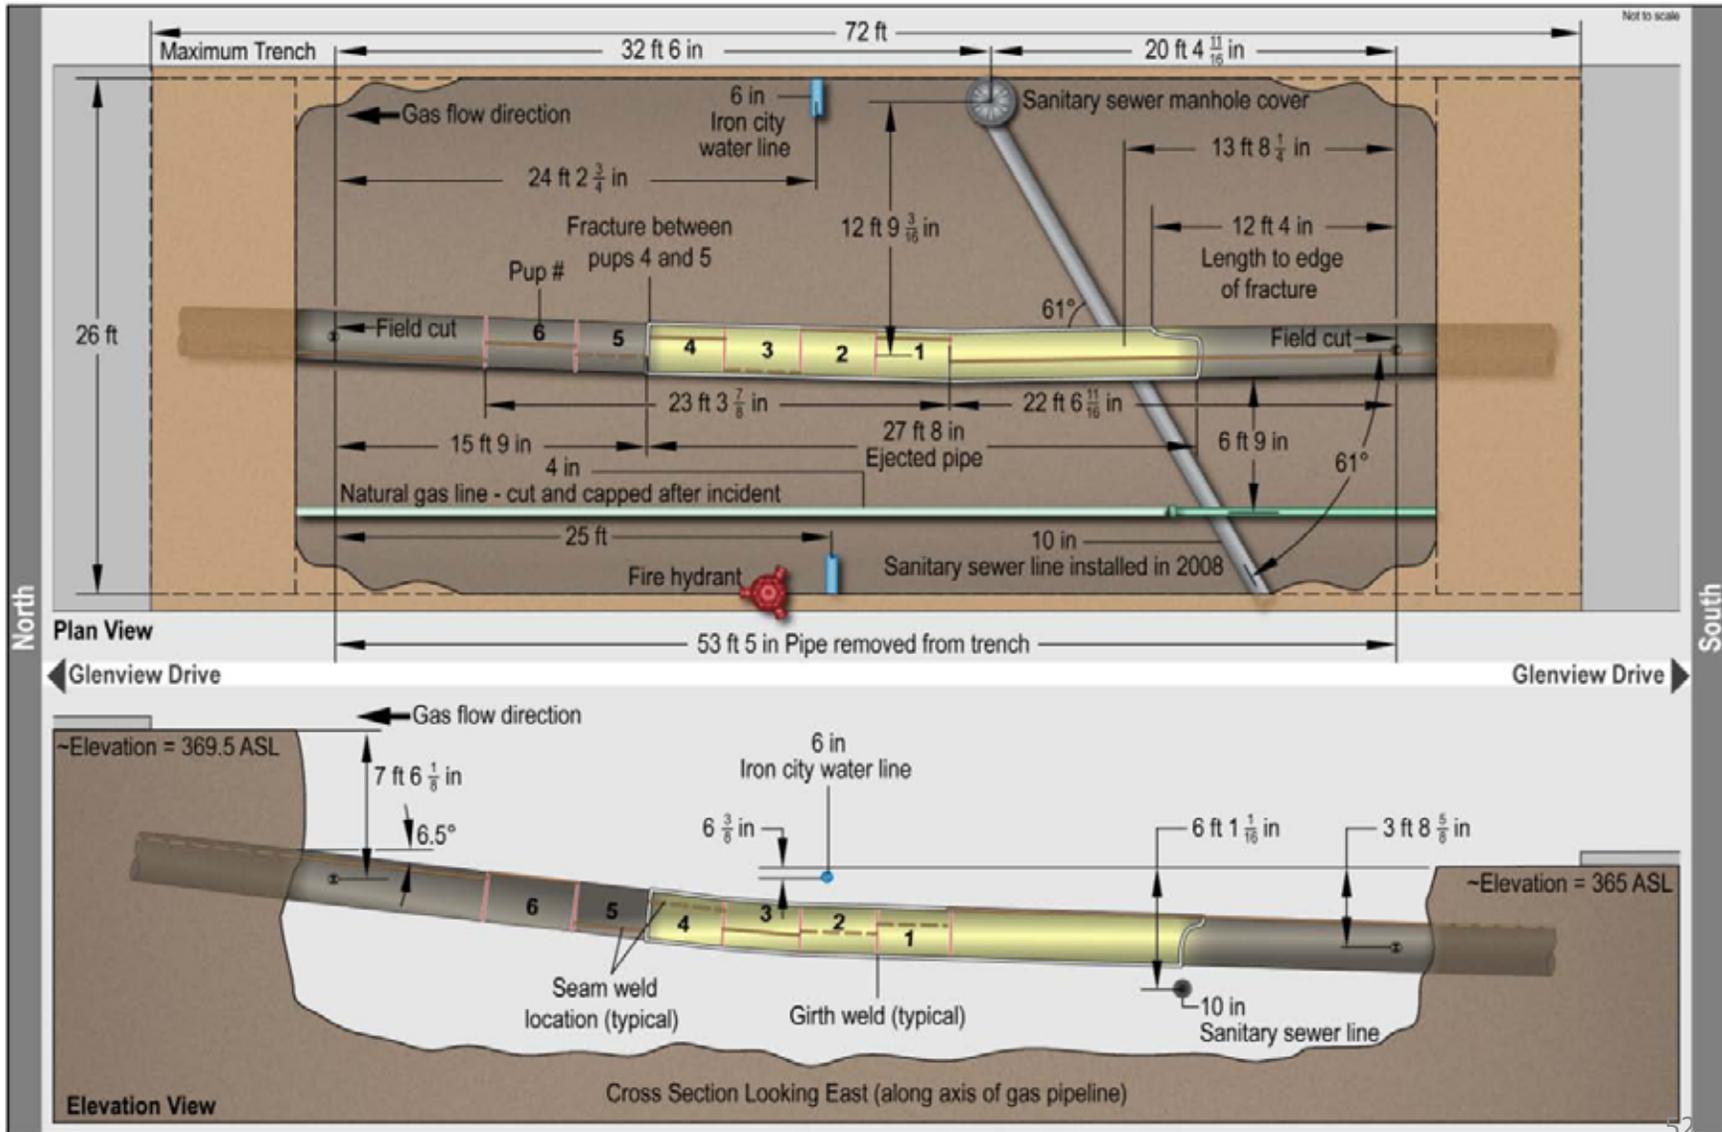
From NTSB Report

- NTSB discounted the effect of the Sewer installation as a root cause of the failure
- Considered video of jacking operation
- Considered Studies on pipe bursting by Army Corp of Engineers 2001 and 2004 Paper at North American Trenchless Technology regarding Vibrations
- Found equivalent stress on pipe was raising internal hoop stress to approximately
 - 6 psi due to bursting head
 - 2.5 psi due to external soil pressure
 - .01 psi due to vibrations
- Considered **minimal** compared to the pressure variations within the pipe of 110 psi

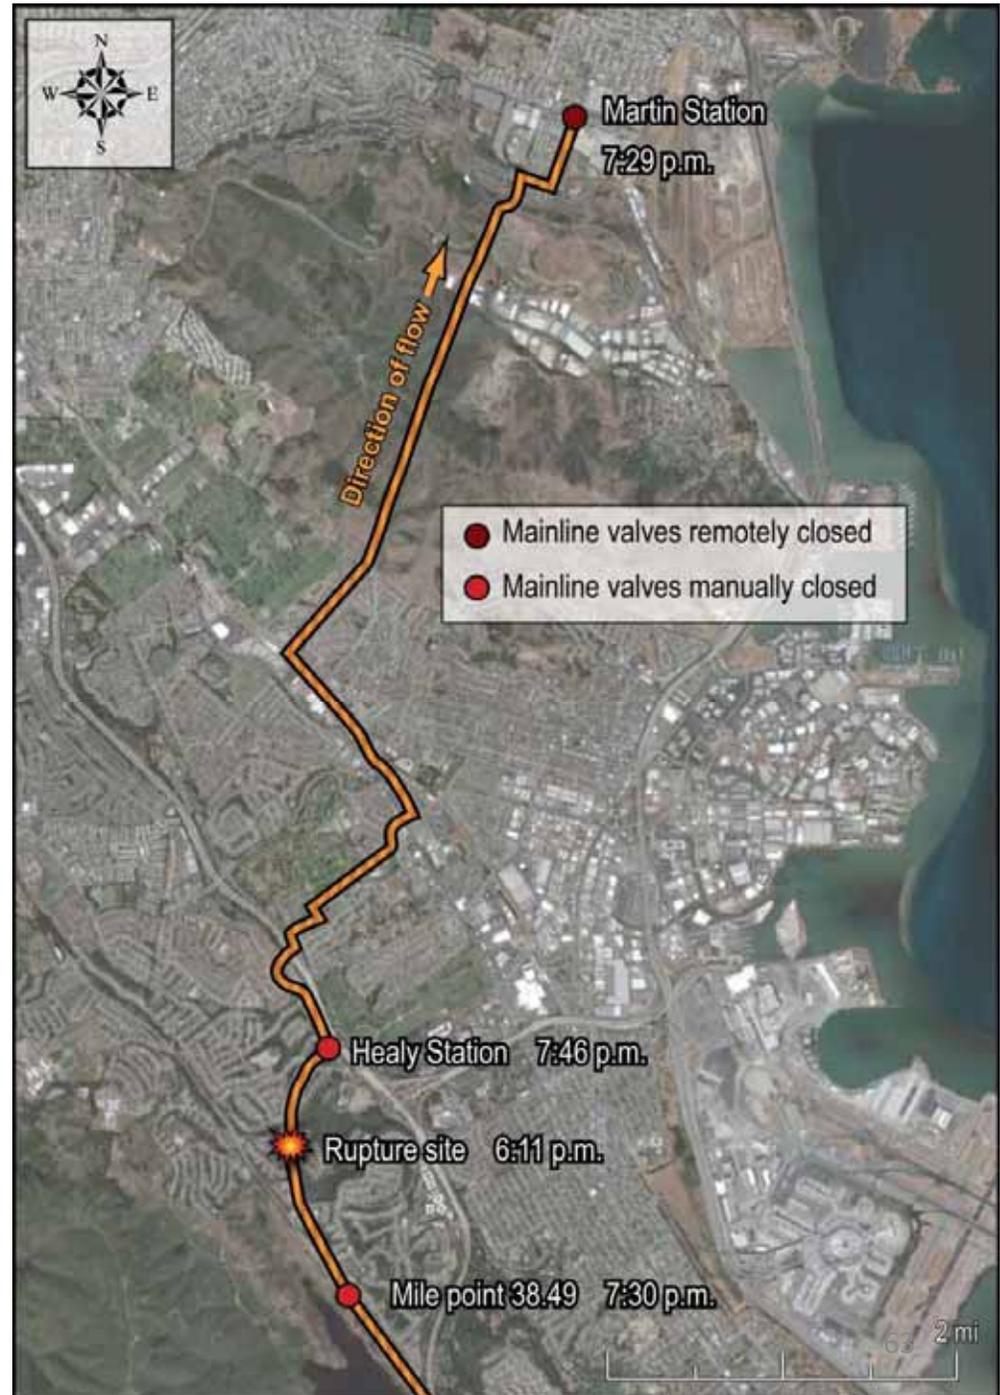
- 7:57 pm PG&E engineer confirmed location of rupture to Scada Center and that cross ties to Line 109 had been opened at the Martins Station to keep Line 100 active.
- 7:57 pm Red Cross set up shelter
- 11:32 pm more PG&E crews squeezing off distribution lines to limit gas fed house fires
- 4:24 am Sept 11, 2010 75% all house fires knocked down
- 8:00 pm Sept 11 Incident Command transferred to PD and FD monitoring hot spots

1. PG&E took 95 minutes to stop the flow of gas and to isolate the rupture site—a response time that was *excessively long* and contributed to the extent and severity of property damage and increased the life-threatening risks to the residents and emergency responders.
2. The National Transportation Safety Board found that PG&E *lacks a detailed and comprehensive procedure for responding to large-scale emergencies* such as a transmission pipeline break, including a defined command structure that clearly assigns a single point of leadership and allocates specific duties to supervisory control and data acquisition staff and other involved employees.
