Mass Tank Inspection Services, LLC  
29 Abbey Lane  
Middleboro, MA 02346  
Office 508-947-8826  
email: [Matt@masstankinspection.com](mailto:Matt@masstankinspection.com)

March 2, 2020

Abenaki Water Company Inspection Report  
2 @ 15,000 Gallon Underground Storage Tanks  
Service: Potable Water  
Inspection Date: February 11 & 19, 2020

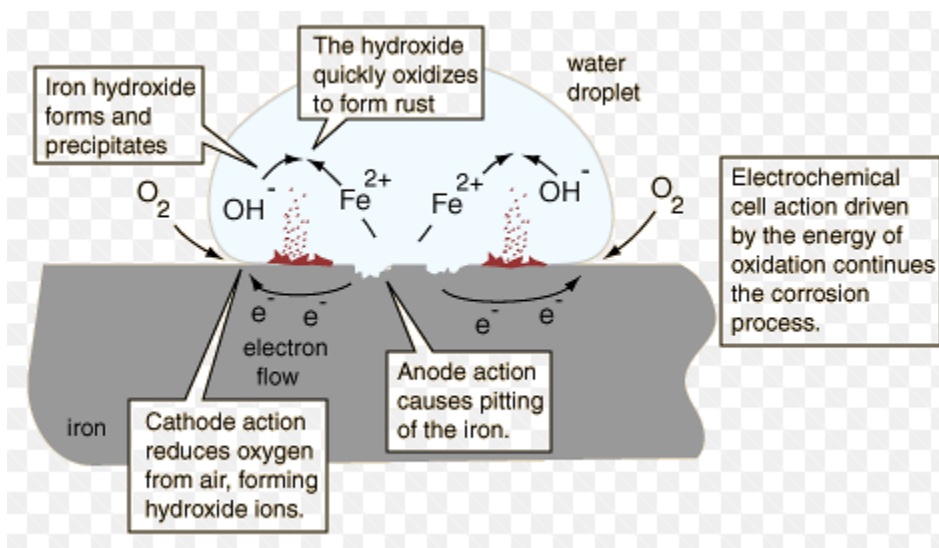
Tubercles are a common occurrence in steel water tanks that operate without the protection of a viable liner. Tubercles can be defined as structurally complex corrosion cells in which accumulations of metal oxides, deposits, and corrosion products cap localized regions of metal loss. Differential aeration cells caused tuberculation, where oxygen deficient regions below the accumulated corrosion products form anodic sites, surrounded by areas that are cathodic. Tubercles grow as a result of both internal (anodic) and external (cathodic) reactions.

A diagram of the tubercle formation and subsequent metal loss and pitting is shown left.
