**STATE OF NEW HAMPSHIRE**  
**PUBLIC UTILITIES COMMISSION**

**DOCKET NO. DE 08-066**

**IN THE MATTER OF:**  
**PUBLIC SERVICE COMPANY OF NEW HAMPSHIRE, INC.**  
**2007 ENERGY SERVICE AND STRANDED COST RECOVERY CHARGE**  
**RECONCILIATION**

**DIRECT TESTIMONY**

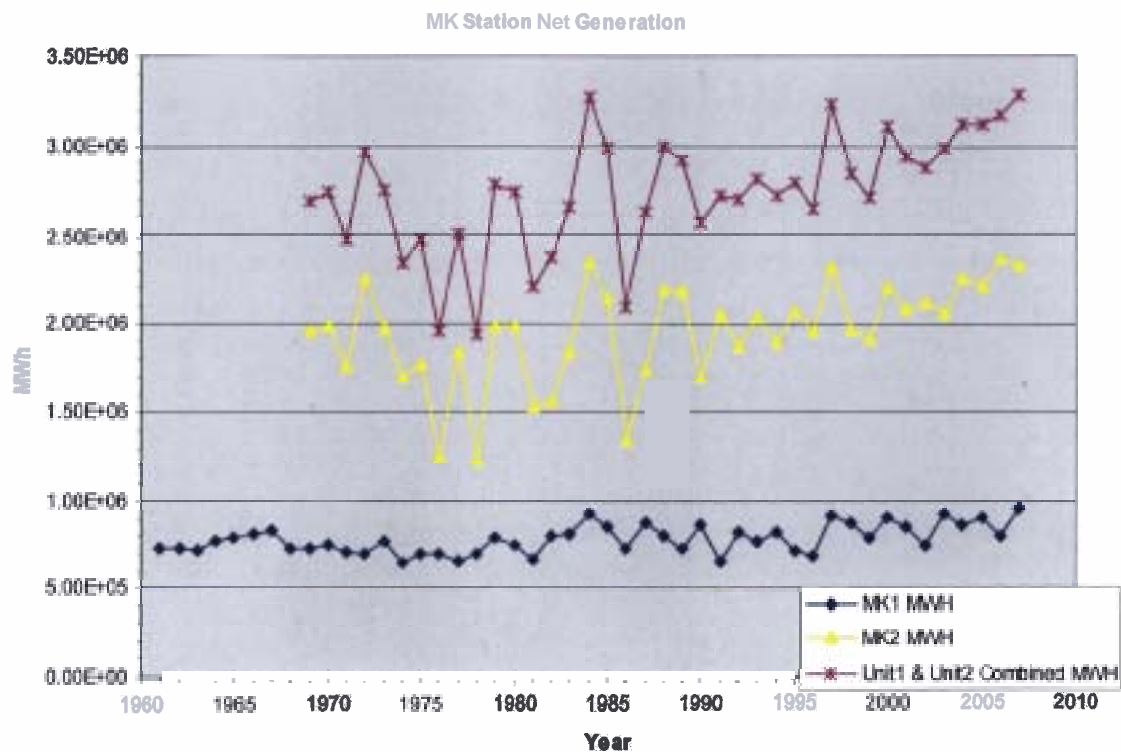
PSNH's Merrimack units are operating at higher than historic capacity factors . The chart below shows that the total generation at **Merrimack** is on an increasing trend that began in the mid- to late 1990s. It also shows that there is less volatility to the annual output at the station. There has been an approximate 800,000 MWH increase in plant output sine the mid- to late 1990s, or about a one-third increase. That energy with a price differential to market of approximately \$30/MWH brings an additional \$25 million of customer benefit per year compared to historical values.
