Unitil Energy Systems, Inc.  
May 1, 2012 Step Adjustment

**REP and VMP Annual Report 2011**

**UES - Capital Reliability Analysis and Recommendations 2011**

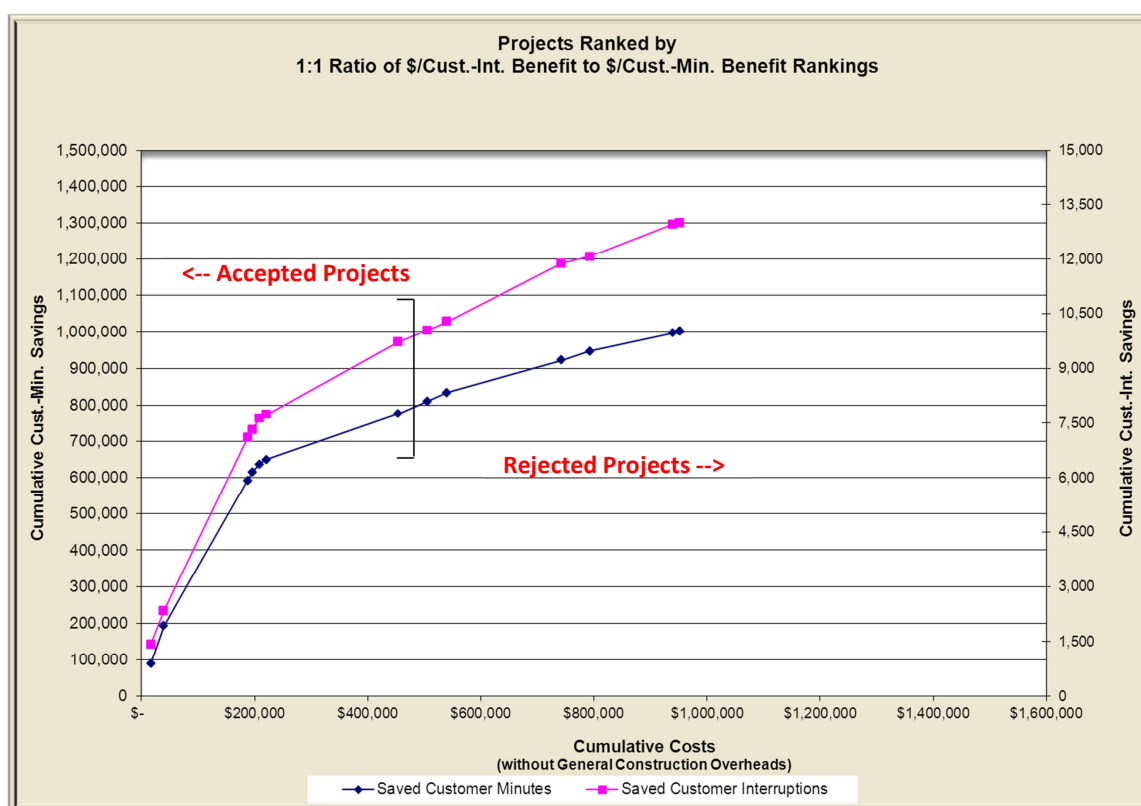
Chart 1

Another tool used by Distribution Engineering in selecting projects is shown in Figure 1 below. This chart displays the cumulative project cost versus anticipated reliability benefits of all projects. Each data point pair represents a specific project and its associated reliability benefits (saved customer minutes and saved customer interruptions). This chart is used to determine when there is a diminishing return of reliability benefits associated with project cost as indicated by the “knee” of the curve. Proposed projects to the left of the cutoff line are accepted in the 2012 Capital Budget and those to the right have been rejected.

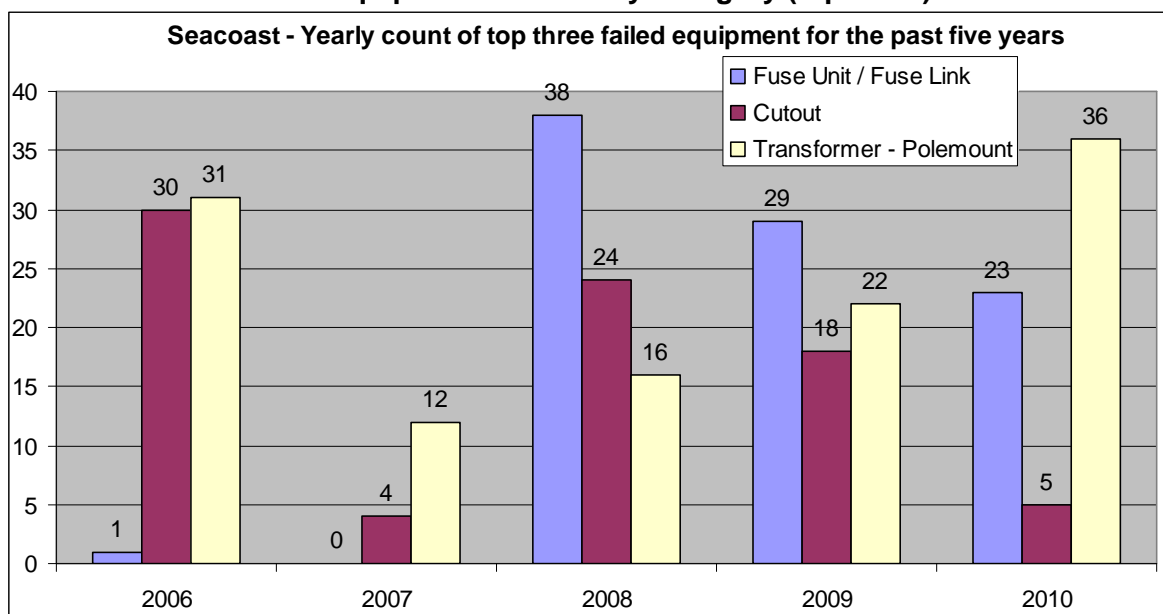
**Chart 3**  
**Annual Equipment Failures by Category (top three)**

Note: Fuse Unit/Fuse link failures are failures of a particular model of Current Limiting Fuse known to be defective. The identified model of Current Limiting Fuse is no longer being installed and is being replaced when practical.

This section is intended to clearly show all equipment failures throughout the study period from January 2010 through June 2011. It is important to track these failures so that trends, if any exist, can be observed and corrected in an effort to reduce failures of a specific type of equipment in the future. *Chart 1*, shown below, shows all equipment failures throughout the study period. In addition, *Chart 2* shows each equipment failure as a percentage of the total failures within this same study period. The number of equipment failures in each of the top three categories of failed equipment for the past five years are shown below in *Chart 3*.
