STATE OF NEW HAMPSHIRE
 BEFORE THE
 NEW HAMPSHIRE PUBLIC UTILITIES COMMISSION
 DIRECT TESTIMONY OF
 WILLIAM H. SMAGULA

PUBLIC SERVICE COMPANY OF NEW HAMPSHIRE
 RECONCILIATION OF ENERGY SERVICE AND STRANDED COSTS FOR 2007

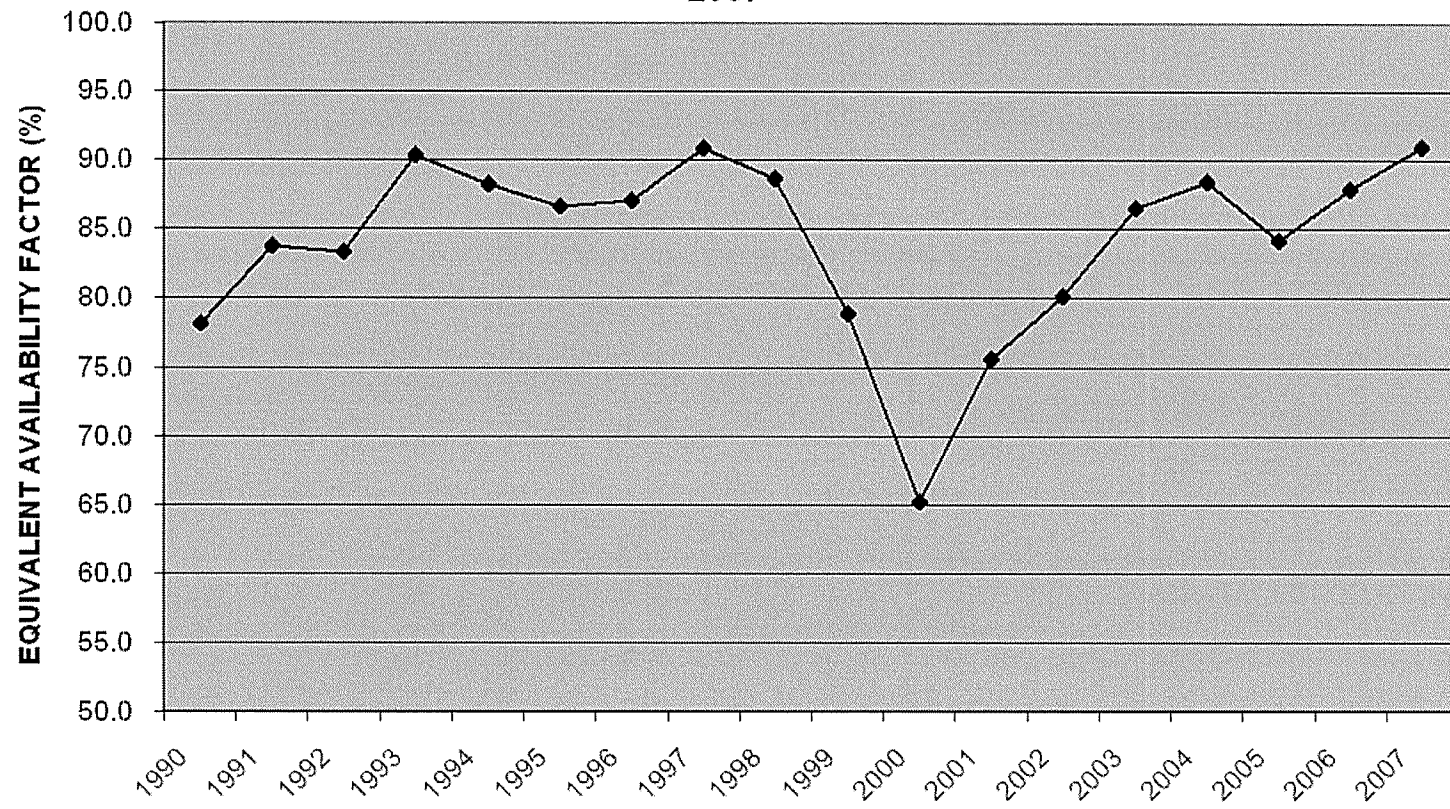
PSNH FOSSIL SYSTEM WEIGHTED EAF
2007

$$\frac{(\text{Available Hours} - \text{Equiv. Unit Derated Hours} - \text{Equiv. Seasonal Derated Hours}) \times 100}{\text{Period Hours}}$$
