RE: DE 08-066 Public Service Company of New Hampshire, Inc.
2007 Energy Service and Stranded Cost Recovery Charge Reconciliation

DIRECT TESTIMONY

MICHAEL D. CANNATA, JR., P. E.
SENIOR CONSULTANT
THE LIBERTY CONSULTING GROUP

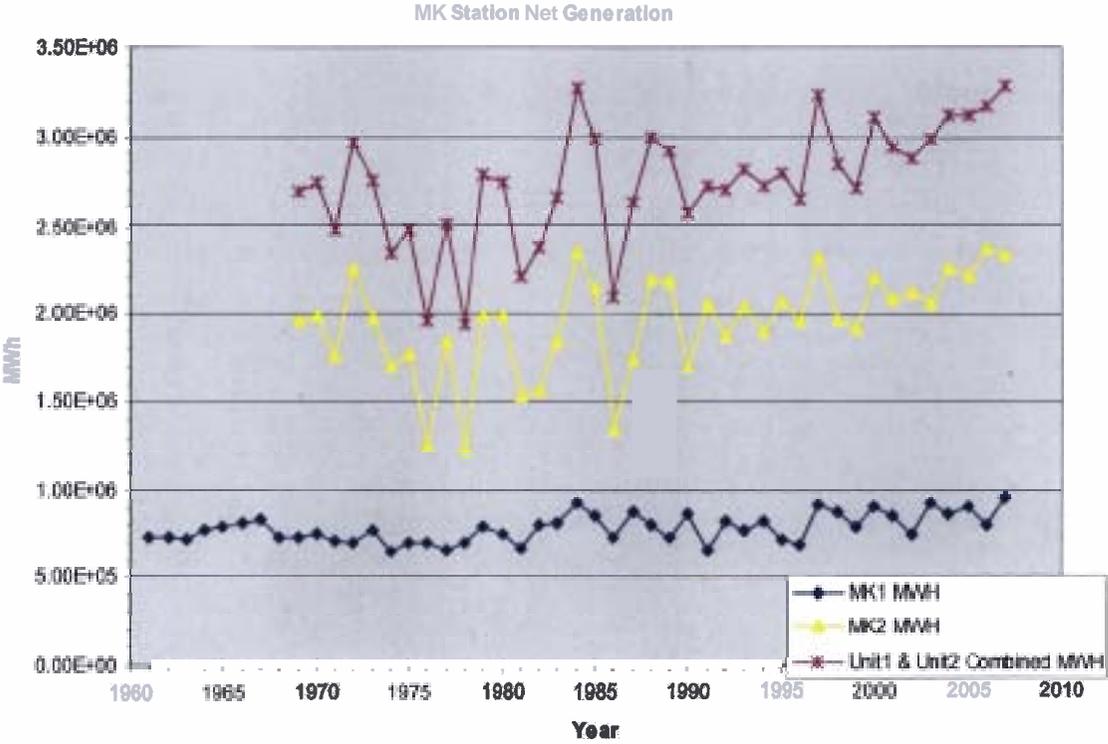
PSNH's Merrimack units are operating at higher than historic capacity factors . The chart below shows that the total generation at **Merrimack** is on an increasing trend that began in the mid- to late 1990s. It also shows that there is less volatility to the annual output at the station. There has been an approximate 800,000 MWH increase in plant output sine the mid- to late 1990s, or about a one-third increase. That energy with a price differential to market of approximately \$30/MWH brings an additional \$25 million of customer benefit per year compared to historical values.
