Reliability Analysis and Recommendations 2015

**Unitil Energy Systems - Capital
Reliability Study
2015**

Prepared By:
Cyrus Esmaeili
Unitil Service Corp.
Oct 1, 2015

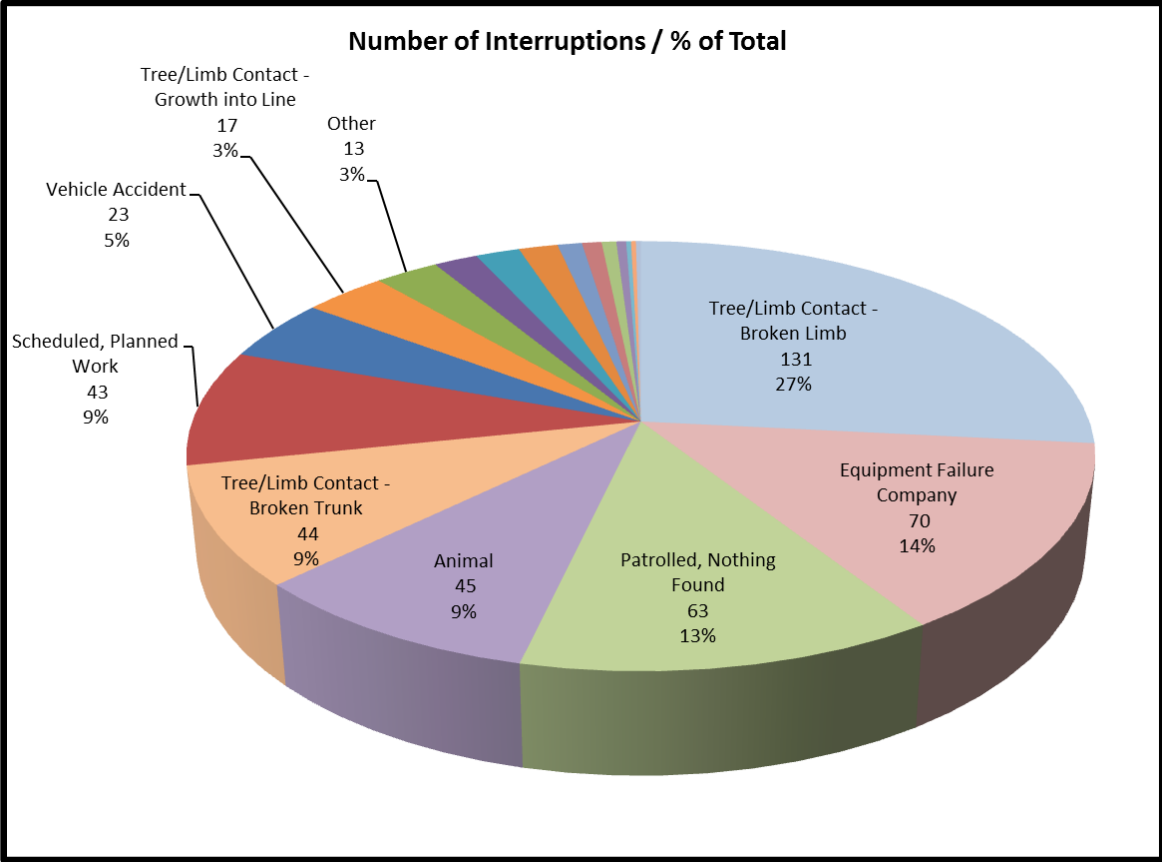
Chart 1
Number of Interruptions by Cause

This section provides a breakdown of all outages by cause code experienced during 2014. Chart 1 lists the number of interruptions due to each cause. For clarity, only those causes occurring more than 10 times are labeled. Chart 2 details the percent of total customer-minutes of interruption due to each cause. Only those causes contributing greater than 2% of the total are labeled.
