3. Reliability Planning and Performance

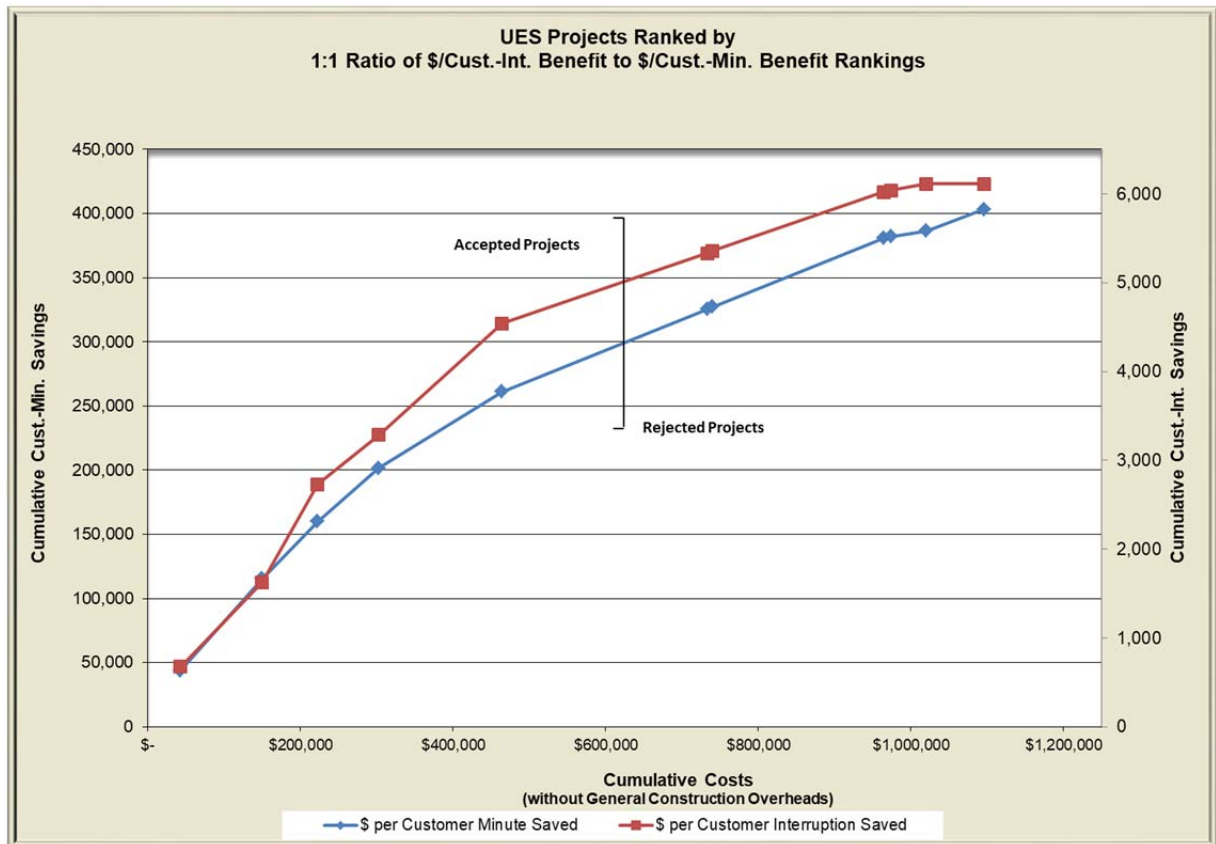
An overall project rank is derived from the sum of these two cost benefit rankings. In general, projects with low construction cost and high saved customer minutes or high saved customer interruptions are ranked highest on the list while those projects with high construction cost and low saved customer minutes or saved customer interruptions are ranked low on the list. Another way these projects are analyzed by Distribution Engineering is shown in Chart 2 below. This chart displays the cumulative project cost compared to the anticipated reliability benefits of all projects. Each data point pair represents a specific project and its associated reliability benefits (saved customer minutes and saved customer interruptions). This chart is used to compare the relative return of reliability benefits associated with project cost between all projects. The projects to the left of the cutoff line are those that are entered into the annual Capital Budget for approval. Those to the right have been rejected.
