**Storm Resiliency Program Analysis
and Acceleration Proposal**

Sara Sankowich, Richard Francazio, and Raymond Letourneau
Unitil Service Corp.
February 28, 2018

1. Storm Resiliency Program Overview

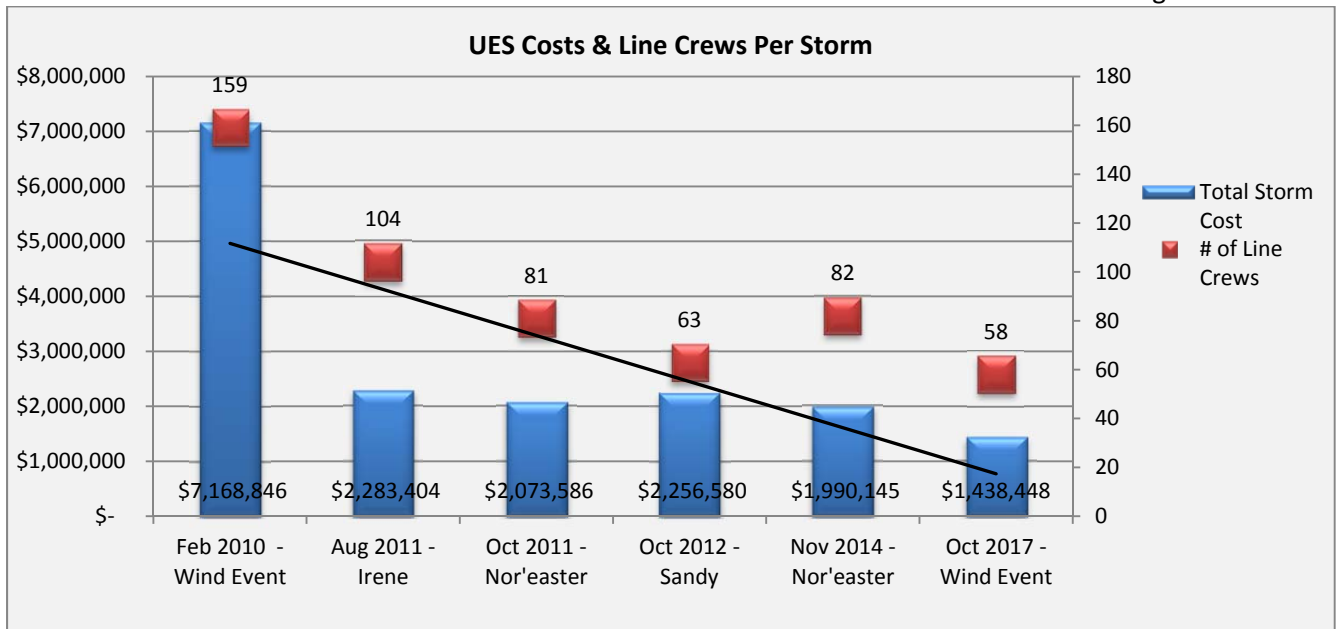
Chart 1

Company has reviewed the biggest storm events to impact New Hampshire over the past 7 years (see Chart 1). The data shows a decline in resources needed and thereby a decline in the overall cost of the restoration. The Company is of the opinion that there is a break point as how fast restoration can occur after the onset of an event, given the activities that have to be performed prior and during restoration such as the public safety phase. The Company believes, however, that restoration times in general have been reduced by approximately 1-2 days such that the type of storms that would have formerly taken 5-6 days to recover from are now are being restored in 4-5 days. The key is that we can now restore with fewer resources as a result of fewer damage locations related to trees, a direct result of the SRP.

In major events, the reduction in outages is not quite as pronounced, due to the lack of data being collected during storm events, and lack of opportunity to collect the data. Without data showing locations of tree-related trouble, an outage affecting a large amount of customers Pre-SRP could be related to numerous cases of tree damage, and that same outage Post-SRP could be related to only one case of tree damage. However, both events appear as a similar, single outage on the circuit. Setting aside discrepancies in the outage data, attempting to compare Pre-SRP major events and Post-SRP major events is difficult due to the fact that in many of the events, individual outage data (or even circuit level data) is not available. The February 25, 2010 wind storm, August 28, 2011 Hurricane Irene, October 31, 2011 Nor'easter, and October 29, 2012 Sandy do not have outage data for comparison. In these events it was not feasible to collect individual outage data. Perhaps the ability to be able to collect circuit and outage level data in recent major events, such as the October 29, 2017 wind storm, speaks to the reduction in trouble locations and damage on the system due to SRP efforts. At the present, the best measure of SRP effectiveness in a storm can be seen in a reduction of the overall storm restoration duration and the number of resources required shown in Chart 1.

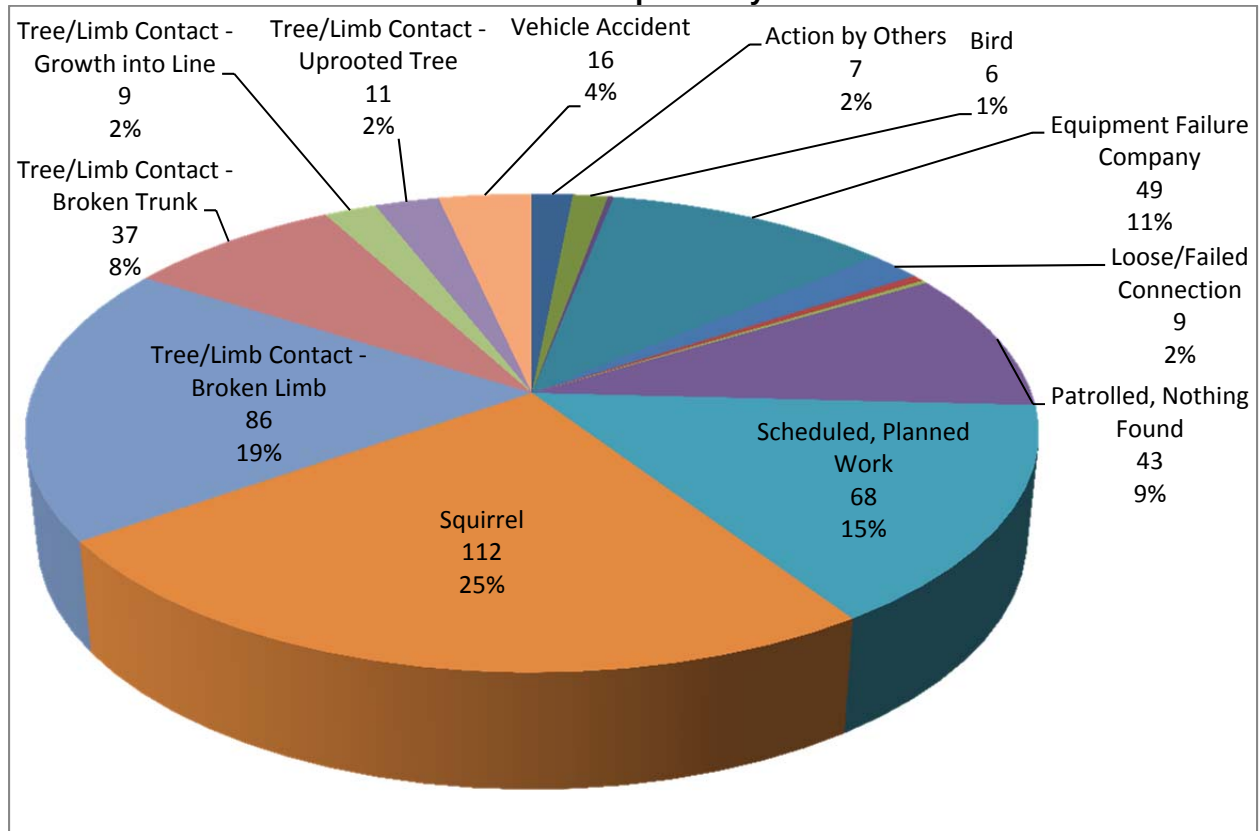
Chart 1
Number of Interruptions by Cause

This section provides a breakdown of all outages by cause code experienced during 2016. Chart 1 lists the number of interruptions, and the percent of total interruptions, due to each cause. For clarity, only those causes occurring more than 5 times are labeled. Chart 2 details the percent of total customer-minutes of interruption due to each cause, only those causes contributing greater than 2% of the total are labeled.

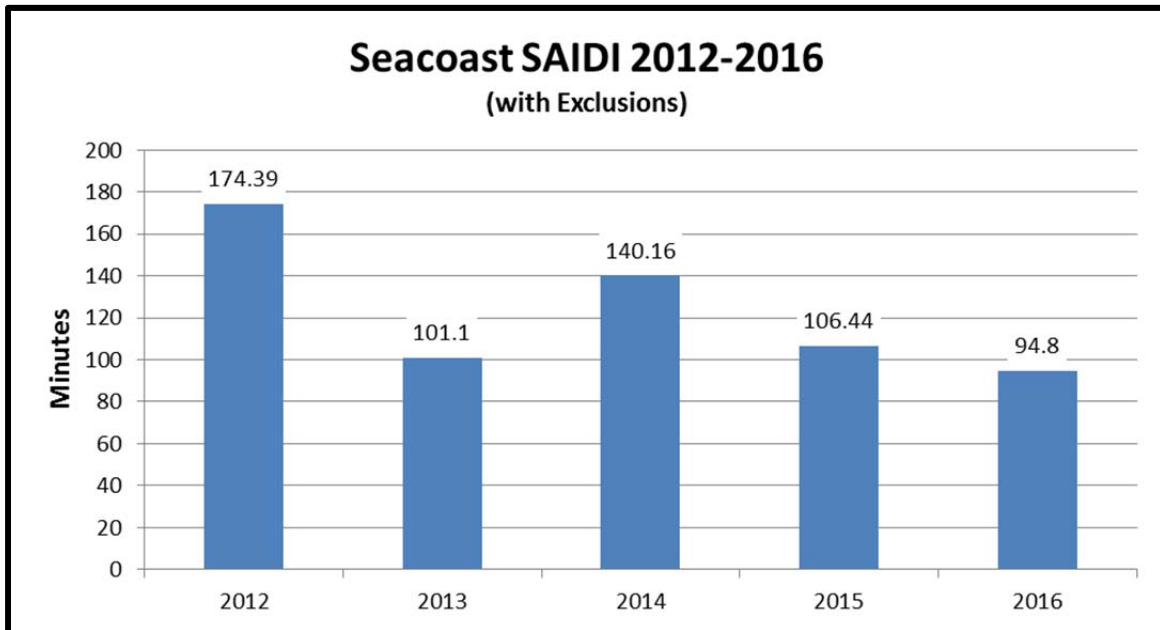
Chart 1
Annual UES-Seacoast SAIDI

UES-Seacoast SAIDI was 94.80 minutes in 2016 after removing all Major Event Days. Chart 1 below shows UES-Seacoast SAIDI over the past five years.
