Annual Reliability Report

2022 Report to the NH Public Utilities Commission

2022 Reliability Report

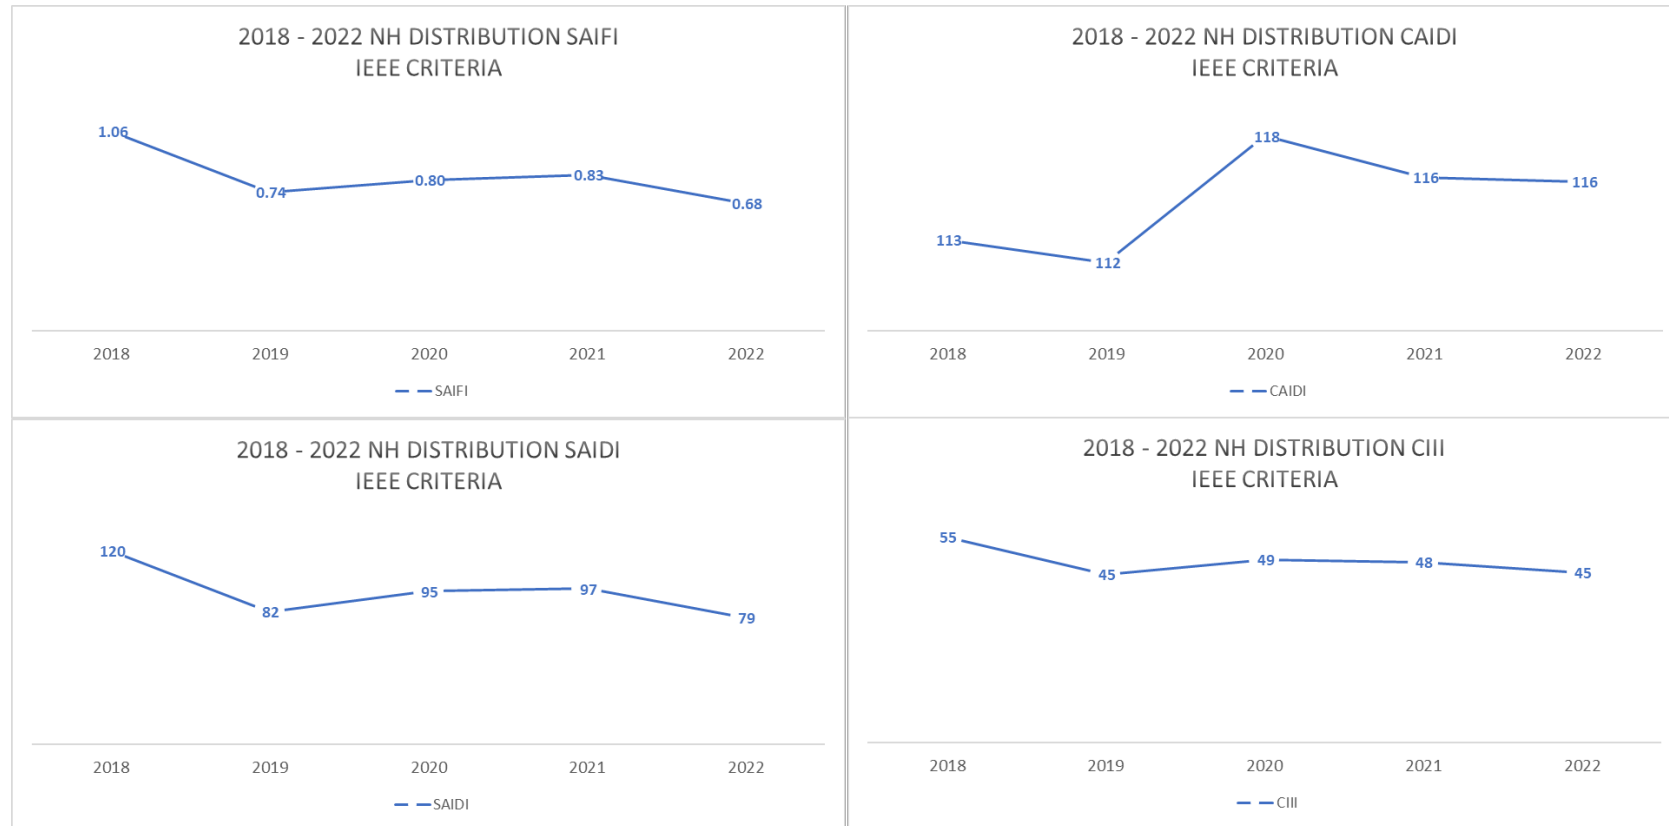
Section 1.1 SAIFI (frequency), SAIDI (minutes), CAIDI (minutes), CIII (# of customers) – Distribution System Only – IEEE Criteria

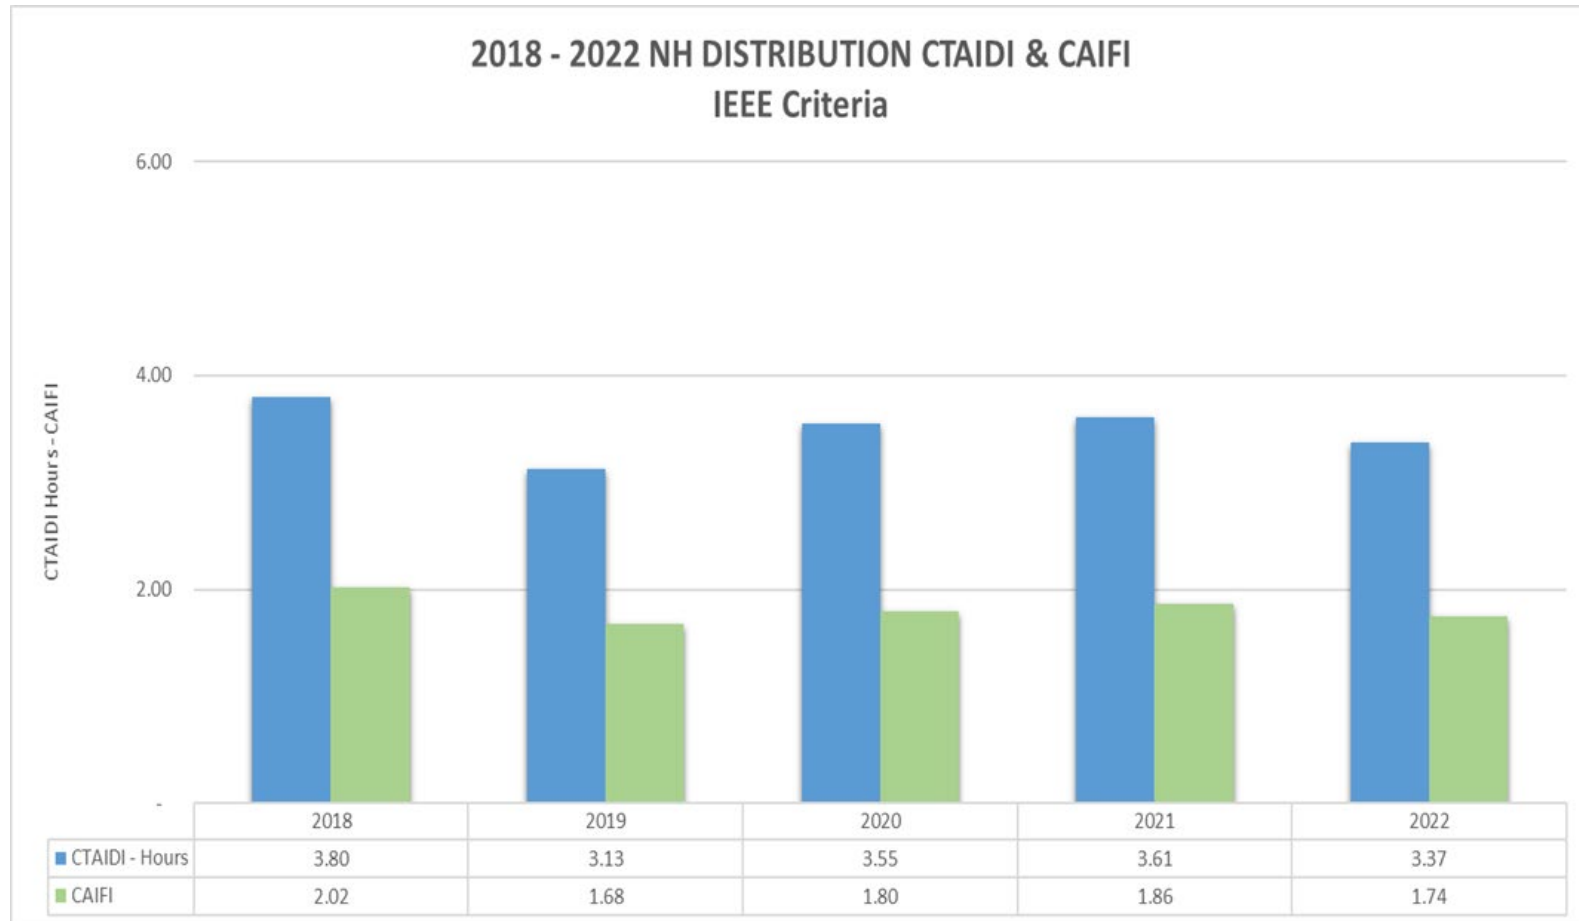
Section 1.2 CAIFI (frequency), CTAIDI (hours) – Distribution System Only – IEEE Criteria

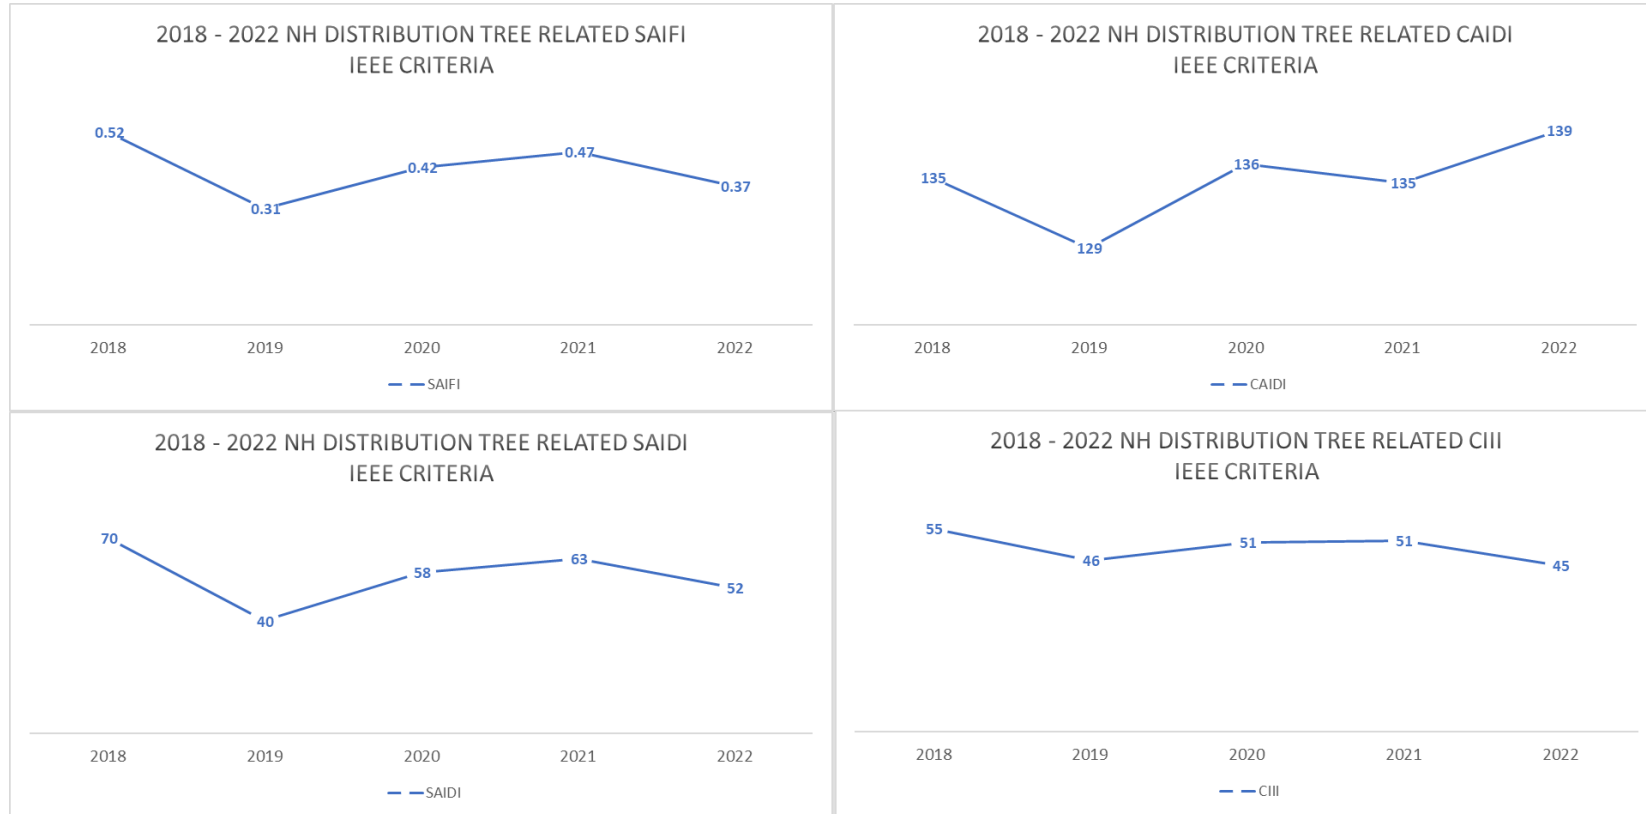
Section 1.3 SAIFI, SAIDI, CAIDI, CIII – Distribution System – Tree Related – IEEE Criteria

Section 1.3 depicts Eversource tree related statistics. The largest cause group for outages is trees and limbs, primarily from outside of the clearance area, therefore all four indices closely follow the total distribution system indices shown in Section 1.1. More than half of all tree related outages included in the reporting metrics occur during minor storm events and, therefore, tend to be longer duration outages. SAIDI, SAIFI and CIII showed improvement in 2022 compared to 2021, with CAIDI showing an uptick due to tree related outages during minor storms.

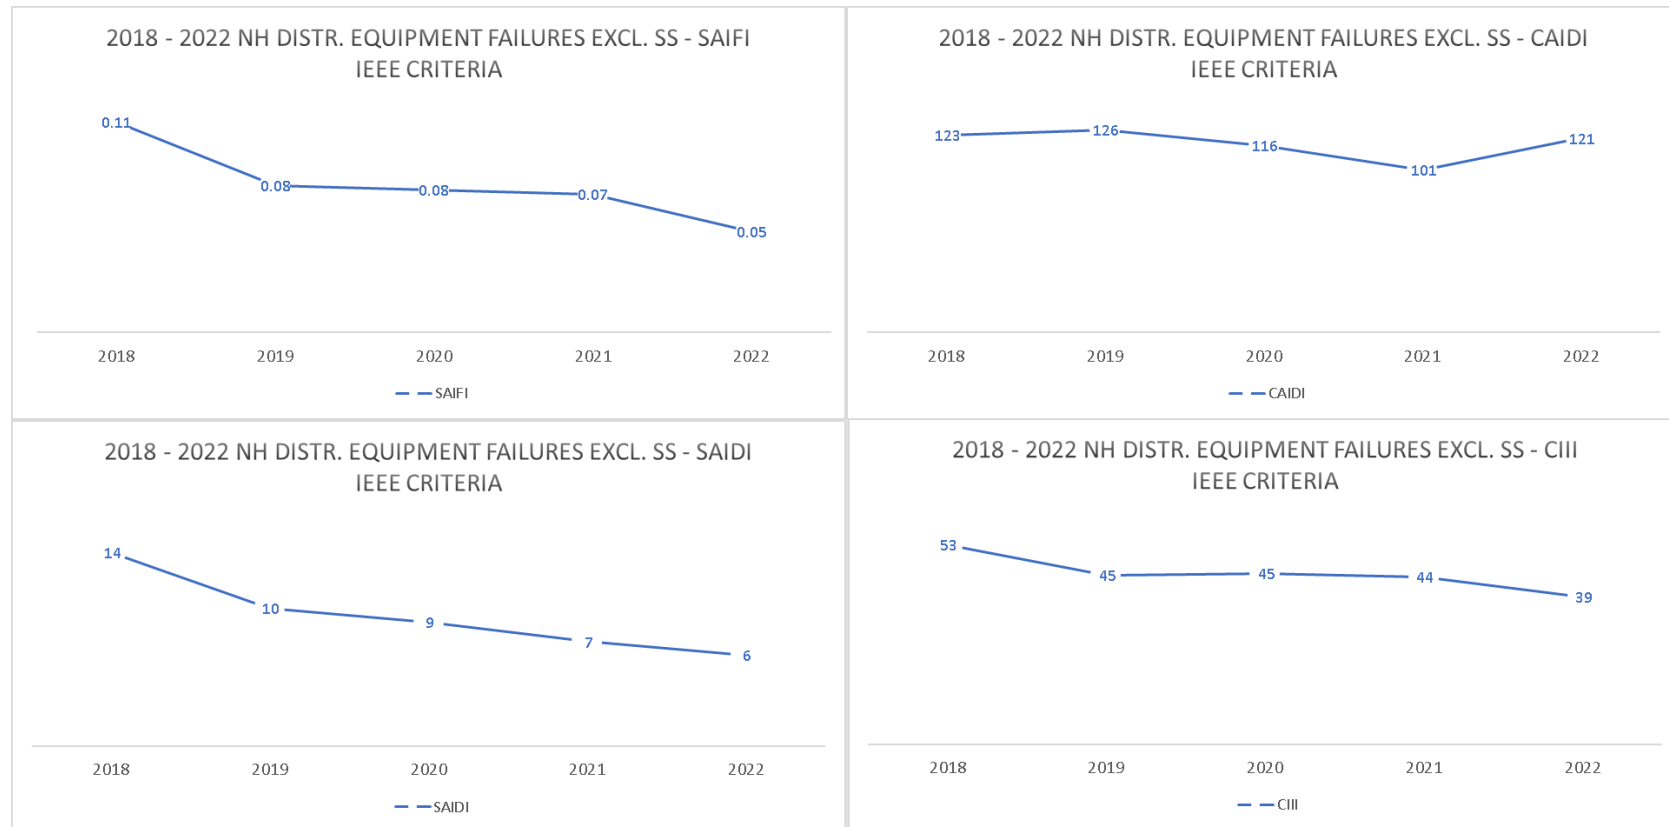
Section 1.4 SAIFI, SAIDI, CAIDI, CIII – Distribution (excluding Substation) Equipment Failures – IEEE Criteria

Section 1.4 shows Eversource equipment related statistics on the distribution system. These statistics exclude substation equipment, which are presented separately in the Section 1.5. Equipment failures were between the second and fourth leading cause contributors for SAIDI and SAIFI over the presented time frame. SAIFI, SAIDI and CIII all showed a downward trend over the reporting period.

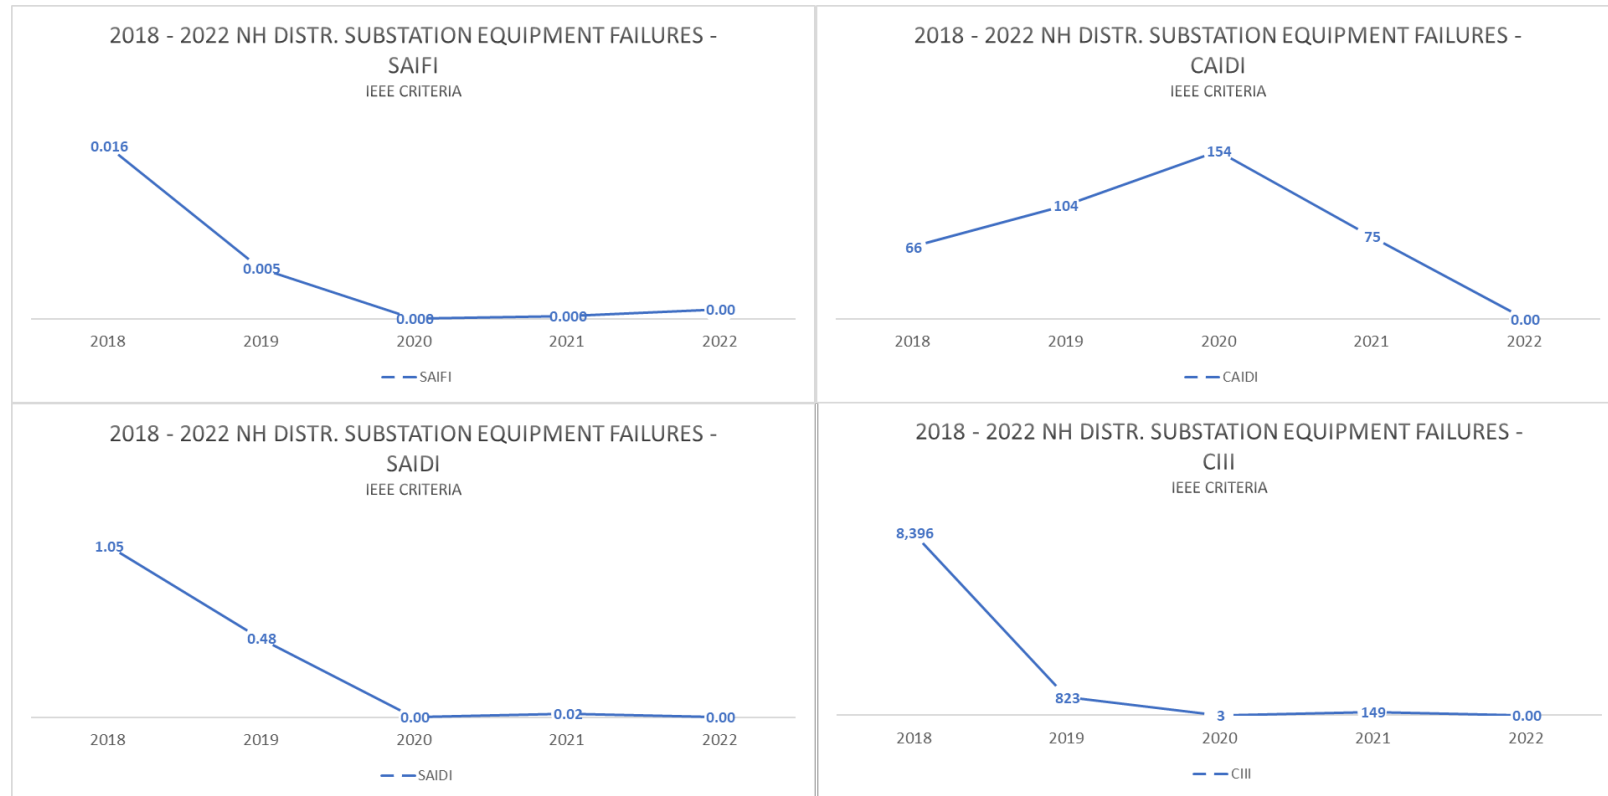
Section 1.5 SAIFI, SAIDI, CAIDI, CIII – Distribution Substation Equipment Failures - IEEE Criteria

Section 1.5 shows results for distribution substation equipment failures. Power outages caused by equipment failures inside substations typically affect many customers and can be long in duration. That said, the reliability impact from substation outages has been minimal over the presented time frame. There was no equipment failure event in 2022, compared to one in 2021, one in 2020, three in 2019 and one in 2018.

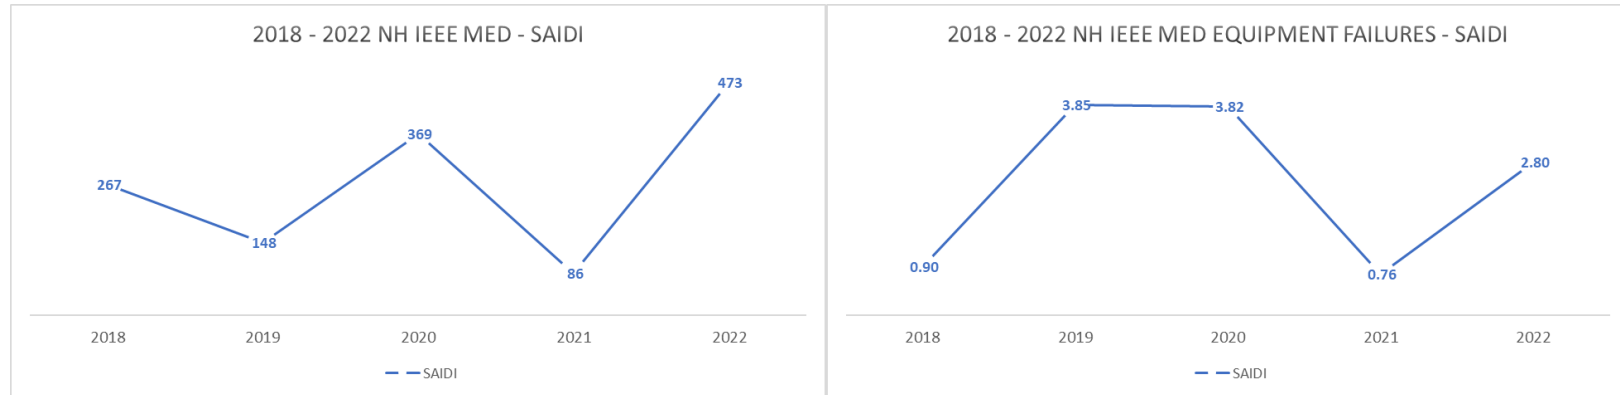
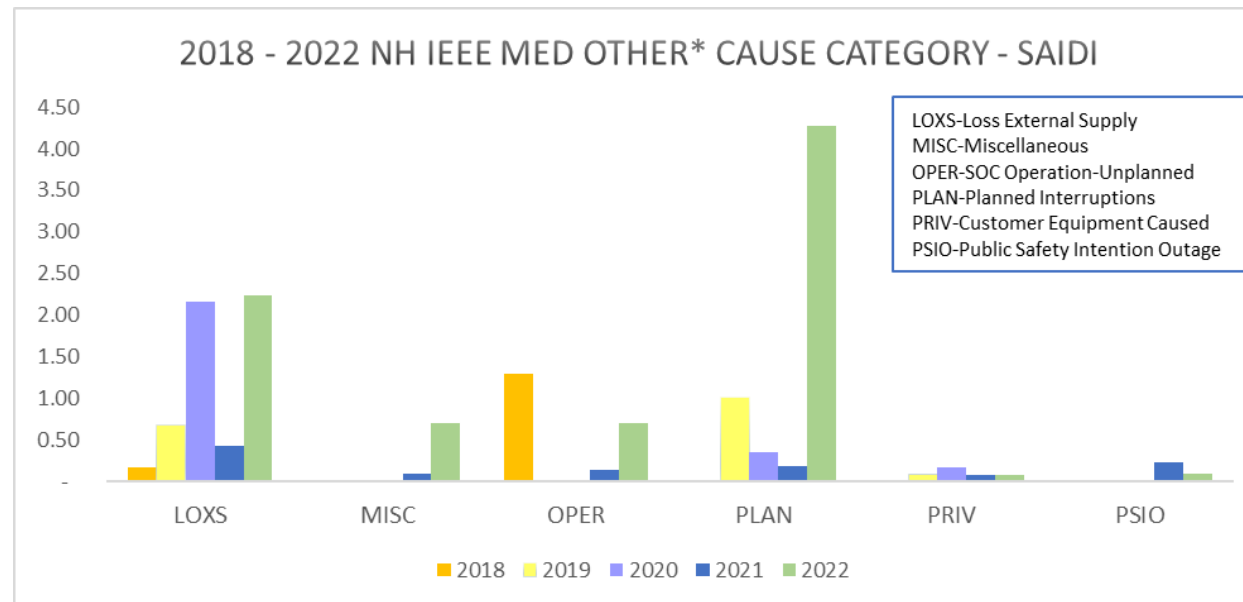
Section 1.6 SAIDI (IEEE MED) – Storm MED; Equipment Failure MED- Total System

Section 1.6 shows Total SAIDI and Equipment Failure SAIDI that occurred during IEEE MEDs. The reliability impact of these major storms is not included in Eversource statistics presented elsewhere.

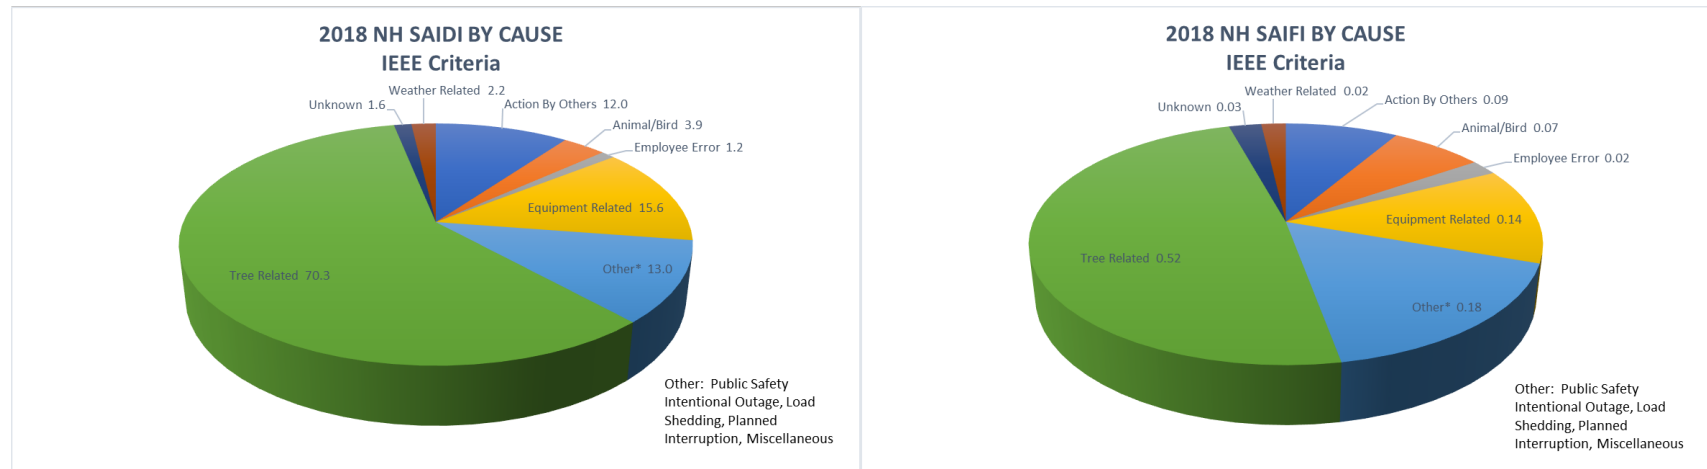
2018:

Section 1.7 SAIDI and SAIFI by Cause – Total System - IEEE Criteria

Cause	SAIDI
Tree Related	70.3
Equipment Related	15.6
Other	13.0
Action By Others	12.0
Animal/Bird	3.9
Weather Related	2.2
Unknown	1.6
Employee Error	1.2

Cause	SAIFI
Tree Related	0.52
Other	0.18
Equipment Related	0.14
Action By Others	0.09
Animal/Bird	0.07
Unknown	0.03
Employee Error	0.02
Weather Related	0.02

Section 1.7 shows SAIDI and SAIFI broken down by cause for each year 2018 through 2022. Tree related outages are the top driver of both statistics for the entire period, averaging 57 SAIDI minutes per year over the reporting period. Second, third and fourth places include Equipment Related, Action By Others and Other related outages. Outages due to equipment related causes averaged 10 SAIDI minutes per year. Action by Others, which includes causes such as motor vehicle accidents, customers and contractors digging into underground cables or felling trees on lines or vandalism, etc., averaged 10 SAIDI minutes per year. The "Other" category includes Public Safety Intentional Outages, Load Shedding, Planned Interruptions and Miscellaneous and averaged 12 SAIDI minutes per year over the reporting period.

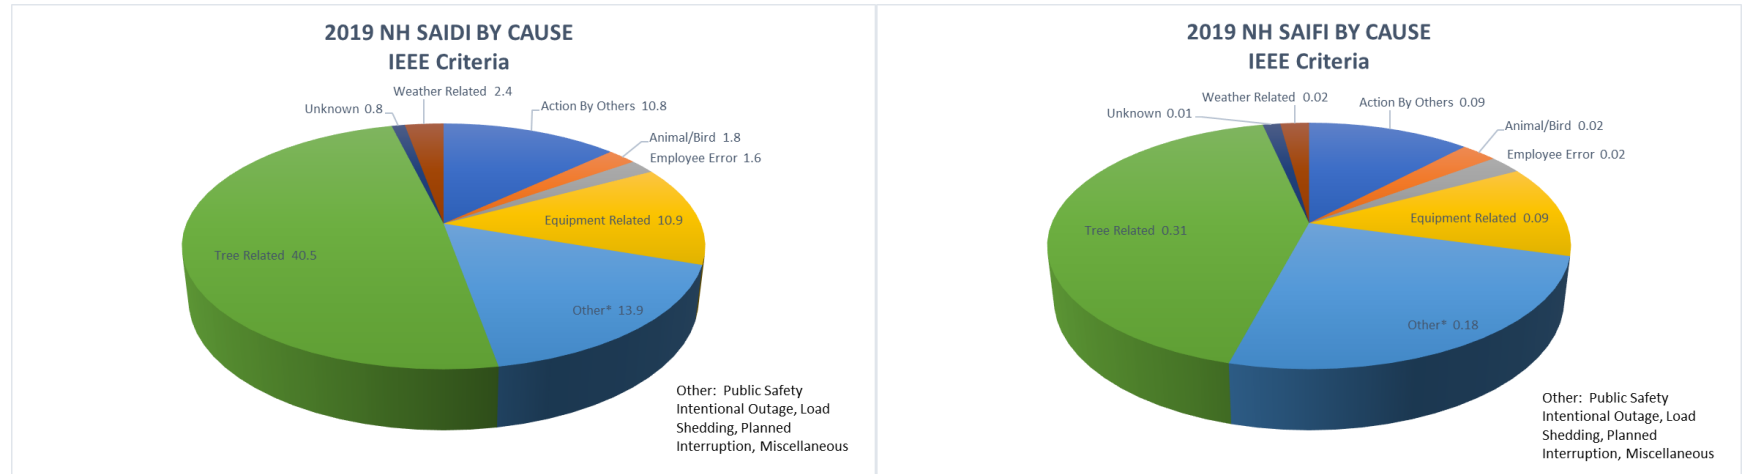
2019:

Section 1.7 cont'd SAIDI and SAIFI by Cause – Total System - IEEE Criteria

Cause	SAIDI
Tree Related	40.5
Other	13.9
Equipment Related	10.9
Action By Others	10.8
Weather Related	2.4
Animal/Bird	1.8
Employee Error	1.6
Unknown	0.8

Cause	SAIFI
Tree Related	0.31
Other	0.18
Action By Others	0.09
Equipment Related	0.09
Animal/Bird	0.02
Employee Error	0.02
Weather Related	0.02
Unknown	0.01

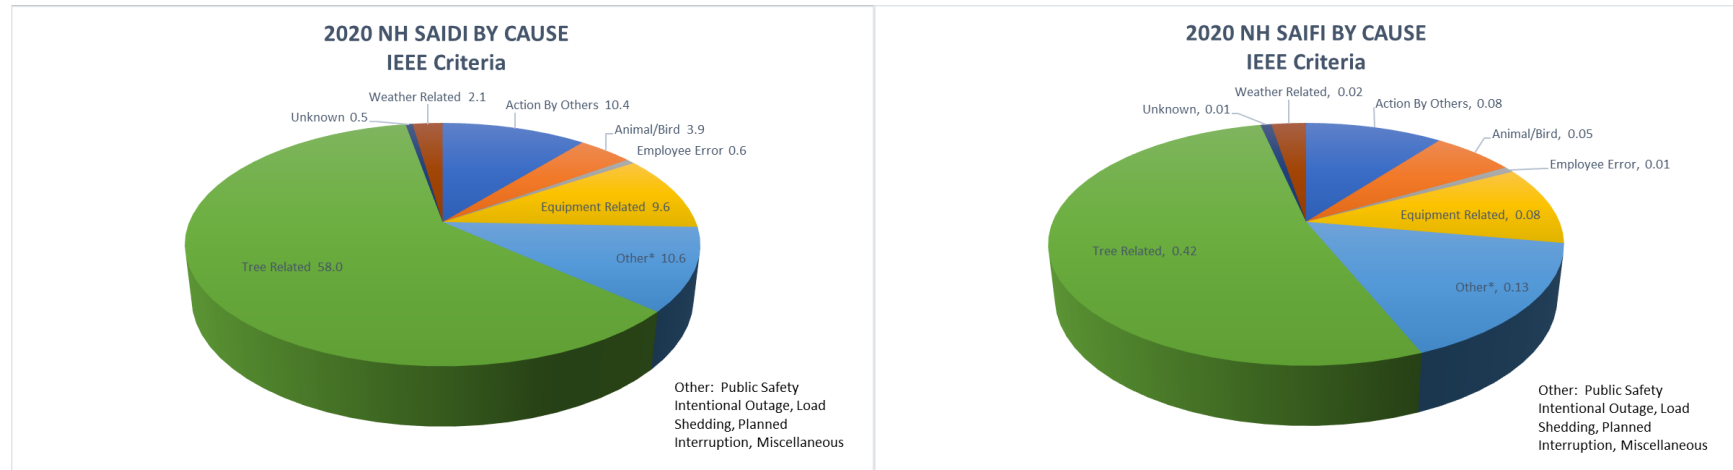
2020:

Section 1.7 cont'd SAIDI and SAIFI by Cause – Total System - IEEE Criteria

Cause	SAIDI
Tree Related	58.0
Other	10.6
Action By Others	10.4
Equipment Related	9.6
Animal/Bird	3.9
Weather Related	2.1
Employee Error	0.6
Unknown	0.5

Cause	SAIFI
Tree Related	0.42
Other	0.13
Action By Others	0.08
Equipment Related	0.08
Animal/Bird	0.05
Weather Related	0.02
Employee Error	0.01
Unknown	0.01

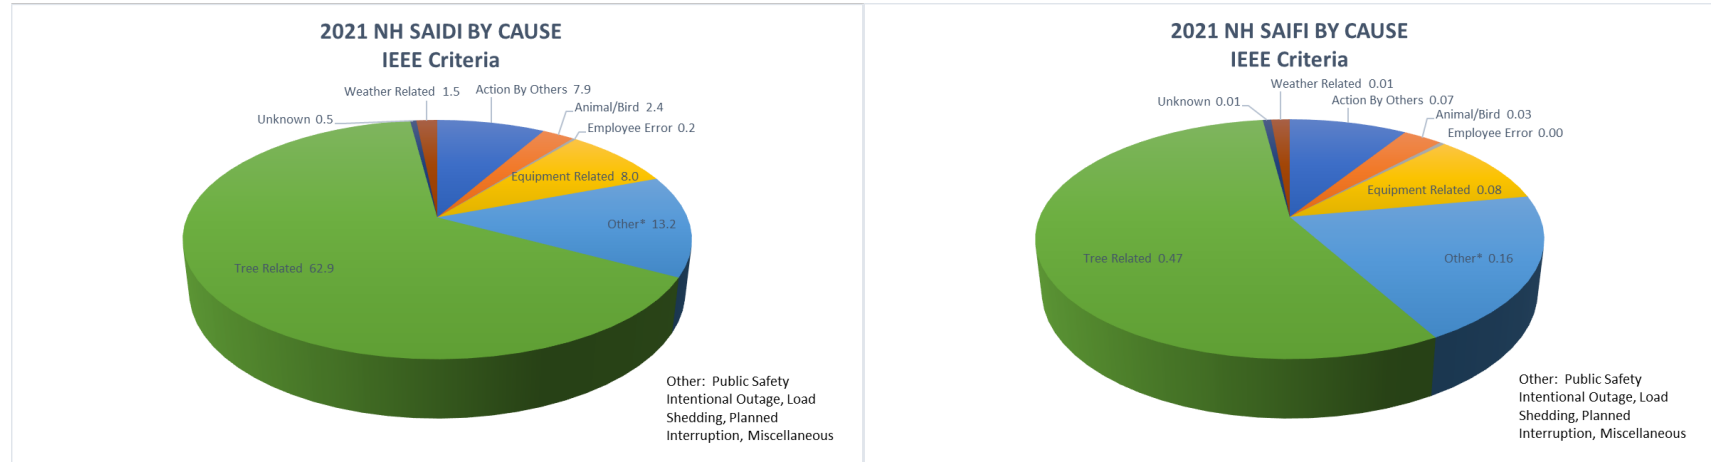
2021:

Section 1.7 cont'd SAIDI and SAIFI by Cause – Total System - IEEE Criteria

Cause	SAIDI
Tree Related	62.9
Other	13.2
Equipment Related	8.0
Action By Others	7.9
Animal/Bird	2.4
Weather Related	1.5
Unknown	0.5
Employee Error	0.2

Cause	SAIFI
Tree Related	0.47
Other	0.16
Equipment Related	0.08
Action By Others	0.07
Animal/Bird	0.03
Weather Related	0.01
Unknown	0.01
Employee Error	0.00

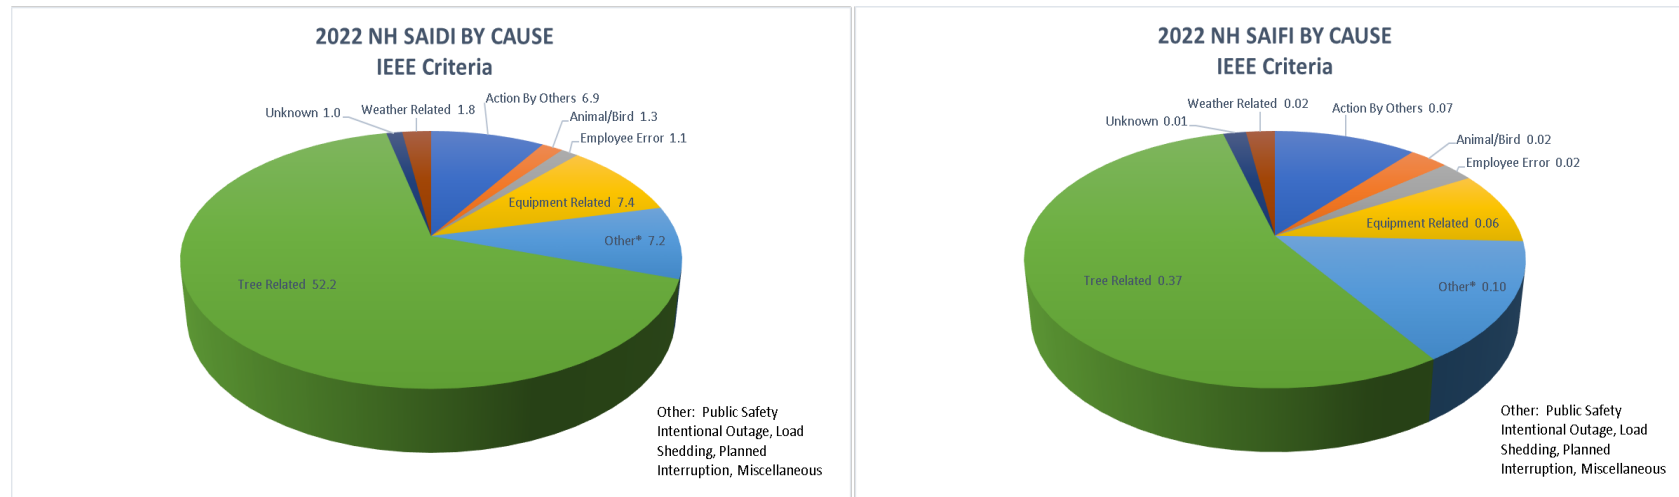
2022:

Section 1.7 cont'd SAIDI and SAIFI by Cause – Total System - IEEE Criteria

Cause	SAIDI
Tree Related	52.0
Equipment Related	7.4
Other	7.2
Action By Others	6.9
Weather Related	1.8
Animal/Bird	1.3
Employee Error	1.1
Unknown	1.0

Cause	SAIFI
Tree Related	0.37
Other	0.10
Action By Others	0.07
Equipment Related	0.06
Animal/Bird	0.02
Employee Error	0.02
Weather Related	0.02
Unknown	0.01
