Annual Reliability Report

2022 Report to the NH Public Utilities Commission

March 1, 2023

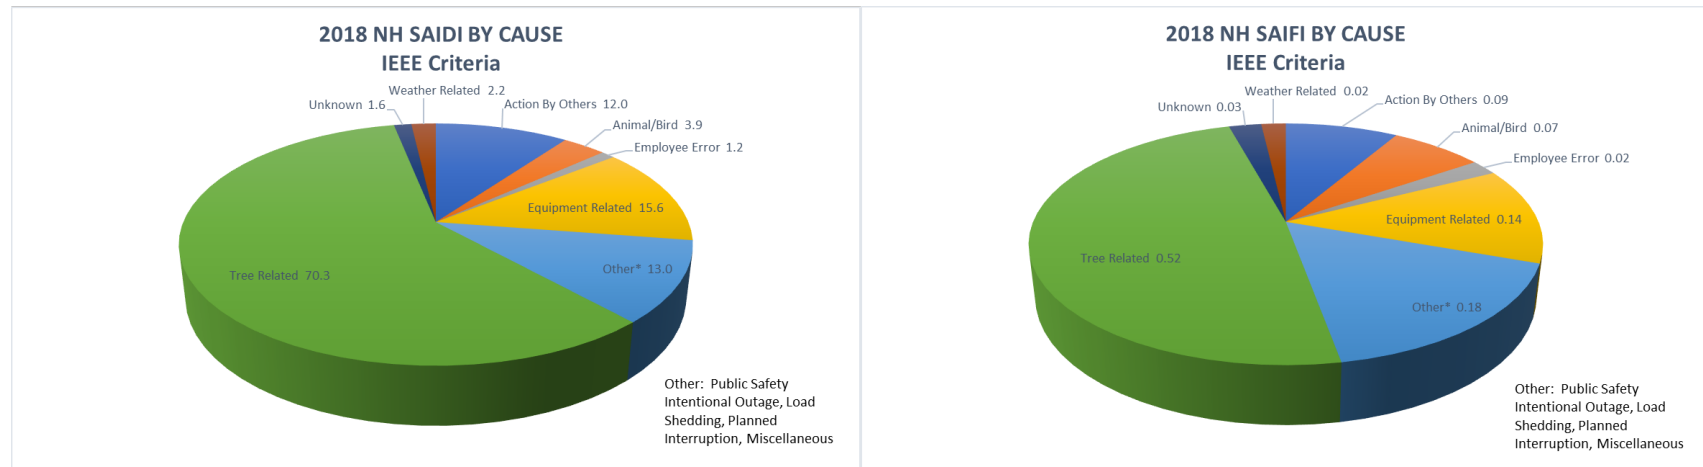
2018:

Section 1.7 SAIDI and SAIFI by Cause – Total System - IEEE Criteria

Section 1.7 shows SAIDI and SAIFI broken down by cause for each year 2018 through 2022. Tree related outages are the top driver of both statistics for the entire period, averaging 57 SAIDI minutes per year over the reporting period. Second, third and fourth places include Equipment Related, Action By Others and Other related outages. Outages due to equipment related causes averaged 10 SAIDI minutes per year. Action by Others, which includes causes such as motor vehicle accidents, customers and contractors digging into underground cables or felling trees on lines or vandalism, etc., averaged 10 SAIDI minutes per year. The "Other" category includes Public Safety Intentional Outages, Load Shedding, Planned Interruptions and Miscellaneous and averaged 12 SAIDI minutes per year over the reporting period.

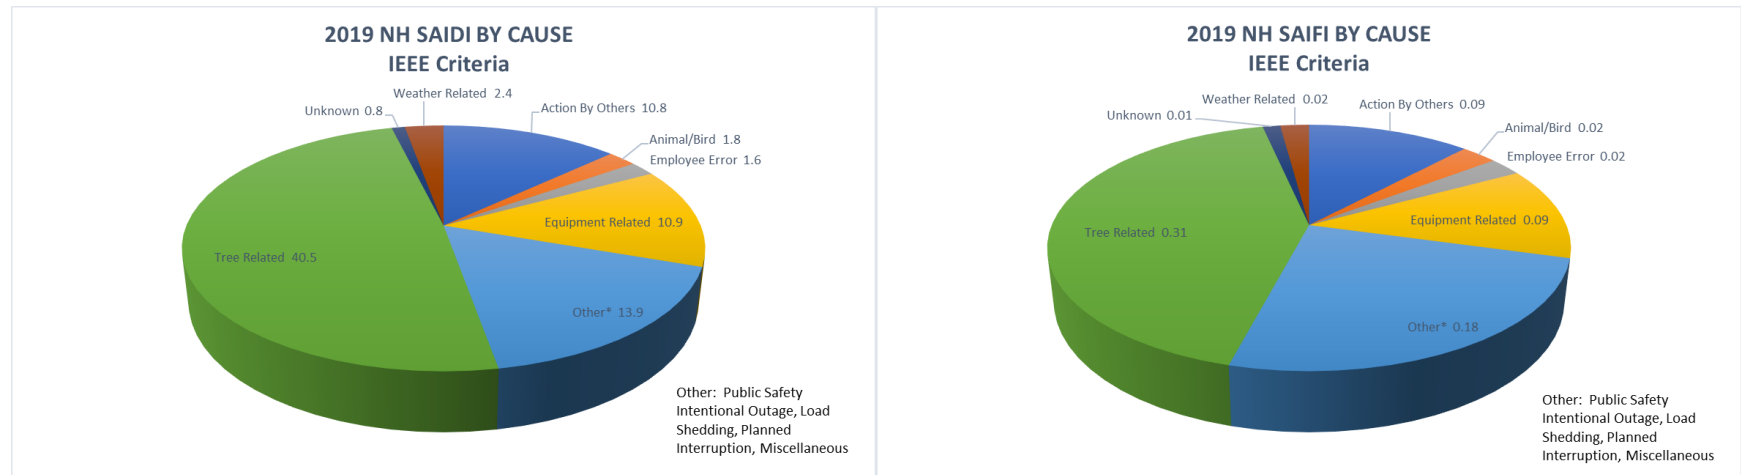
2019:

Section 1.7 cont'd SAIDI and SAIFI by Cause – Total System - IEEE Criteria

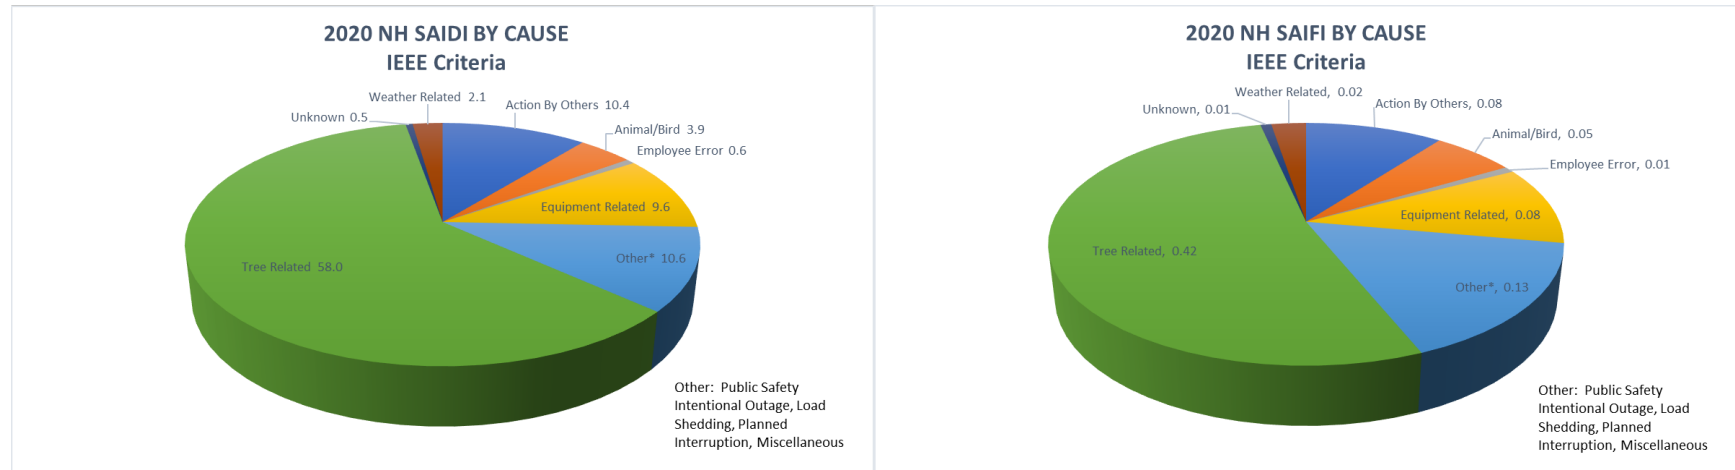
2020:

Section 1.7 cont'd SAIDI and SAIFI by Cause – Total System - IEEE Criteria

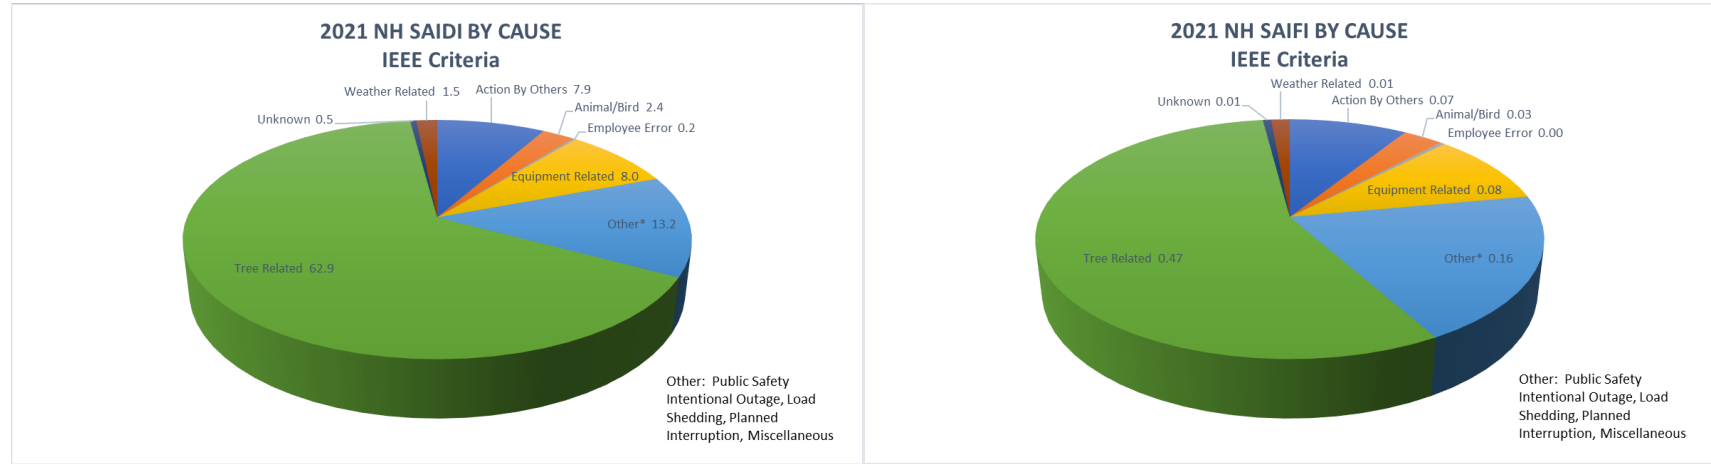
2021:

Section 1.7 cont'd SAIDI and SAIFI by Cause – Total System - IEEE Criteria
