History of Eversource X-178 structures.

In 1985 the X-178 1 & 2 were replaced by PSNH:

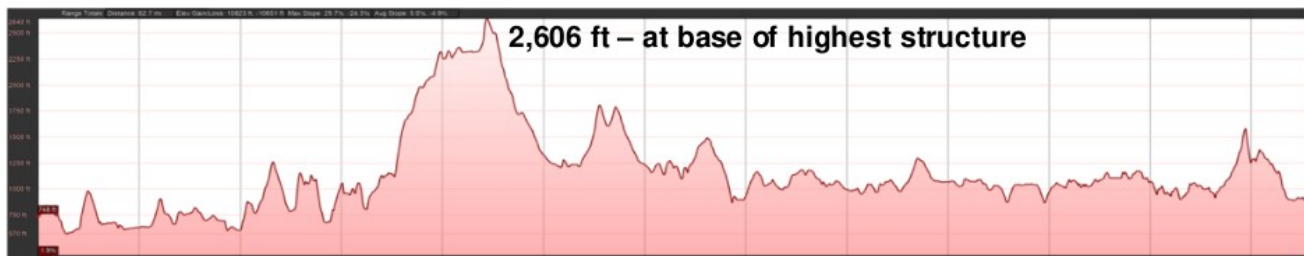
Elevation profile along route

None of these replacements were on Section 2 where the line reaches its highest elevation.
