WHS - APPENDIX A

Recommendation No. 2012-1:

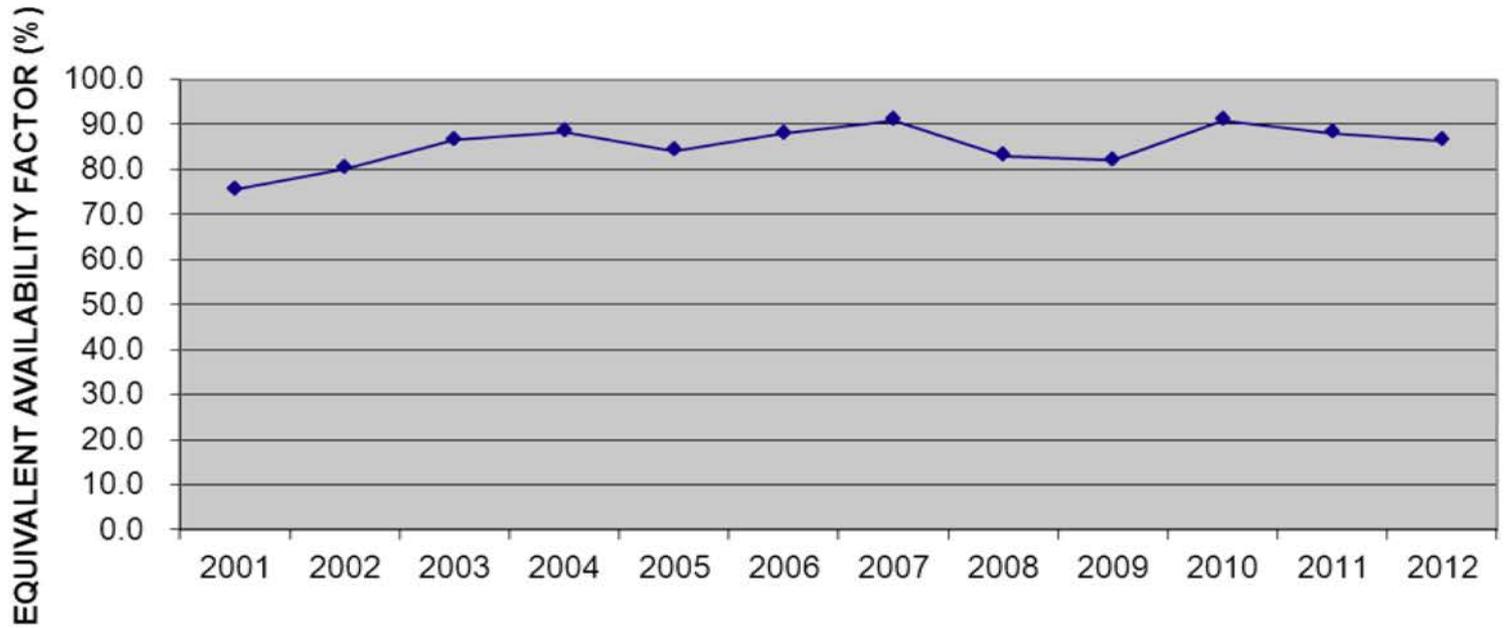
PSNH FOSSIL SYSTEM WEIGHTED EAF 2012

Unit	Month(s)
Merrimack 1	Sept-Oct
Merrimack 2	Oct-Nov
Newington	Apr
Schiller 5	Mar-Apr
