New Hampshire December 2008 Ice Storm Assessment Report

October 28, 2009

NEI ELECTRIC POWER ENGINEERING

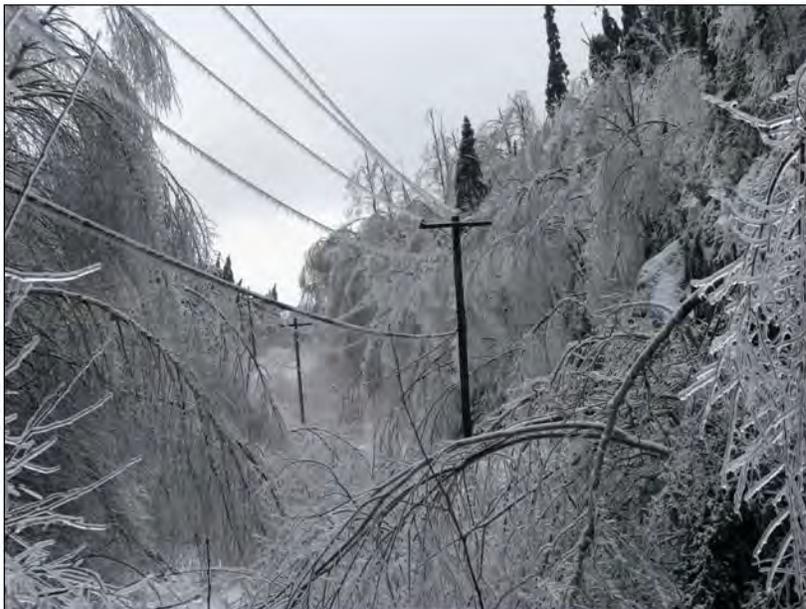
Figure I-2 – Damage in PSNH distribution line corridor.
(Photo courtesy of PSNH. Exact location unknown.)

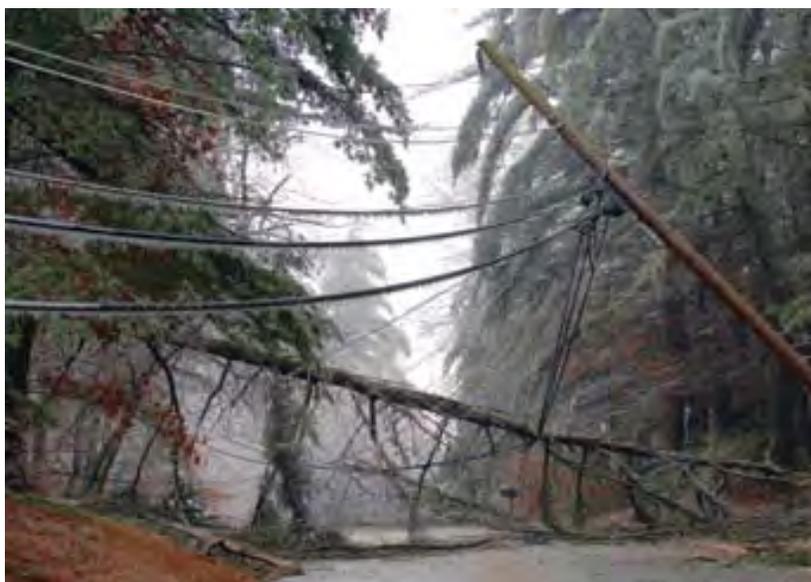
The restoration of power was a long and difficult process due to the record amount of damage to the power system. In addition, ice and tree covered roads, as seen in Figure I-3, made the initial damage assessments difficult and time consuming, and hampered repair crews trying to enter damaged areas. The ice storm was followed by two snow events 4 days and 7 days later during the restoration period that further hampered the restoration of power outages. At the peak of the outage there were nearly a half-million customers without power in New Hampshire.¹ The storm

Figure I-3 - Impassable roads due to ice damage in Londonderry, NH
(Photo courtesy of PSNH)

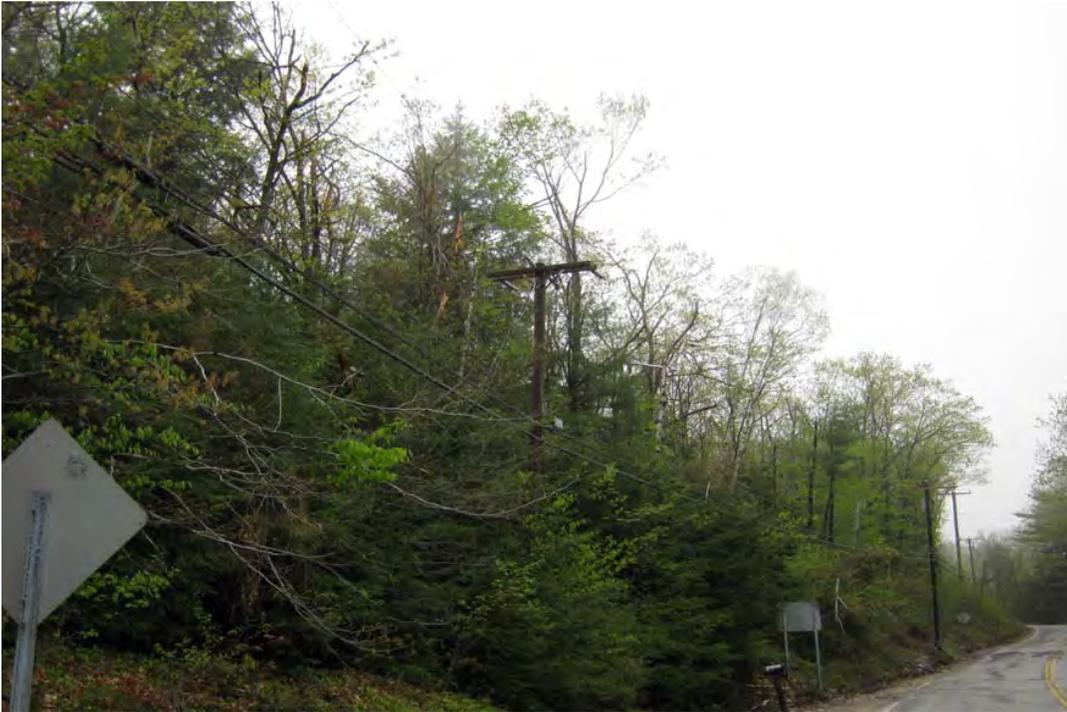
**Figure IV-5 -Typical PSNH distribution circuit near Greenville, New Hampshire.
(Photo by NEI - PSNH System)**

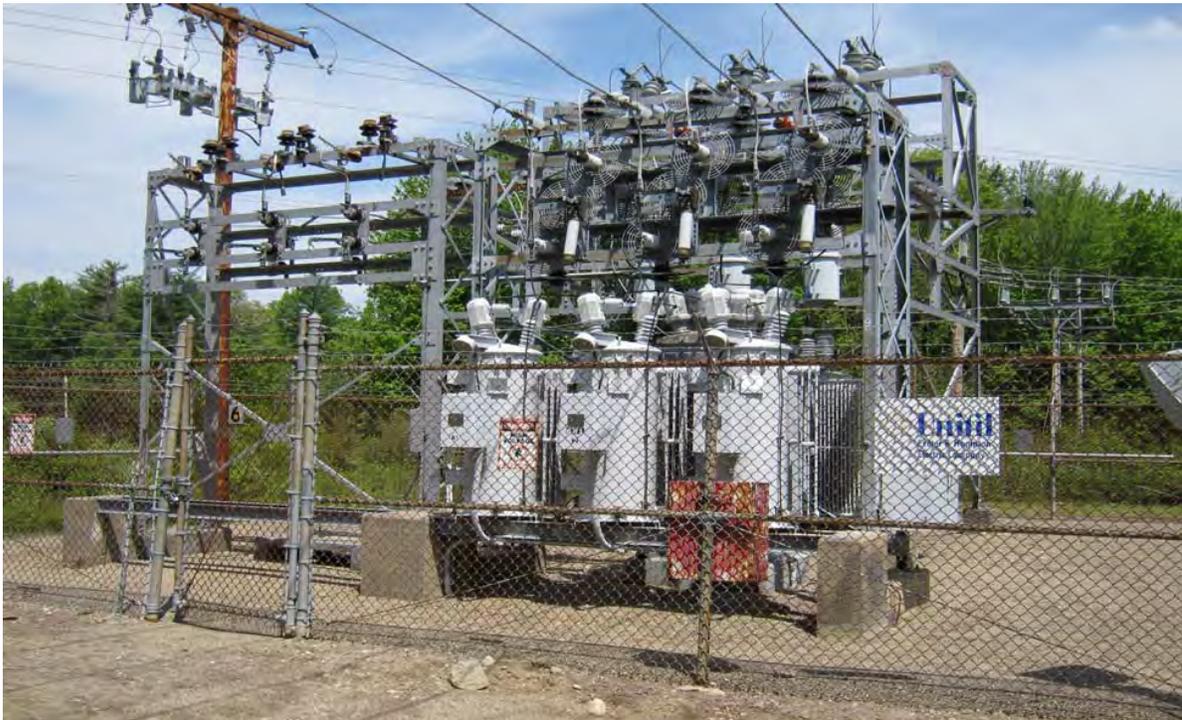
Figure IV-6 – 34.5kV to 13.8kV Unitil electric distribution substation located in East Kingston, New Hampshire. (Photo by NEI-Unitil System)

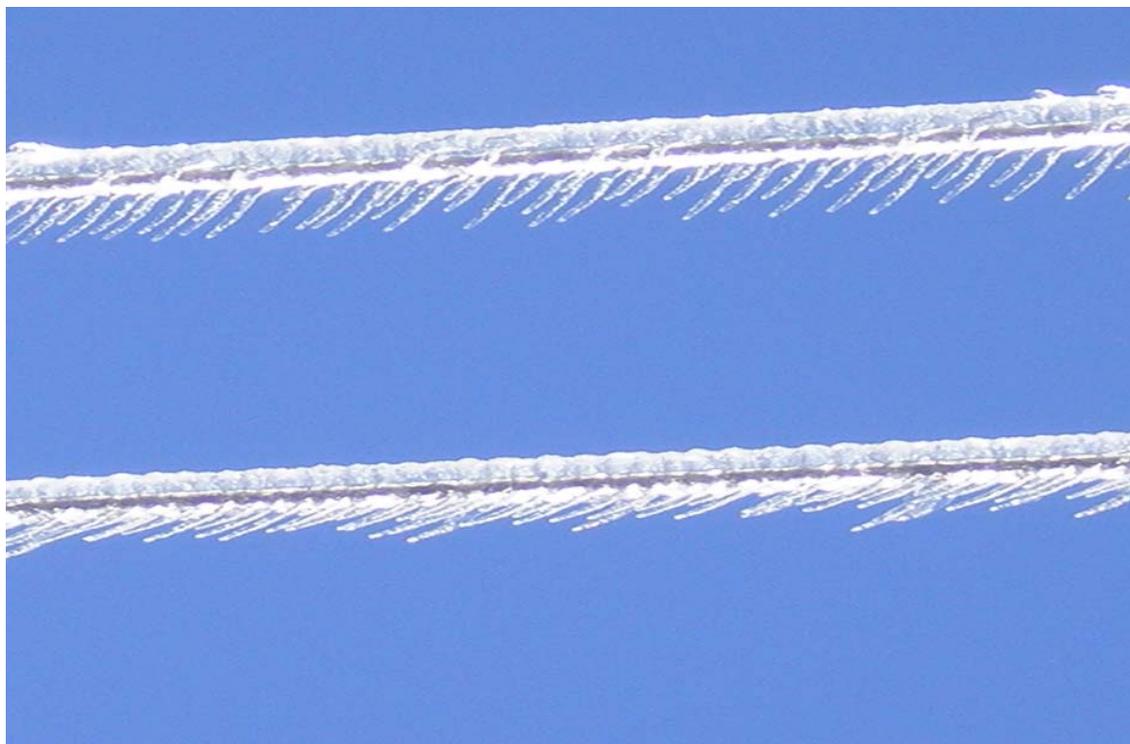
Figure IV-10 - Close-up of ice shown in Figure IV-9. (Photo courtesy of PSNH)

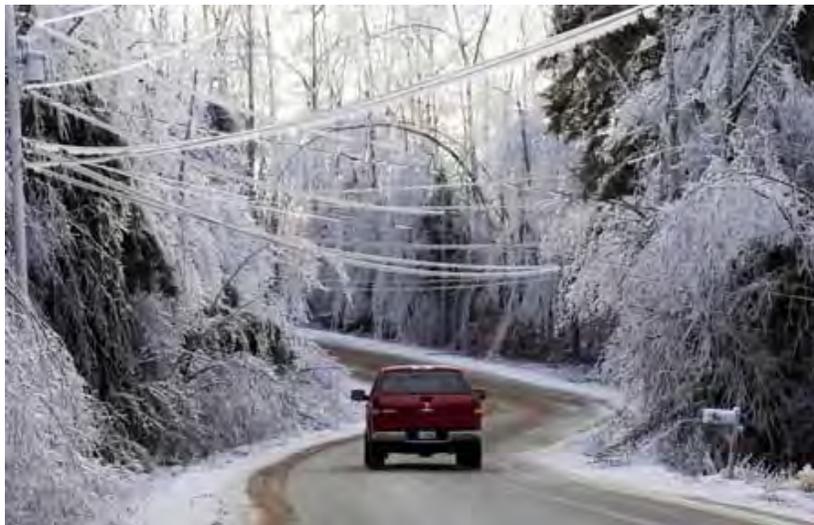
**Figure V-2 - Ice loading on lines during December 2008 ice storm.
(Photo courtesy of PSNH, location unknown.)**

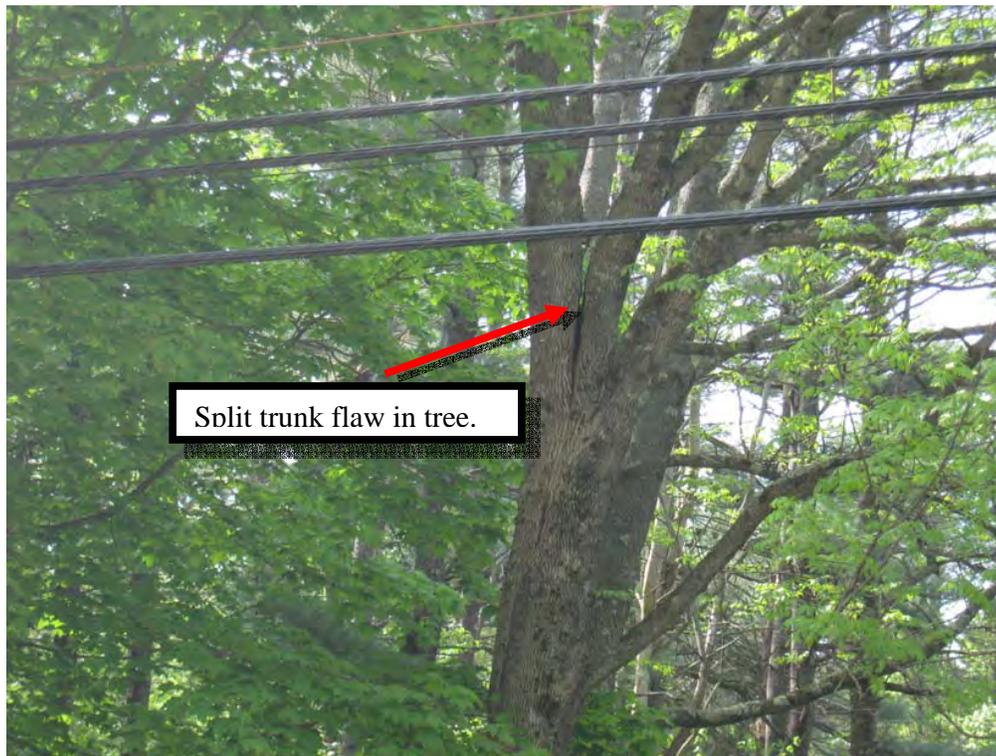
Figure V-4 - Neglected damage and weakness to large limb of tree near Hampton, NH. (Photo by NEI)

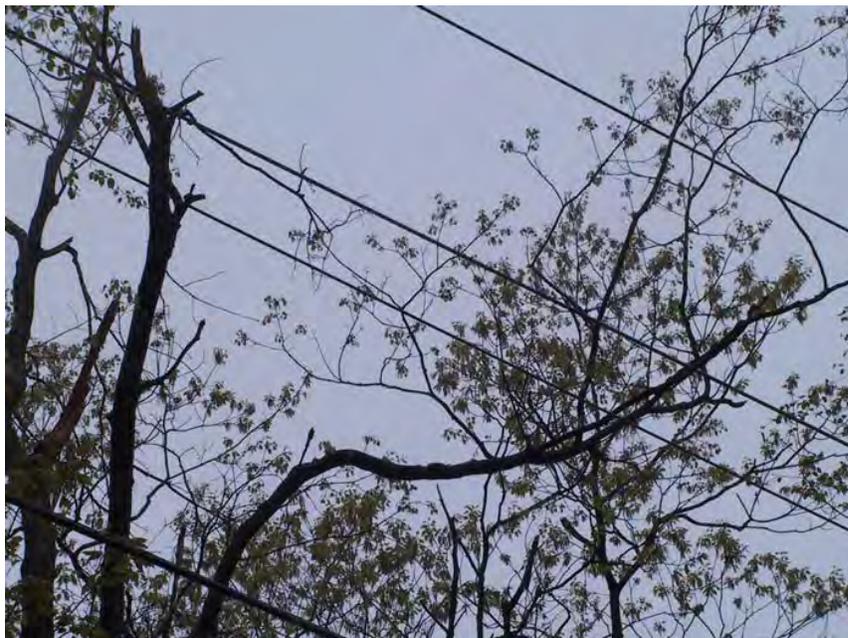
Figure V-5 - Small diameter immature trees broken above conductors in New Ipswich, NH. (Photo by NEI)

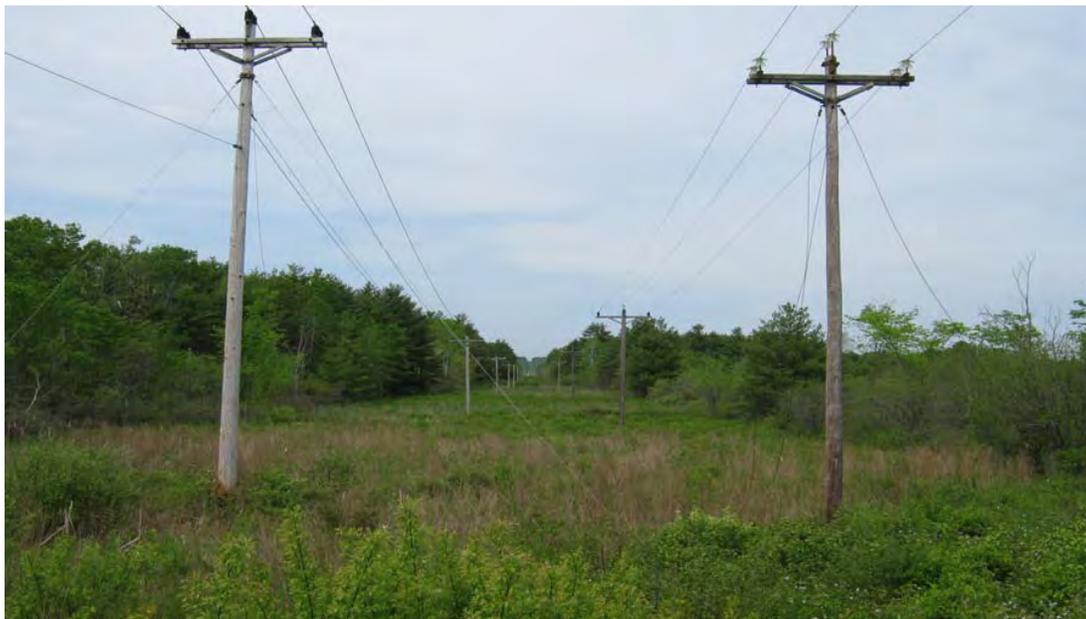
under this circuit is insufficient and if not improved could result in the trees growing into the lines or major damage if a fire were to occur in the ROW.

Figure V-9 - Example of 34.5 kV Unitil sub-transmission line ROW. (Photo by NEI)

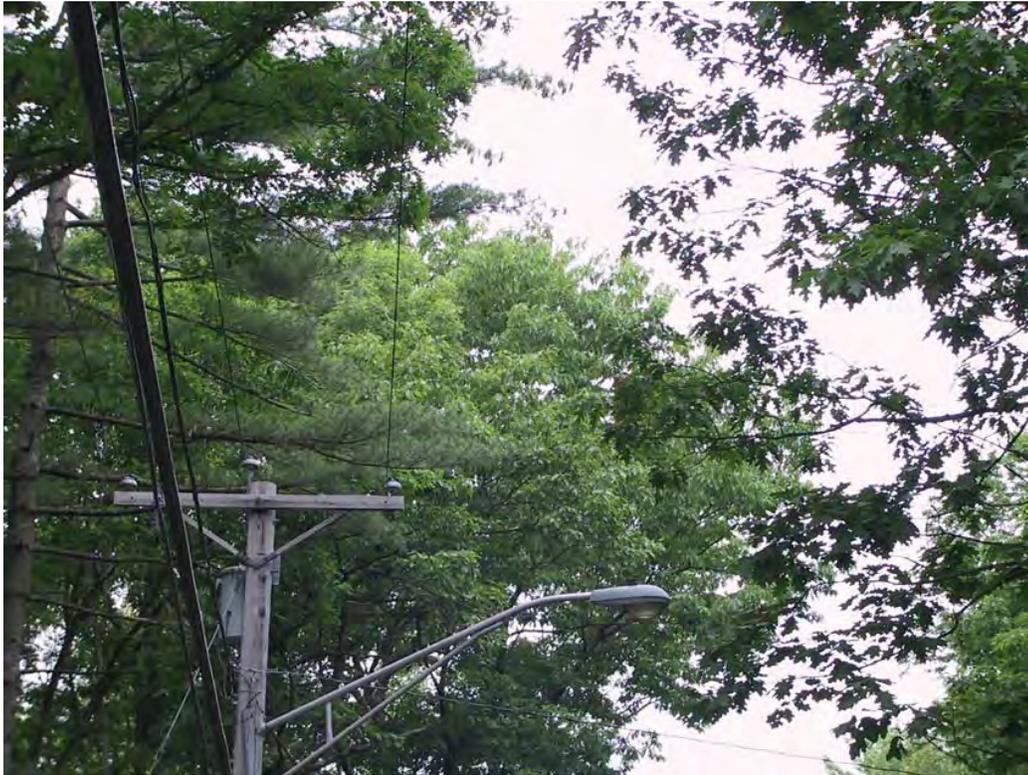
Figure V-13 - White pine recently trimmed in Pelham, New Hampshire. (Photo by NEI)

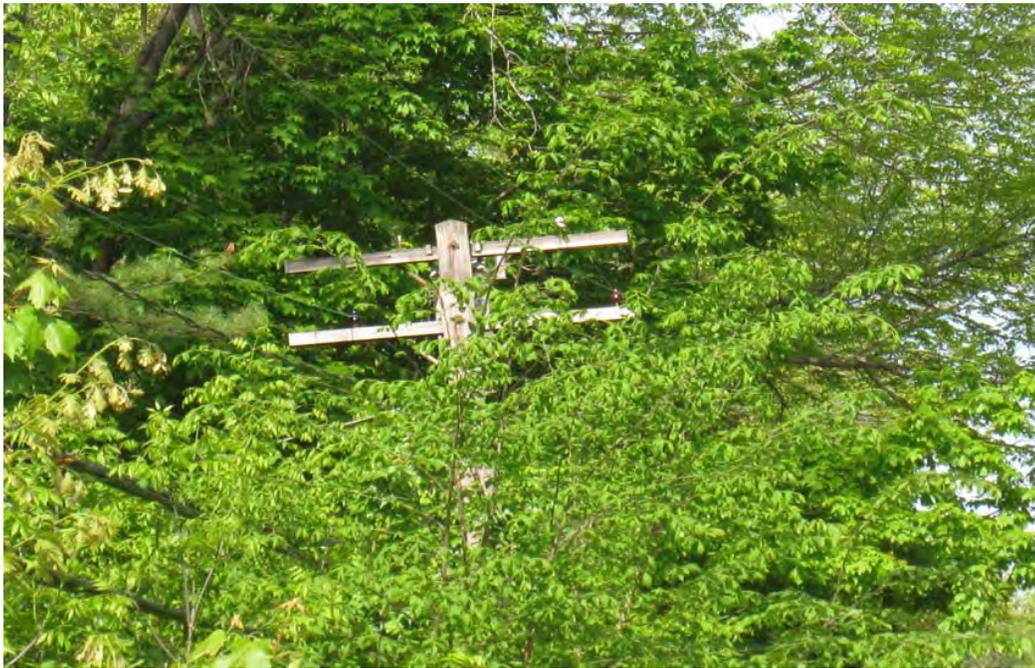
This growth is unsafe, violates the NESC, and is possibly damaging the conductors. While this photograph was taken on Unutil's system, it is not meant to single out Unutil. Similar situations occur on the systems of each utility.

Figure V-14 – NESC Rule 218 violation in Unutil service area.

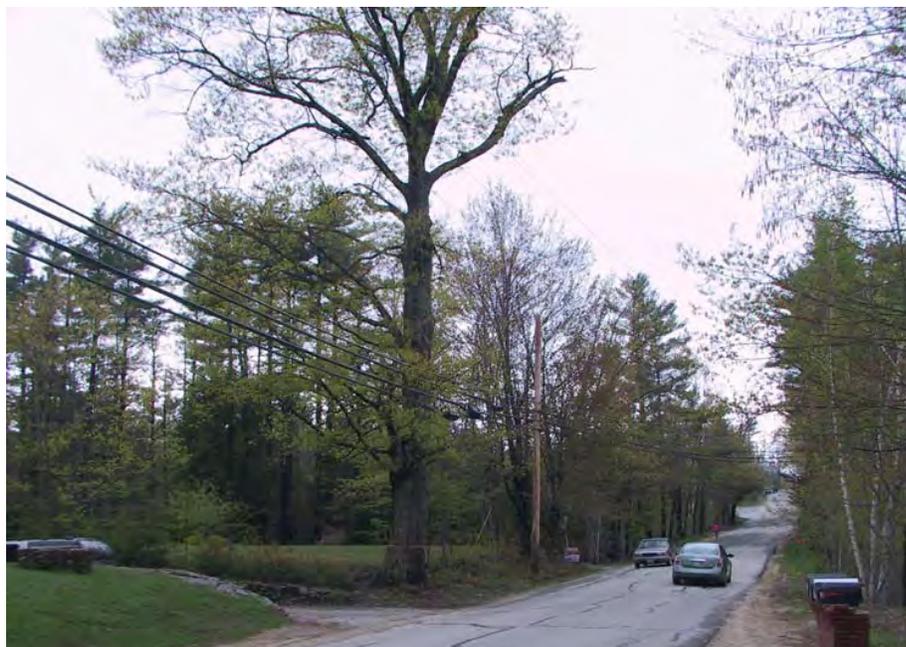
equipment most utilities have available. This particular tree was marked for removal as a "hazard tree." However, this was not done merely due to its proximity to the power line. In New Hampshire, placing the line at risk is not sufficient cause for a tree to be labeled as a hazard. To be classified as a hazard tree, it must also be either infected or dying in addition to its proximity to the line. Within the state, there are many large healthy trees which pose a hazard to power lines and should be considered for removal.

Figure V-15 - Mature oak to be removed in New Ipswich, New Hampshire. (Photo by NEI)

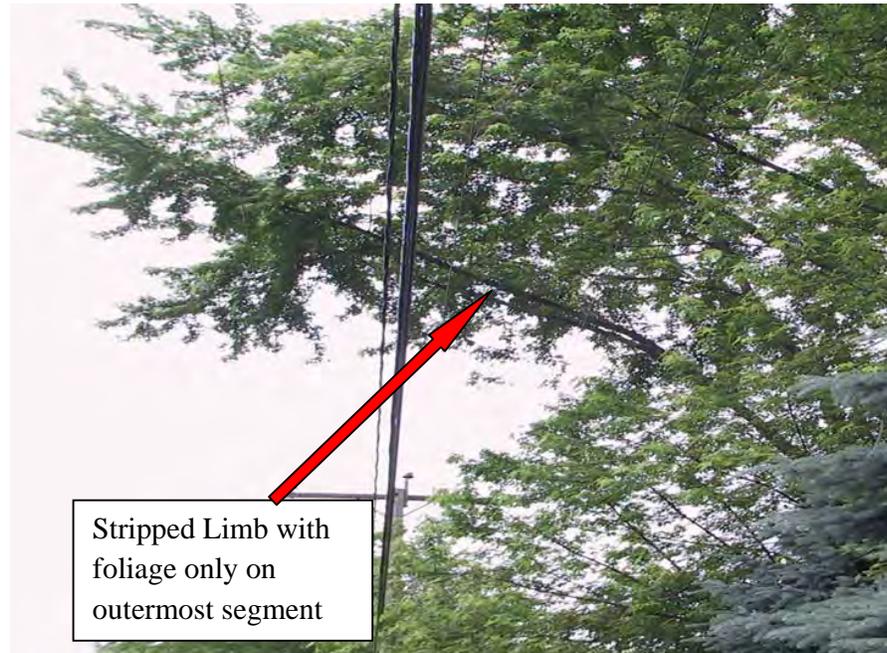
- The utility's trimmers should not strip foliage and side limbs from the part of the branch nearest the trunk and leave foliage at the outermost end of the branch. This practice, called "lion-tailing" and illustrated in Figure VII-1, leads to excess weight at the end of limbs and the reduction of limb diameter over time.

Figure VII-1 - Example of "lion-tailing." (Photo by NEI)

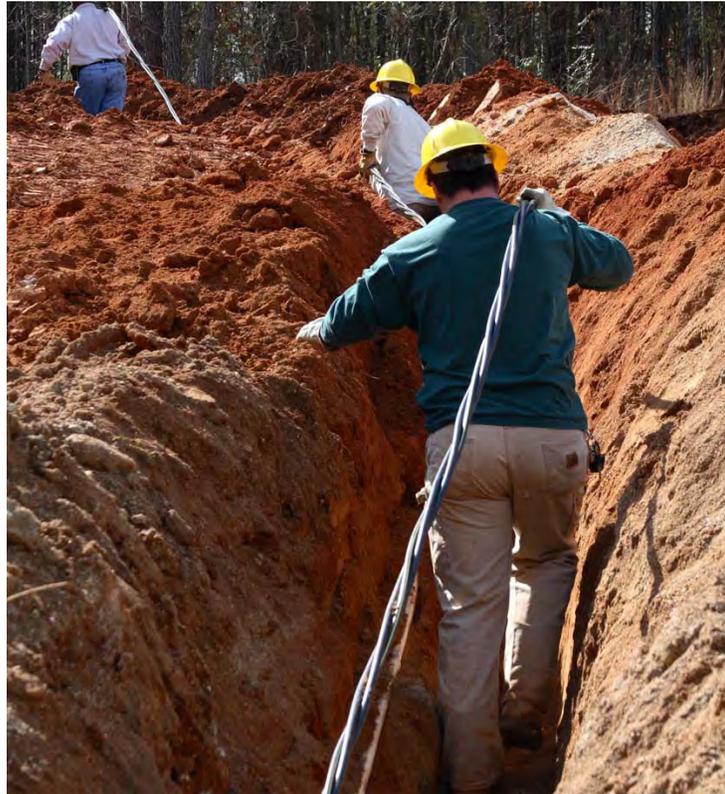
Figure B-2-Installing direct buried cable. (Photo courtesy of Southwire)

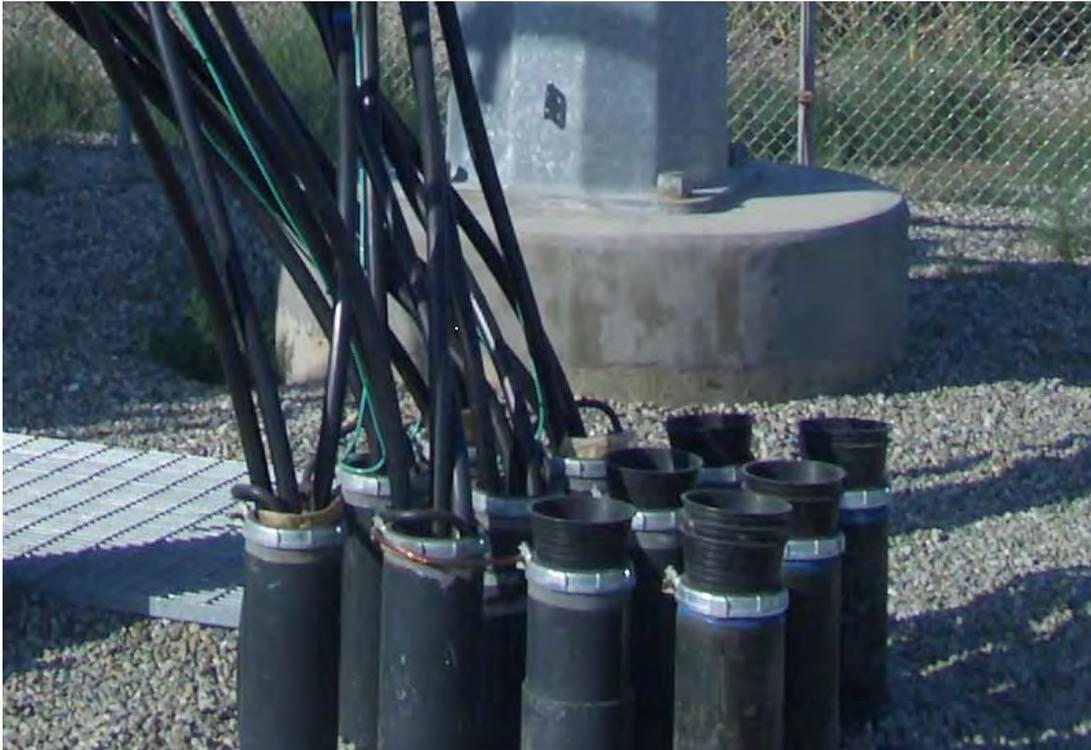
Figure B-3 – Typical underground conduit and cable. (Photo by NEI)

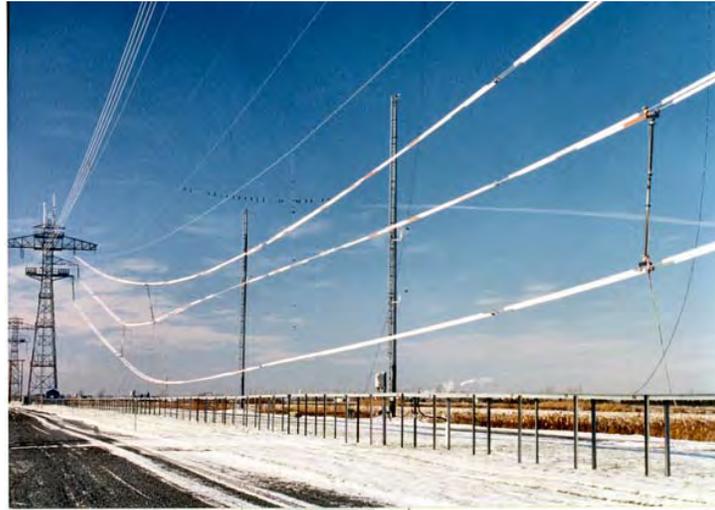
Figure F-9-Excessive sag as a result of galloping. (Photo courtesy of CIGRE)
