**DOCKET NO. DE 19-057**  
**REQUEST FOR PERMANENT RATES**

**REBUTTAL TESTIMONY OF**  
**ROBERT D. ALLEN and WILLIAM A. VAN DAM**

***Vegetation Management***

# New Hampshire December 2008 Ice Storm Assessment Report

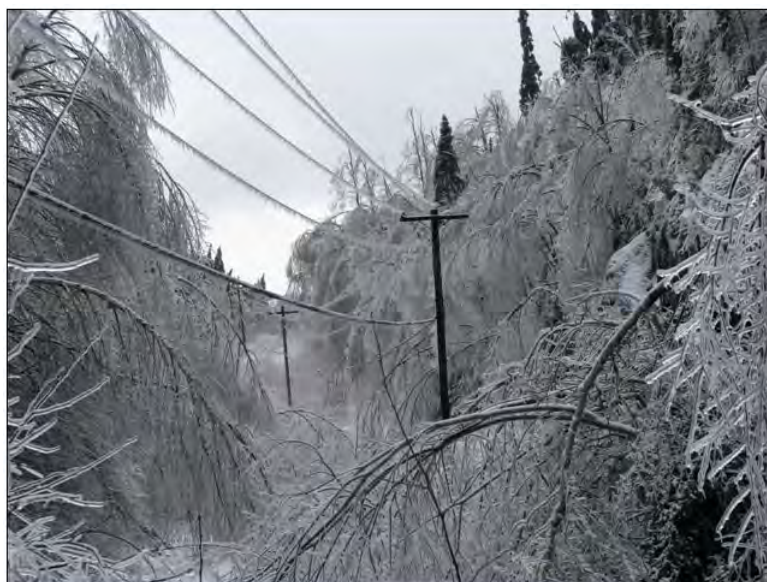
**Figure I-2 – Damage in PSNH distribution line corridor.**  
(Photo courtesy of PSNH. Exact location unknown.)

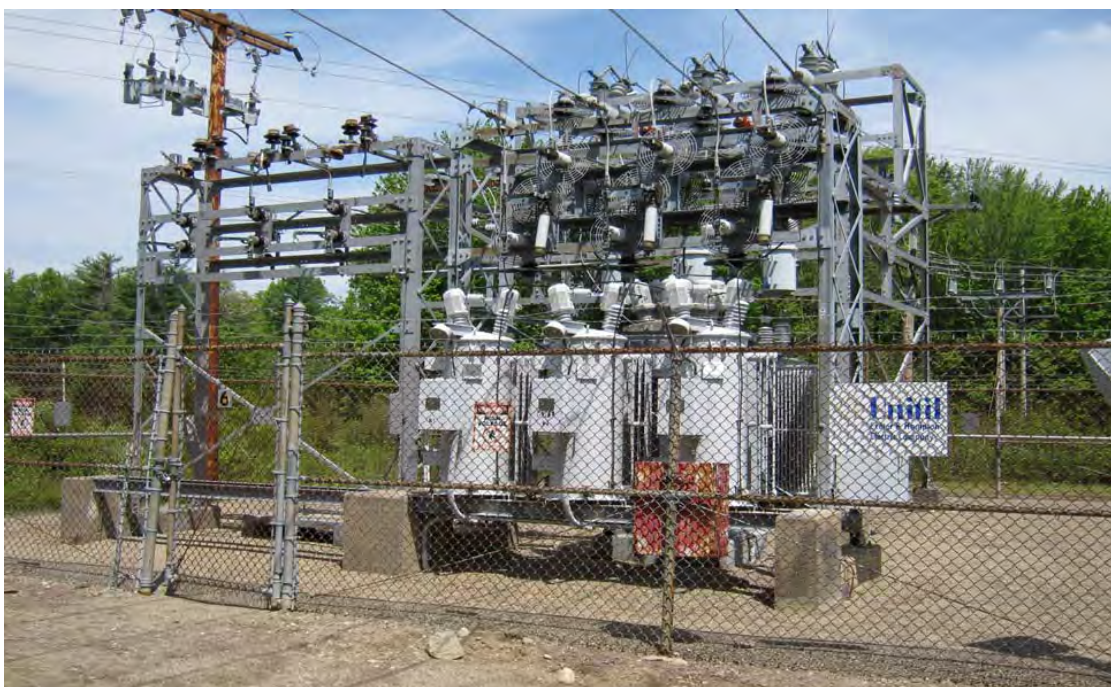
**Figure IV-6 – 34.5kV to 13.8kV Unitil electric distribution substation located in East Kingston, New Hampshire. (Photo by NEI-Unitil System)**

- Electric outgoing distribution circuits complete with metering and circuit protection as circuit breakers or reclosers
- A substation fence for safety and security purposes

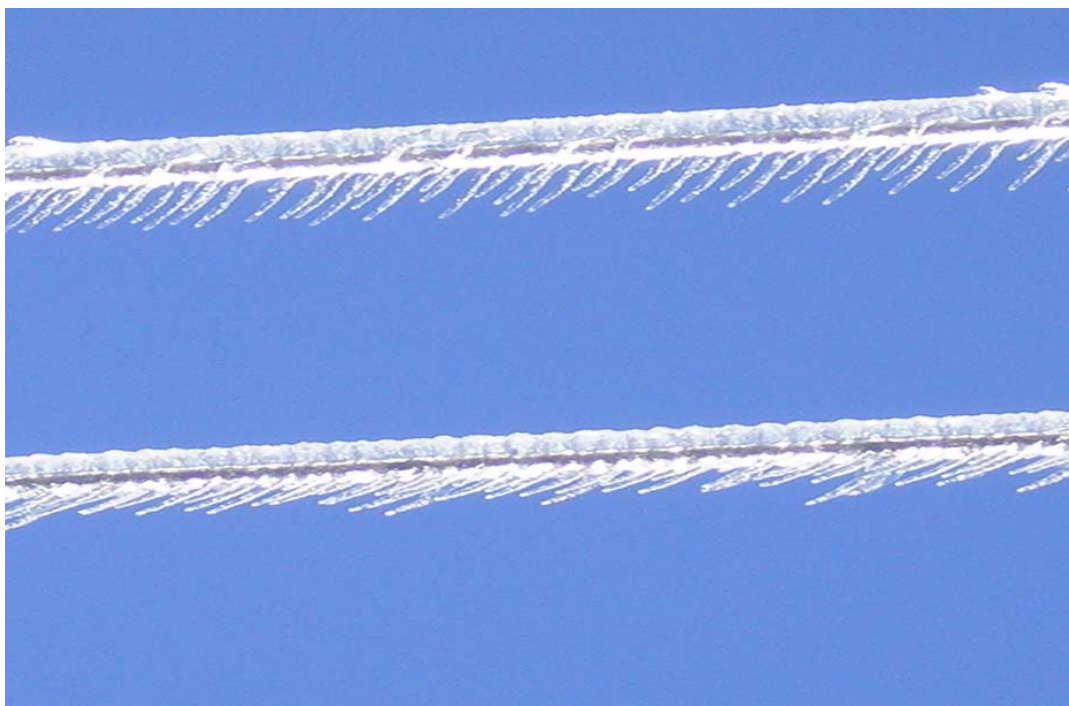
Figure IV-10 - Close-up of ice shown in Figure IV-9. (Photo courtesy of PSNH)

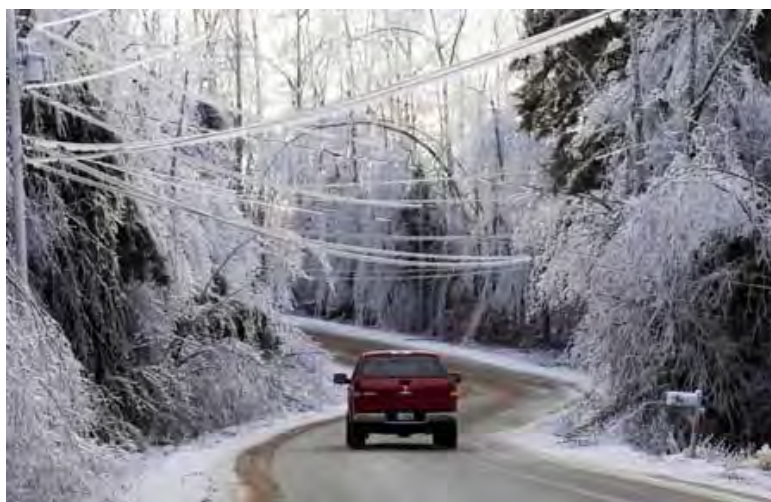
**Figure V-2 - Ice loading on lines during December 2008 ice storm.  
(Photo courtesy of PSNH, location unknown.)**

For the most part, the December 2008 ice storm did not directly damage the transmission and distribution systems. Instead it damaged the woodlands of New Hampshire, causing tree limbs and whole trees to fall, which in turn damaged the power system by breaking poles, cross arms, hardware, and conductors. Poles and conductors are quite resilient to simple ice loading as is evident in Figure V-2 where it may be seen that wires, poles, and a transformer are all carrying heavy ice loads, yet are all completely intact. If a limb or a tree were to break off due to the ice and fall on the wires or against a pole, the additional stress raises the risk that that poles or wires could fail.

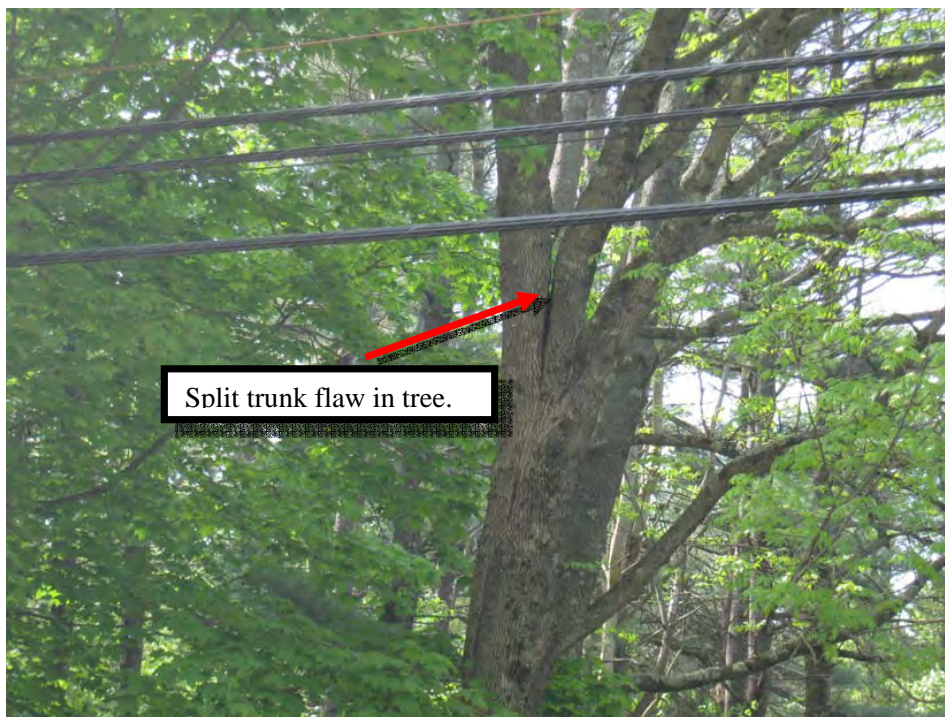
Figure V-4 - Neglected damage and weakness to large limb of tree near Hampton, NH. (Photo by NEI)

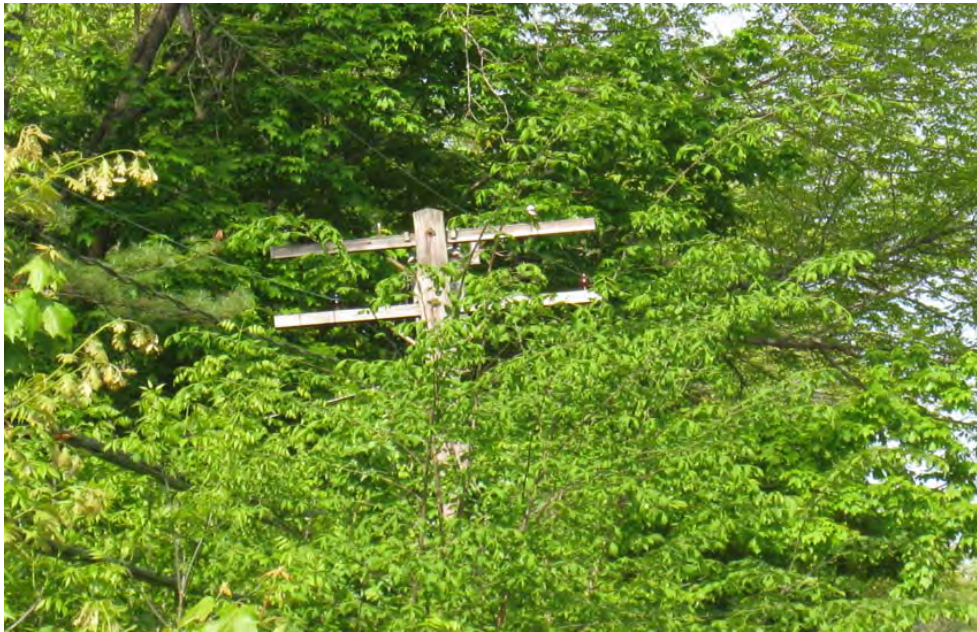
**Figure V-14 – NESC Rule 218 violation in Unitil service area.  
(Photo by NEI)**

This growth is unsafe, violates the NESC, and is possibly damaging the conductors. While this photograph was taken on Unitil's system, it is not meant to single out Unitil. Similar situations occur on the systems of each utility.

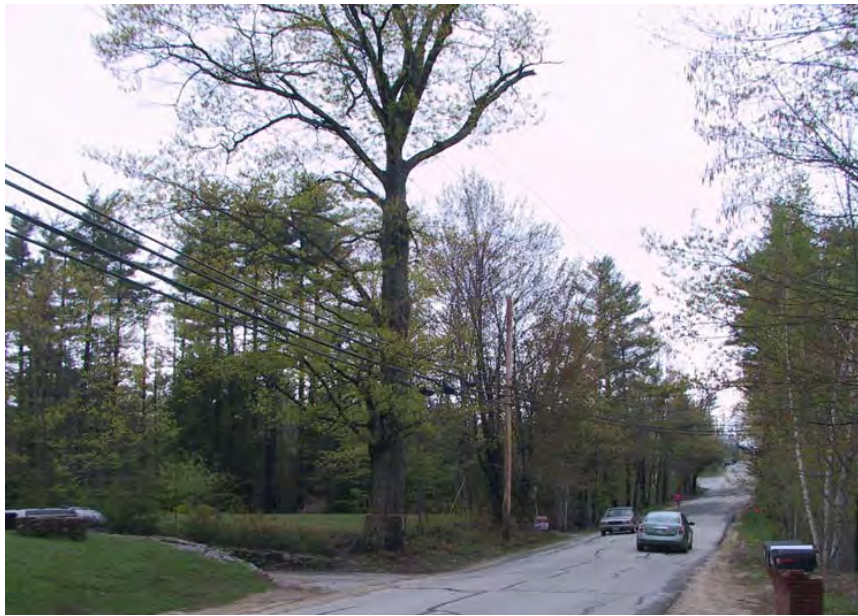
Figure V-15 - Mature oak to be removed in New Ipswich, New Hampshire. (Photo by NEI)

equipment most utilities have available. This particular tree was marked for removal as a "hazard tree." However, this was not done merely due to its proximity to the power line. In New Hampshire, placing the line at risk is not sufficient cause for a tree to be labeled as a hazard. To be classified as a hazard tree, it must also be either infected or dying in addition to its proximity to the line. Within the state, there are many large healthy trees which pose a hazard to power lines and should be considered for removal.

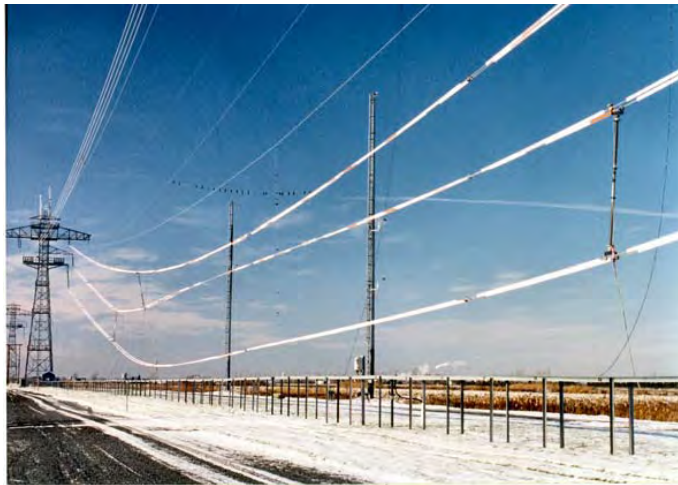
Figure F-9-Excessive sag as a result of galloping. (Photo courtesy of CIGRE)
