Attachment - KFD -1

Power Factor and Power Monitoring Equipment

Request for Information 37 Line/4X1Non-Wires Alternative Project for Distribution Load Relief

2. Monsey Non-wires Alternative Project Description

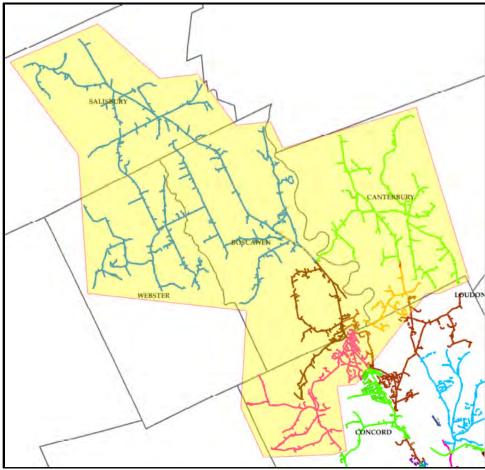
Diagram 1 – 37 Line / 4X1 Load Area

This portion of the Unitil system typically peaks in the late afternoon between the hours of 3PM and 7PM during the months of July and August.

Unitil has identified a possible overload of the 37 line conductor following the switching to restore all load for contingent loss of the 4X1 supply. The recommended traditional option to resolve this constraint is to rebuild approximately 1.6 miles of the 37 line.

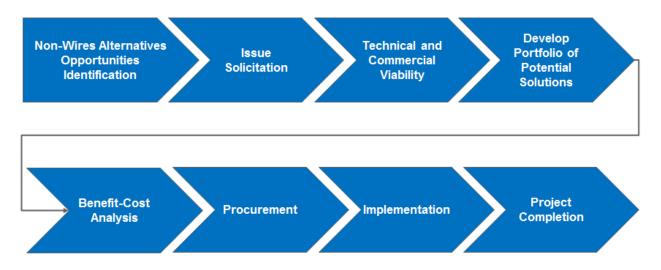
Figure 1: O&R NWA Process Flow

The process shown below is an example of the high-level steps that occur during the identification of NWA solutions, as well as the evaluation, implementation, and verification of the identified solutions. Please note that there are multiple actions that take place between each step to move NWA projects forward to implementation and verification of load relief achieved.

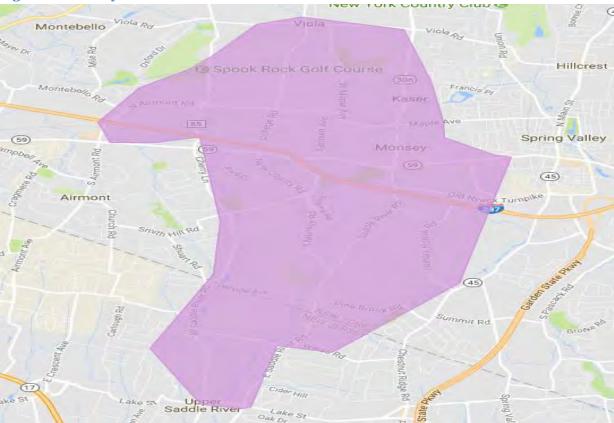
Figure 2 - Monsey Area

Figure 2 below shows the area where load reduction is required which includes area served by Bank 144 and Bank 244 and the associated circuit ties of Bank 244 during the above mentioned contingency. Table 3 indicates the required load reductions by year and the associated time frames when load relief is required. Figure 3 below graphs the typical weekday peak load profile of the Monsey substation with the loss of Bank 244, as forecasted for years 2020, 2022 and 2029.

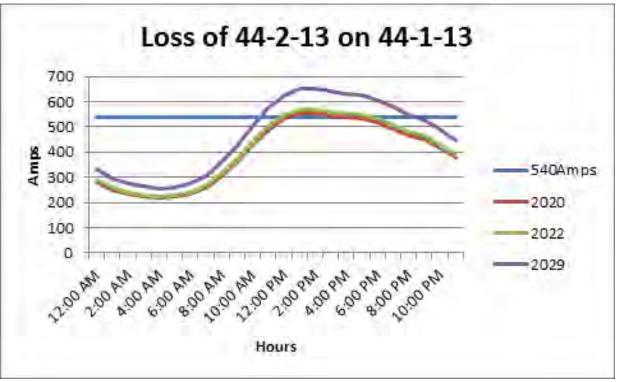
Figure 4: Typical Peak Day Load Profiles for Circuit 44-2-13 Contingency on Circuit 44-1-13

The load profiles for the loss of 44-2-13 on 44-1-13 on a peak day are shown in Figure 4 for years 2020, 2022 and 2029. A geographical map of the area served by 44-1-13 and portions of 44-2-13 is shown in Figure 5.

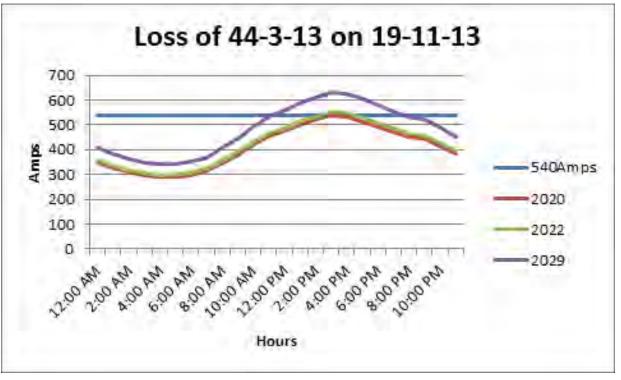
Figure 6: Typical Peak Day Load Profiles for Circuit 44-3-13 Contingency on Circuit 19-11-13

The load profiles for the loss of 44-3-13 on 19-11-13 on a peak day are shown in Figure 6 for years 2020, 2022 and 2029. A geographical map of the area served by 19-11-13 with 44-3-13 is shown in Figure 7.

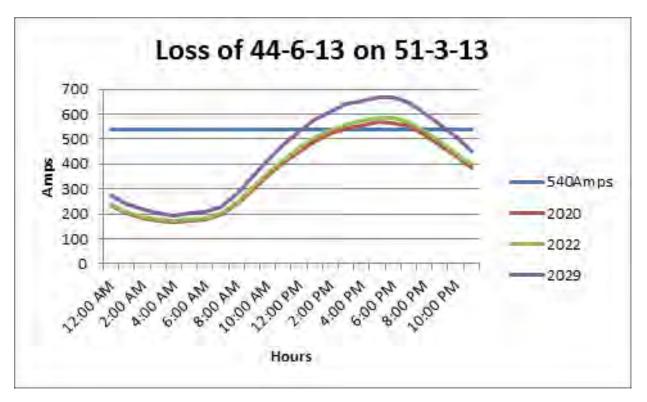
Figure 8: Typical Peak Day Load Profiles for Circuit 44-6-13 Contingency on Circuit 51-3-13

The load profiles for the loss of 44-6-13 on 51-3-13 on a peak day are shown in Figure 8 for years 2020, 2022 and 2029. A geographical map of the area served by 51-3-13 with 44-6-13 is shown in Figure 9.

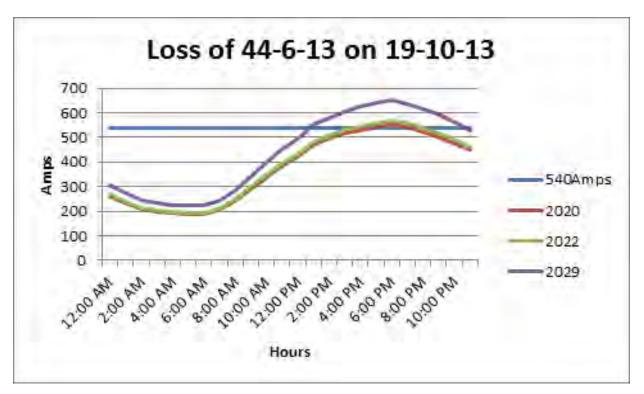
The load profiles for the loss of 44-6-13 on 19-10-13 on a peak day are shown in Figure 10 for years 2020, 2022 and 2029. A geographical map of the area served by 19-10-13 with 44-6-13 is shown in Figure 11.

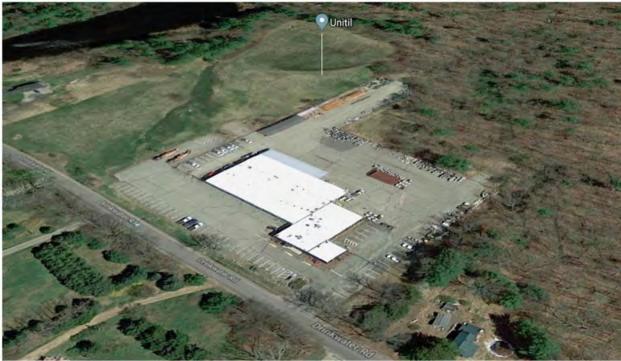
EXISTING CONDITIONS

The current facility at 114 Drinkwater Road in Kensington is located within a residential neighborhood, with single family residences on both sides and across the street. The site is relatively flat and surrounded by wetlands. To the north of the existing building there is an open body of water. The building is served by a well to the north of the existing vehicle storage garage and a leach field located to the west of the building. Both the well and leach field are located out of wetland areas, but not wetland boundaries.

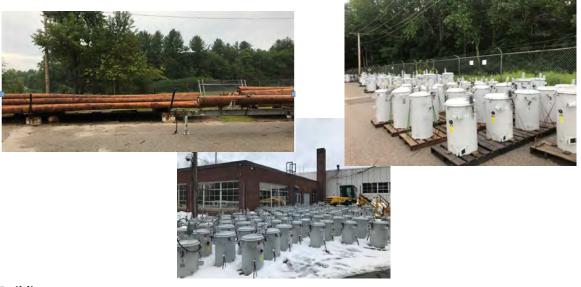
Photos of the existing yard; including pole and transformer storage areas:

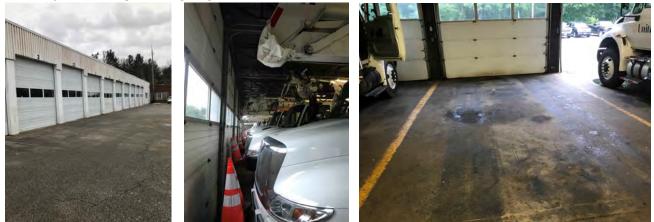
The vehicle garage is too small for modern utility trucks currently in use at the facility. The larger vehicles are difficult to drive into the garage due to the low ceiling height and lack of space. It is difficult to work on the trucks in the garage due to the low ceiling height and limited circulation space around the utility trucks. The floor of the garage doesn't have proper drainage and the space lacks proper ventilation. There are 10 large overhead doors, one for each of the utility trucks. This overhead door arrangement is less energy efficient due to the lack of insulation in the doors and the gaps around the opening that allow heat to escape; compared with a layout with only 2 overhead doors (one for inbound and one for outbound) that can be found at Unitil's Concord and Lunenburg DOC facilities.

Photos of the existing vehicle garage

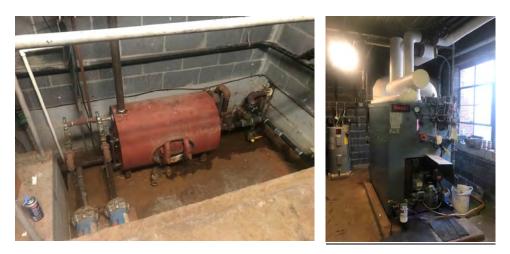
There is a lack of ventilation in the vehicle garage and warehouse areas. In addition, the building's heating system, which consists of cast iron piping, is deteriorating. The deterioration of these pipes requires constant attention and repair and replacement costs. The electrical systems are inadequate for the building's use and do not meet current codes. There is no sprinkler system within the facility, and though it may not be specifically required, it is a best life safety practice to ensure the safety of employees, as well as, building and inventory assets

Photos of the existing MEP components

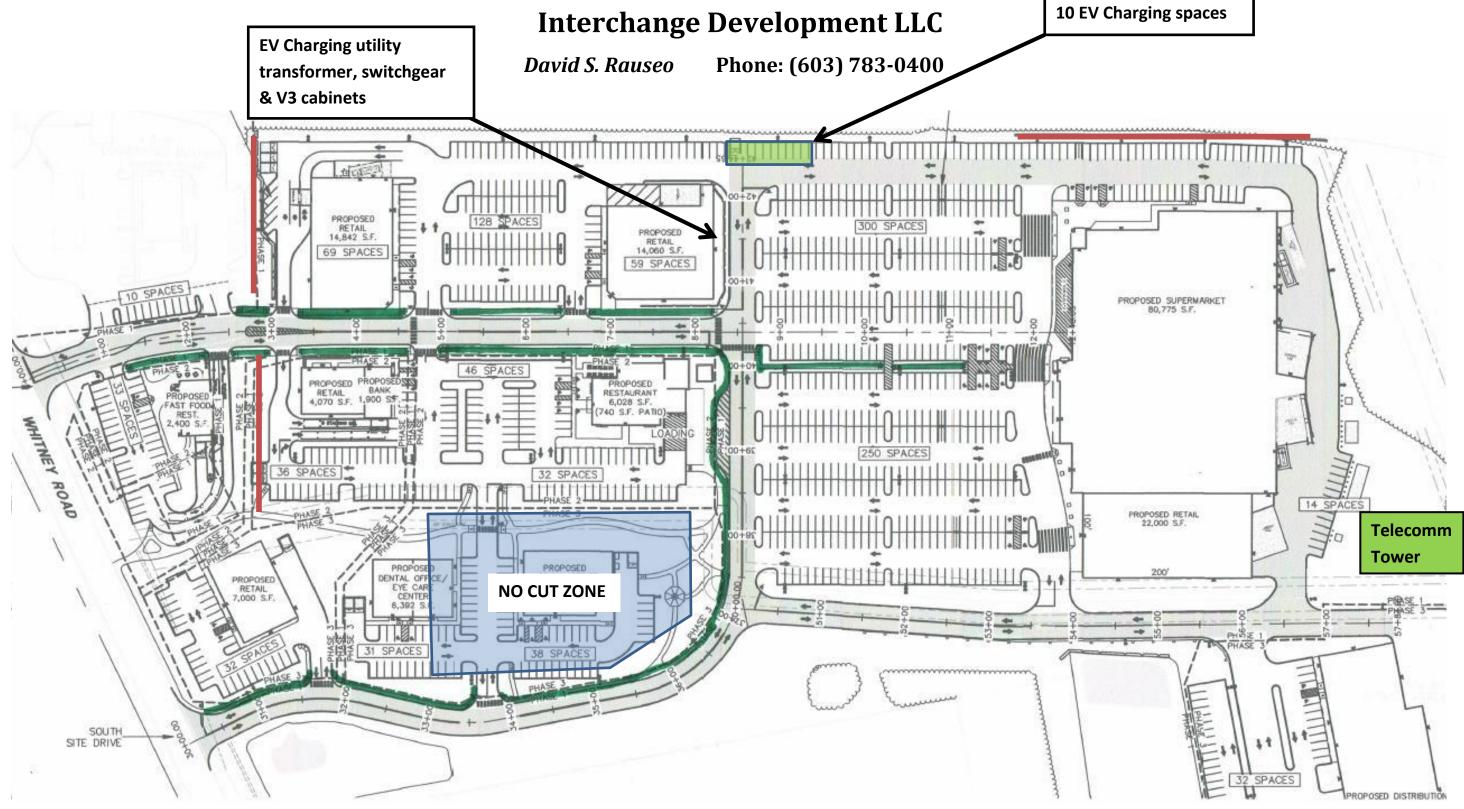
EXIT 17 LIQUOR STORE AND EV PARKING SPACE PLAN 4-21-20

- d. For system and distribution planning purposes Unitil will typically assume 75% of the EV charger ports being utilized at one time. In locations with both Level 2 and DC Fast Charge facilities the Company assumes 75% of the DC fast charge ports being utilized at the same time as 50% of the Level 2 ports. The assumption that 75% of the EV charger ports are being utilized at the same time is based on historical usage of a DC Fast Charge facility in Seabrook. However, in the case of sizing transformers for these facilities Unitil assumes all charging ports being utilized at the same time.
- e. The planned reconductoring will provide sufficient subtransmission line capacity to supply up to two (2) 1MW charge boxes and up to six (6) 150kW chargers.
